# Drinking Water Audit Report

<b>County:</b>	Roscommon	<b>Date of Audit:</b>	22 <sup>nd</sup> June 2015
<b>Plant(s) visited:</b>	Castlerea Drinking Water Treatment Plant  (serving Castlerea Urban PWS and Castlerea Regional PWS).	<b>Date of issue of Audit Report:</b>	25 <sup>th</sup> June 2015
		<b>File Reference:</b>	DW2008/382; DW2008/383
		<b>Auditors:</b>	Ms Yvonne Doris (lead auditor) Ms Michelle Roche
<b>Audit Criteria:</b>	<ul style="list-style-type: none"> <li>• The <i>European Union (Drinking Water) Regulations 2014 (S.I. 122 of 2014)</i>.</li> <li>• <i>The EPA Handbook on the Implementation of the Regulations for Water Services Authorities for Public Water Supplies (ISBN: 978-1-84095-349-7)</i></li> <li>• The recommendations specified in the <i>EPA Drinking Water Report</i>.</li> <li>• The recommendations in any previous audit reports.</li> </ul>

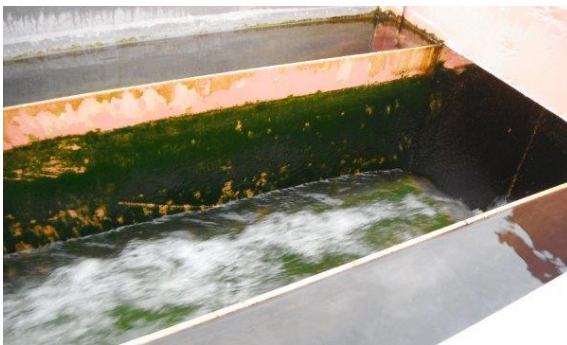
Photograph 1: Algae on filter channel and walls.

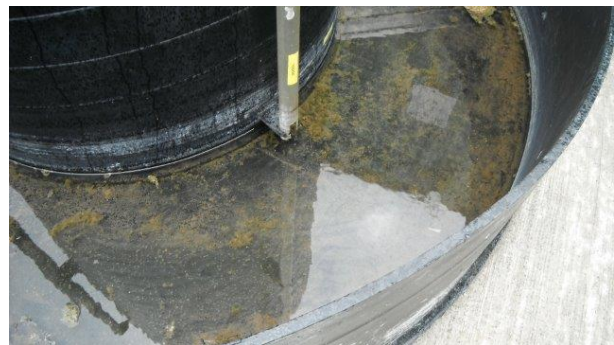
Photograph 2: Water in PAC bund.

6. Irish Water should ensure that standing water in bunds is removed on a regular basis.
7. Irish Water should investigate the storage of Polyaluminium chloride for long periods and
