# Drinking Water Audit Report

<b>County:</b>	Roscommon	<b>Date of Audit:</b>	23 <sup>rd</sup> June 2015
<b>Plant(s) visited:</b>	Killeglan Drinking Water Treatment Plant (serving Killeglan PWS).	<b>Date of issue of Audit Report:</b>	25 <sup>th</sup> June 2015
		<b>File Reference:</b>	DW2011/3
		<b>Auditors:</b>	Ms Yvonne Doris (lead auditor) Ms Michelle Roche Ms Aoife Loughnane.
<b>Audit Criteria:</b>	<ul style="list-style-type: none"> <li>• The <i>European Union (Drinking Water) Regulations 2014 (S.I. 122 of 2014)</i>.</li> <li>• <i>The EPA Handbook on the Implementation of the Regulations for Water Services Authorities for Public Water Supplies (ISBN: 978-1-84095-349-7)</i></li> <li>• The recommendations specified in the <i>EPA Drinking Water Report</i>.</li> <li>• The recommendations in any previous audit reports.</li> </ul>

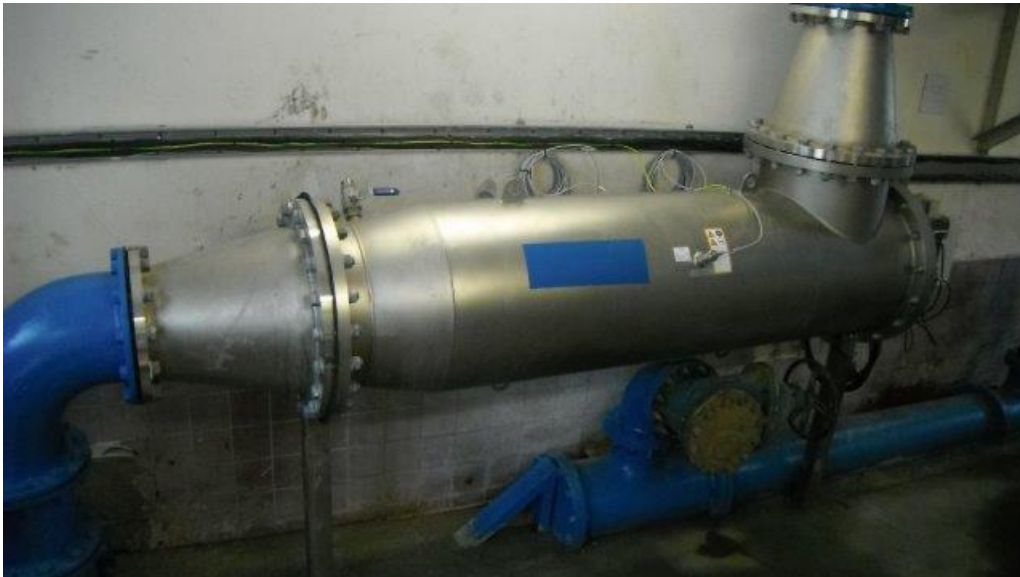
5.	<p><b>Chlorination and Disinfection</b></p> <p><b>UV disinfection</b></p> <ol style="list-style-type: none"> <li>a. A single Xylem/Wedeco Spectrum 900e UV reactor (photograph 1) validated to UVDGM (USEPA) standard is in place to provide a barrier to <i>Cryptosporidium</i>. UV disinfection denatures the DNA of <i>Cryptosporidium</i> oocysts and prevents its replication<sup>1</sup>.</li> <li>b. The UV reactor is validated to achieve 3-log reduction of <i>Cryptosporidium</i>, if operated at an incoming UVT of &gt;73.5% and flow rate of 350m<sup>3</sup>/hr based on the validation certificate document provided by the manufacturer and documentation stating same provided by Irish Water. Below 73.5% UVT the reactor shuts down and no undisinfected water can enter supply. An alarm is sent to the plant operator who attends the site on a 24 hour/7 day basis.</li> <li>c. Incoming UVT, UVI in the reactor, flow rate through the reactor and reactor temperature is recorded continuously. The UVT monitor is checked weekly using a portable UVT monitor and is calibrated monthly. Flow and temperature monitors are calibrated monthly.</li> <li>d. Target UV dose is 14.4mJ/cm<sup>2</sup> in order to ensure the minimum required UV dose of 12 mJ/cm<sup>2</sup> is achieved. An alarm set-point at 13.2mJ/cm<sup>2</sup> alerts the plant operator to a reducing UV dose.</li> <li>e. Flow rate through the reactor is 350m<sup>3</sup>/hr. The UV reactor is capable of treating multiples of this flow rate based on the calculated dose algorithm of the reactor.</li> </ol>

**Photograph 1: Xylem/Wedeco Spectrum 900e UV reactor.**

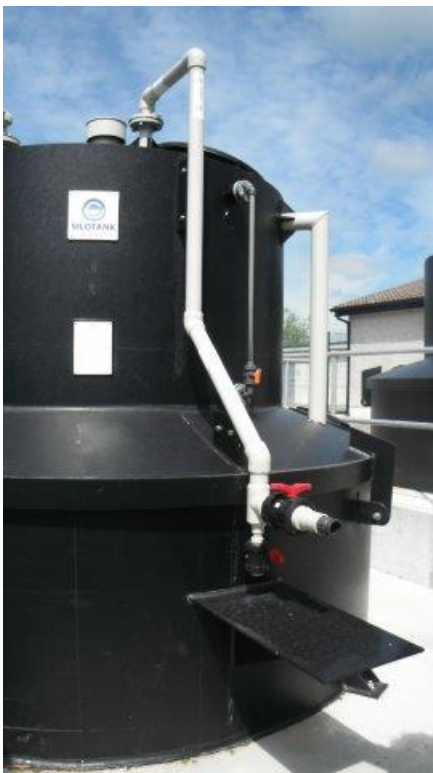
8.	<p><b>Chemical storage and bunds</b></p> <ul style="list-style-type: none"> <li>a. Chemicals are delivered directly into the bulk tanks and are supervised by the plant operator. No delivery can be made without access being provided by the plant operator.</li> <li>b. All chemicals (PAC, chlorine, fluoride) in bulk tanks are in double linked bulk tanks and day tanks are banded. All chemical tanks are fitted with level sensors to indicate when tanks are almost full. Spill kits are carried in the plant operator’s vehicle.</li> <li>c. The fillpoints are not contained in a banded area (photograph 2). Spill trays are on site for use during deliveries. The spill trays in use do not have the capacity to contain the contents of bulk tank delivery pipes. Diesel for the onsite generator is stored in a double lined container.</li> <li>d. All chemical storage tanks are appropriately labelled and fitted with appropriate health and safety signage.</li> </ul>

**Photograph 2: Example of delivery pipe to bulk storage tank not within bunded area.**

- 5. Irish Water should review chemical storage arrangements at the treatment plant. Fill points for storage tanks should be within a bunded area. Refer to EPA guidance document –“*IPC Guidance Note on Storage and Transfer of Materials for Scheduled Activities*”.
- 6. Irish Water should ensure that the spill trays used during the delivery of chemicals into bulk tanks have sufficient capacity to contain the contents of the delivery pipe.
