County:	Roscommon	Date of Audit:	4 th April 2014
Plant(s) visited:	North East Regional Public Water Supply (serving Roosky, Strokestown/Elphin and Tarmonbarry water supply zones)	Date of issue of Audit Report:	9 th April 2014
		File Reference:	DW2011/39
		Auditors:	Ms Yvonne Doris Mr Darragh Page
Audit Criteria:	<ul style="list-style-type: none"> • The <i>European Union (Drinking Water) Regulations 2014 (S.I. 122 of 2014)</i>. • <i>The EPA Handbook on the Implementation of the Regulations for Water Services Authorities for Public Water Supplies (ISBN: 978-1-84095-349-7)</i> • The recommendations specified in the EPA Report on <i>The Provision and Quality of Drinking Water in Ireland</i>. • The recommendations in any previous audit reports.

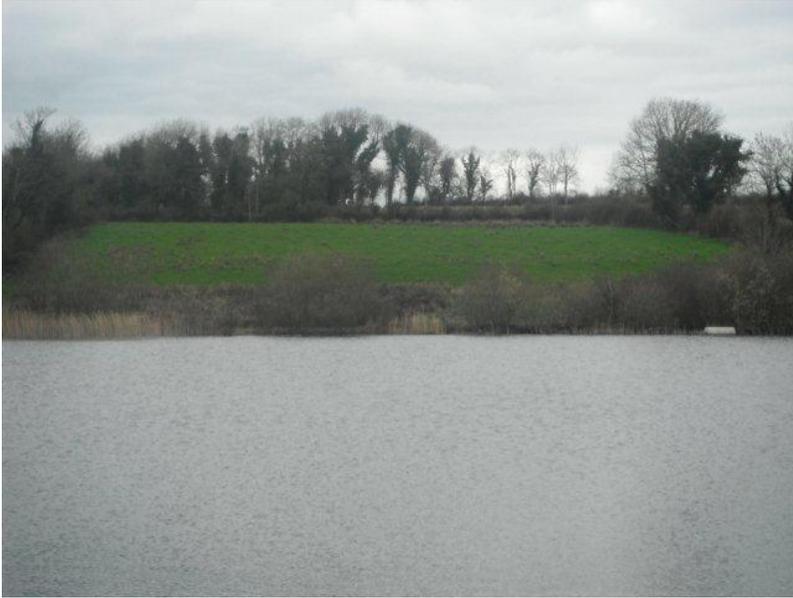
1.	<p>Source Protection</p> <ul style="list-style-type: none"> a. The source of the North East Regional public water supply is Lisheen lake. The lake is fed by the Silverree river and is surrounded by agricultural land, mainly used for grazing (see Photograph 1). Roscommon County Council stated that there is fencing to prevent cattle directly accessing the lake, that landspreading occurs locally and that there are no landspreading buffer zones in place surrounding the lake. There has been no written communication with local farmers to either inform them of the drinking water abstraction at the lake or of their obligations under the Good Agricultural Practice regulations. Houses nearby are served by septic tanks and no survey or inspections of septic tanks have been undertaken locally. b. The <i>Cryptosporidium</i> Risk Assessment Score is 120 (very high risk). c. There is no barrier to the entry of <i>Cryptosporidium</i> if it is present in the raw water. d. Zebra mussels is the lake have fouled the intake and raw water storage tank in the past. e. The lake is used by fishermen using boats with outboard motors. f. The intake is 4 metres below the surface of the lake and two sets of fine screens remove solids prior to the water entering a raw water storage tank. The abstraction rate is 250m³/hour for 12 hours per day.

Photograph 1: Lisheen lake and surrounding grazing land

2. The Water Services Authority should implement the requirements of the *European Union (Good Agricultural Practice for the Protection of Waters) Regulations 2014 (SI No.31 of 2014)* to ensure, unless an alternative setback distance has been set as per Article 17 that:

- i. Organic fertiliser or soiled water is not applied to land within 200 m of the abstraction point; and
 - ii. Farmyard manure held in a field prior to landspreading is not placed within 250 m of the abstraction point.

3. The Water Services Authority should examine the appropriateness of the setback distances in the *European Union (Good Agricultural Practice for the Protection of Waters) Regulations 2014 (SI No.31 of 2014)* for the source of the supply. The Water Services Authority should have regard to the EPA guidance on alternative setback distances.

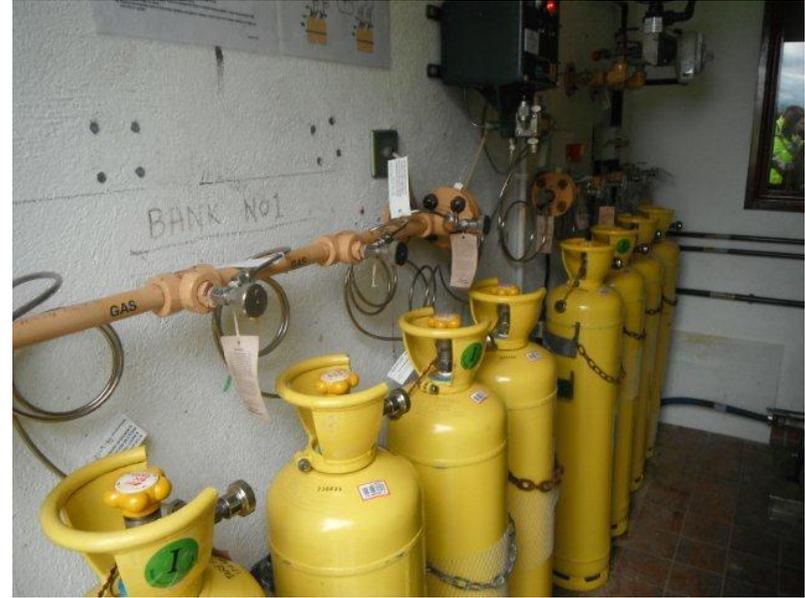
3.	<p>Chlorination and Disinfection</p> <ul style="list-style-type: none"> a. Water from the raw water storage tank is disinfected using chlorine gas at Lisheen pumphouse. The chlorine dosing point is on the rising main just outside the pumphouse (see Photograph 2). Dosing is flow proportional with 4 duty cylinders and 4 standby

<p>cylinders with automatic switchover (see Photograph 3). Chlorine dosing is adjusted manually by the caretaker and is typically 2.1mg/l to achieve 0.1-0.1mg/l at the end of the network.</p> <ul style="list-style-type: none"> b. A chlorine residual monitor is in place at the Kiltristan reservoir. The low alarm is set at 0.5mg/l and the high alarm at 2mg/l. The alarm dials out to the caretaker, the supervisor and the area engineer. The chlorine monitor was reading 1.47ppm at the time of the audit. c. Chlorine contact time in the supply is adequate but a calculation of the contact time was not available during the audit. d. The chlorine monitor readings recorded by the caretaker closely aligned those of the HACH meter used to cross-check the residual chlorine.

Photograph 3: Duty and standby chlorine gas cylinders

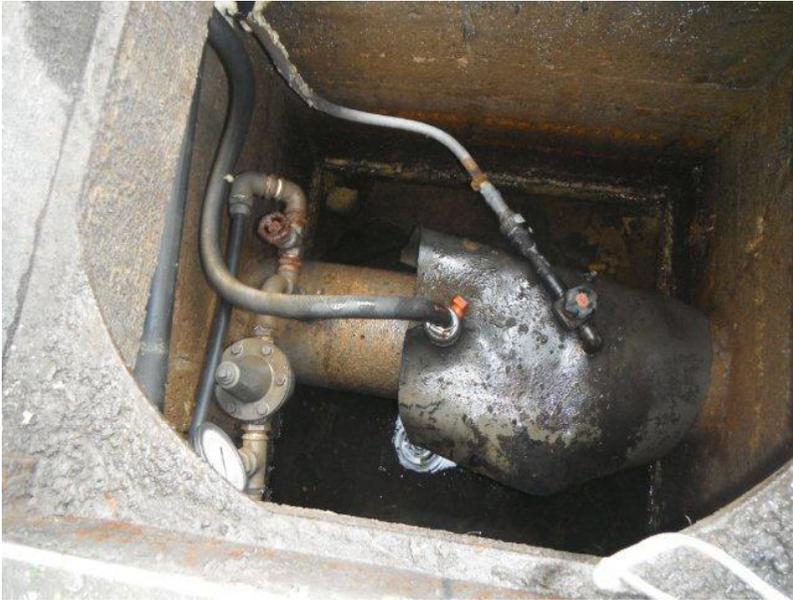
Photograph 2: Chlorine and fluorine dosing points

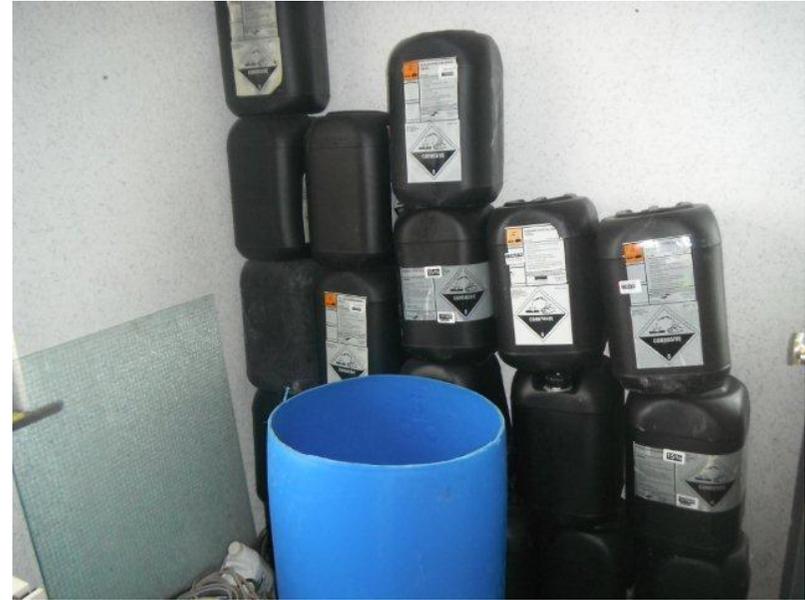
8.	<p>Hygiene and Housekeeping</p> <ul style="list-style-type: none"> a. New water pipes at the pumphouse were being stored unsealed and at risk of contamination (see Photograph 5). b. Empty chloros drums were stored at the Kiltristan reservoir (see Photograph 4).

Photograph 4: Empty chlorine drums

9. The Water Services Authority should ensure waste chloros drums are removed from the Kiltrustan reservoir.

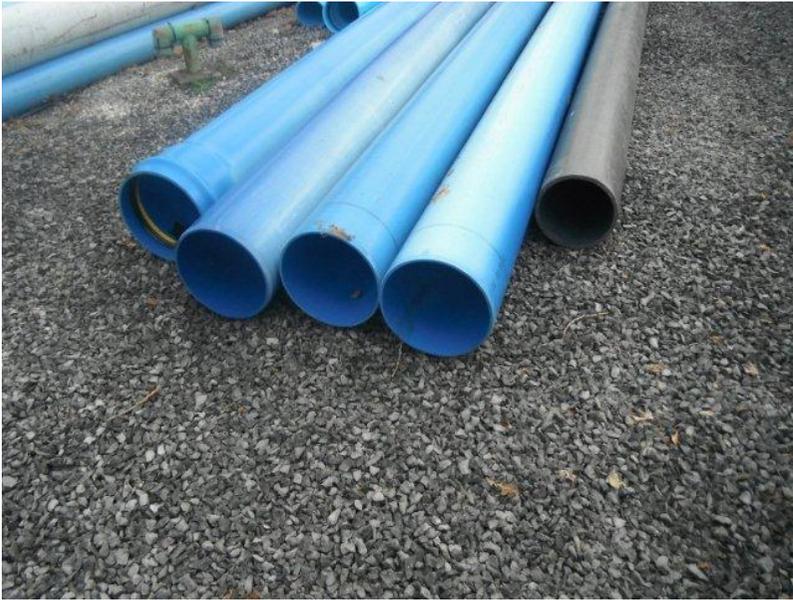
Photograph 5: Unsealed water pipes at Lisheen pumphouse

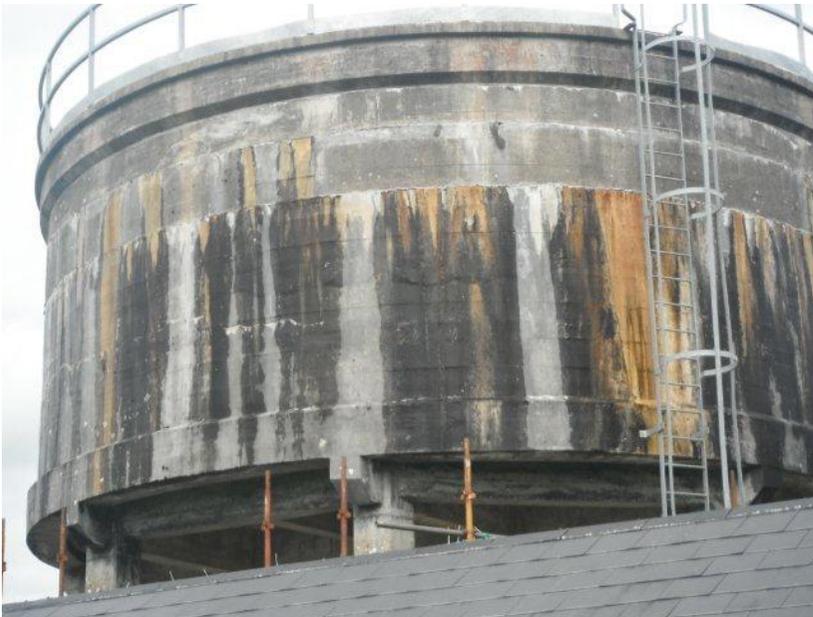
4.	<p>Treated Water Storage</p> <ul style="list-style-type: none"> a. Chlorinated and fluoridated water is pumped to the interim and main reservoirs at Kiltristan and from there to three outlying reservoirs at Elphin, Ballyfeeny and Knockhall where re-chlorination occurs. b. The main reservoir was visited during the audit. The final water turbidity meter at the main reservoir was reading 1.39NTU during the audit. The reservoir access hatch was locked but the mesh covering the vents would allow insects to access the reservoir. c. The reservoir at Elphin was visited during the audit. It was not inspected due to health and safety reasons (unsafe access ladder). The walls of the reservoir were visibly leaking (Photograph 6) d. Each of the reservoirs (interim, main, Elphin, Ballyfeeny and Knockhall) were last cleaned in 2005. They were inspected in 2013 and require cleaning (~10 cm sediment).

Photograph 6: Elphin reservoir (leaking walls)

6. The Water Services Authority should ensure that all reservoirs are inspected and cleaned out on a regular basis and any maintenance and repairs completed as soon as possible after the need has been identified.
7. The Water Services Authority should ensure that all vents on the reservoirs are secured against ingress of animals or insects or deliberate introduction of any contaminant or acts of vandalism.
