Drinking Water Audit Report

County:	Roscommon	Date of Audit:	03/07/2014
Plant visited:	North Roscommon Regional Water Supply Scheme	Date of issue of Audit Report:	17/7/2014
		File Reference:	DW2009/320
		Auditors:	Ms Yvonne Doris
Audit Criteria:	<ul style="list-style-type: none"> • The <i>European Union (Drinking Water) Regulations 2014 (S.I. 122 of 2014)</i>. • The <i>EPA Handbook on the Implementation of the Regulations for Water Services Authorities for Public Water Supplies (ISBN: 978-1-84095-349-7)</i> • The recommendations specified in the EPA Report on <i>The Provision and Quality of Drinking Water in Ireland</i>. • The recommendations in any previous audit reports.

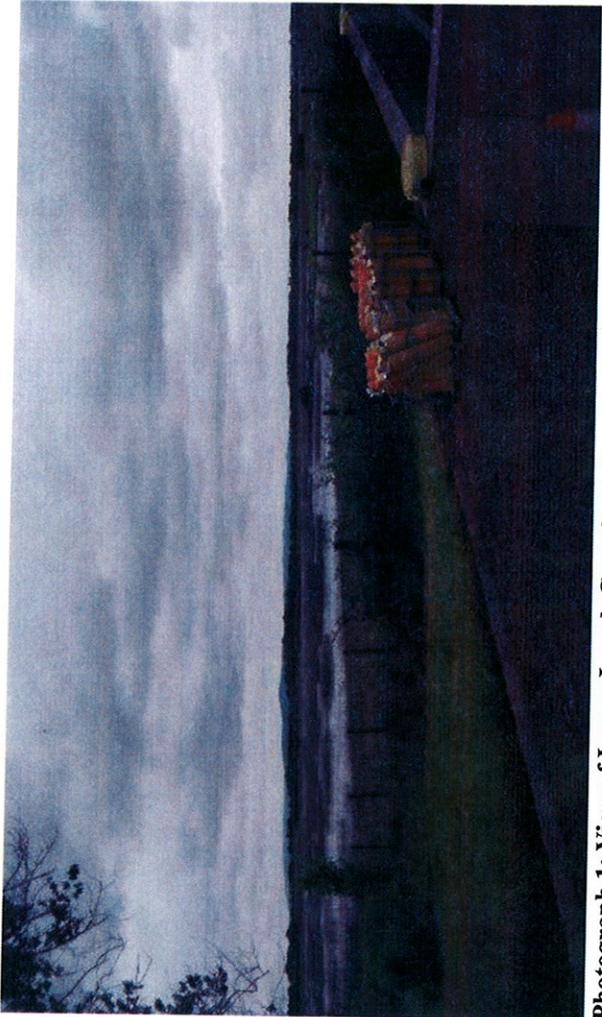
1.	<p>Source Protection</p> <ul style="list-style-type: none">a. The source is Lower Lough Gara, a shallow lake fed by the Breedoge river and possibly by a number of springs (photograph 1). The lake level varies by approximately 1.5m. The lake experiences regular algal blooms. The intake is an unknown distance from the edge of the lake. The intake has coarse screens that are not inspected or cleaned. An automatic water jet rotating screen is also in place. The intake was moved from its original location in the early 1990s following surveys. Cattle can access the lake but fencing prevents access to the area close to the intake. The abstraction is 470m³/hr for 18 hours a day.b. Raw water is monitored manually daily for colour, pH, turbidity and TOC. Raw water turbidity is usually around 3 but can be as high as 5 NTU. Raw water colour is typically 100-200 Hazen Units but can be as high as 450 Hazen Units. Raw water TOC ranges from 9 to 11mg/l. Raw water UVT ranges from 11 to 81%. At the time of the audit raw water turbidity was 3.42 NTU and colour was 100 Hazen Units.c. No farm surveys or catchment inspections have been done in the catchment. Farmers have not been written to. There are no buffer zones established. Catchment surveys will be scheduled but not in 2014. The <i>Cryptosporidium</i> Risk Assessment Score is very high risk but the score was not available at the time of the audit.

Photograph 1: View of Lower Lough Gara from treatment plant

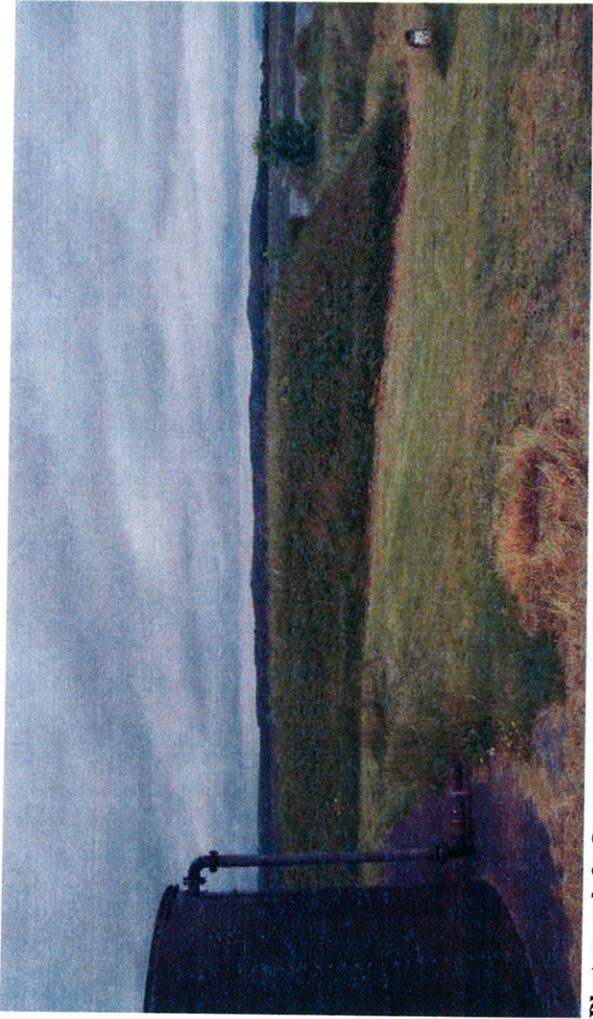
5.	<p>Treated Water Storage and Distribution Network</p> <ul style="list-style-type: none"> a. Two reservoirs are located at the treatment plant (one built in 1981 and one in 1991). There was no information available as to when they were last cleaned. Vegetation has grown over the reservoir built in 1991 (photograph 3) and access hatches were not locked (photograph 4). b. Two reservoirs are located off site. Lissacurkia reservoir and Fairymount reservoir were both built in 1989. There was no information available as to when they were last cleaned. A camera survey was conducted on the Lissacurkia reservoir in 2011. It was deemed to be structurally ok but had 4-5 inches of sediment. The Lissacurkia reservoir is overgrown and the surface could not be accessed (see photograph 5). Roscommon County Council confirmed that the access hatches were locked but that the vents were not meshed. Fairymount reservoir is a double celled round reservoir (see photograph 6). Vents were not meshed and only one of four access hatches was locked. c. Unidirectional flushing and souring is done in the network. It is done based on time every three months. Operators aim to reduce turbidity to below 1 NTU when flushing. There are parts of the network that have insufficient scour valves and therefore are not being scoured. d. Unaccounted for water is approximately 50%. Roscommon County Council has a dedicated repair crew working on leaks in the supply.

Photograph 3: Overgrown reservoir on treatment plant site (built in 1991)

20. The Water Services Authority should remove all vegetation from the sides and cover of the reservoir built in 1991, at the treatment plant and the Lissacurkia reservoir, to ensure that the reservoirs can be visually inspected on all sides and also to prevent damage to the integrity of the reservoir.

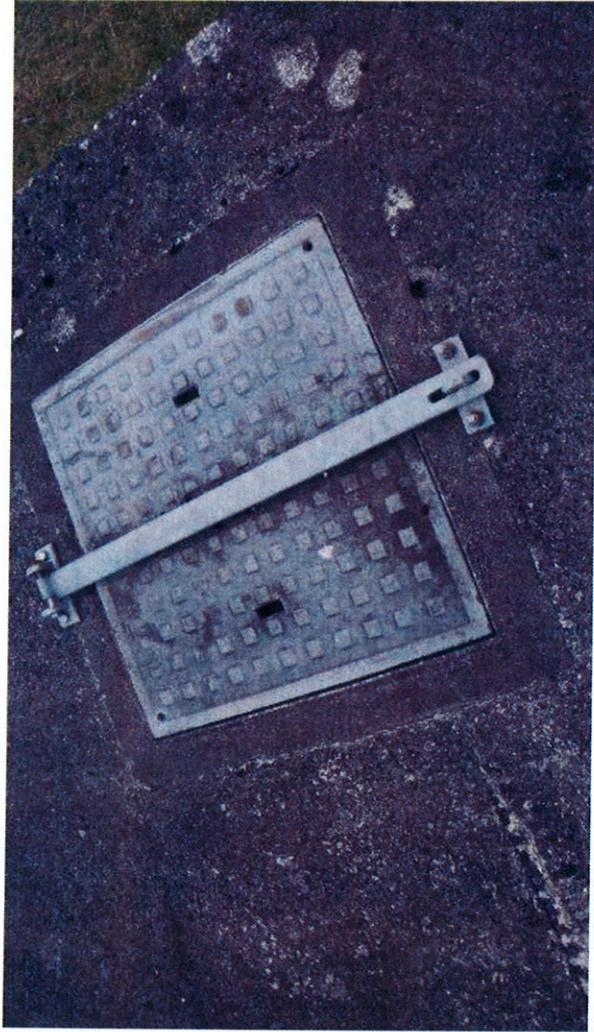
Photograph 4: Unlocked access hatch on reservoir at treatment plant (built in 1981)

18. The Water Services Authority should clean all four reservoirs (the two reservoirs at the plant and the Lissacurkia and Fairymount reservoirs).
19. The Water Services Authority should ensure that all vents and access hatches on all four reservoirs are secured against ingress of animals or deliberate introduction of any contaminant or acts of vandalism.

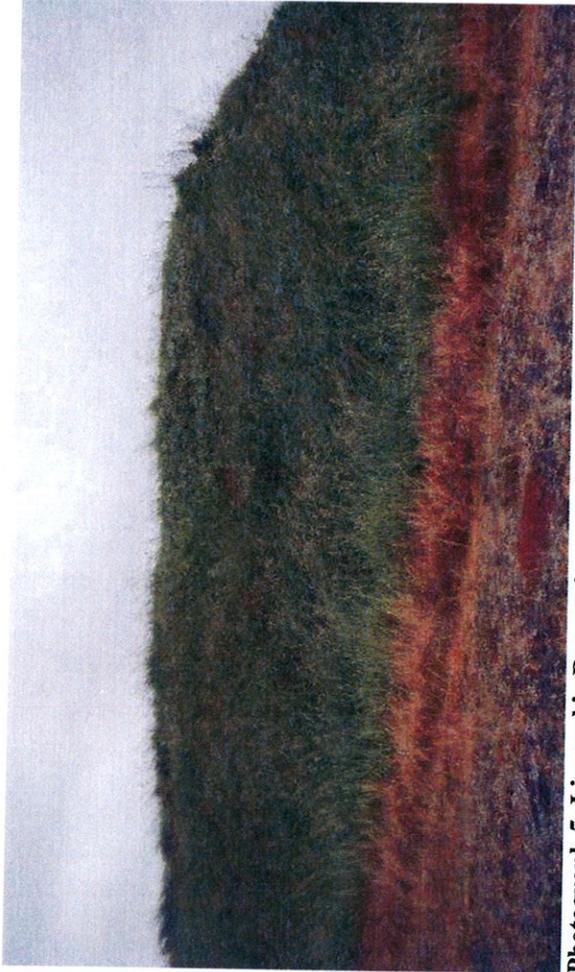
Photograph 5: Lisacurkia Reservoir – overgrown

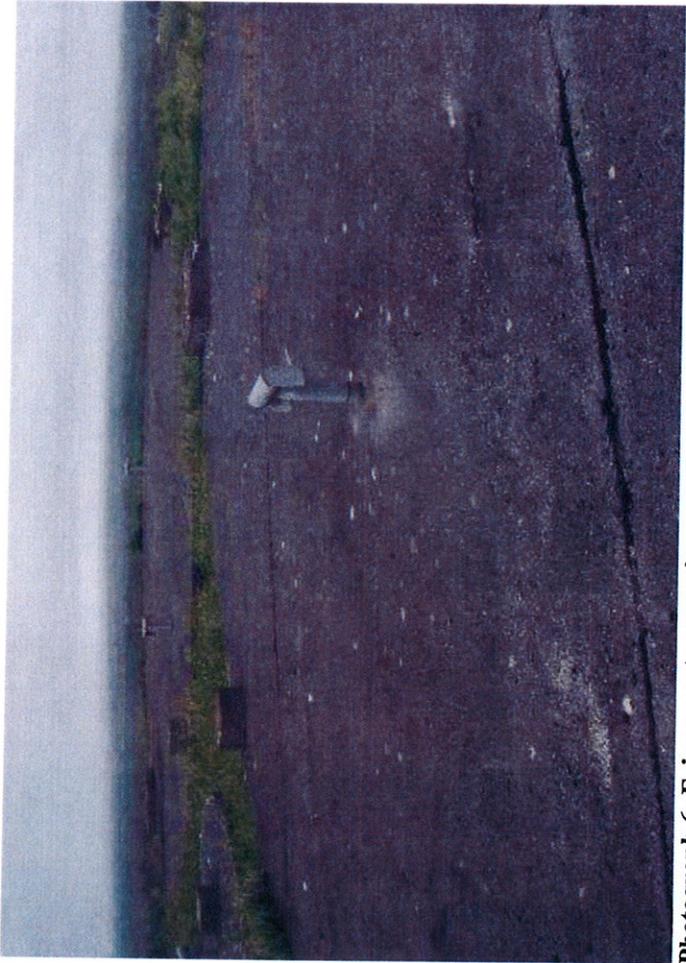
Photograph 6: Fairymount reservoir – unmeshed vents and only one of four access hatches were locked.
