# Drinking Water Audit Report

<b>County:</b>	Tipperary	<b>Date of Audit:</b>	28/05/19
<b>Plant(s) visited:</b>	Borrisokane Water Supply (Scheme Code 2800PUB1002)	<b>Date of issue of Audit Report:</b>	10/06/19
		<b>File Reference:</b>	DW2019/99
		<b>Auditor:</b>	Criona Doyle
<b>Audit Criteria:</b>	<ul style="list-style-type: none"> <li>• The <i>European Union (Drinking Water) Regulations 2014 (S.I. 122 of 2014) as amended.</i></li> <li>• <i>The EPA Handbook on the Implementation of the Regulations for Water Services Authorities for Public Water Supplies (ISBN: 978-1-84095-349-7)</i></li> <li>• The recommendations specified in the <i>EPA Drinking Water Report.</i></li> <li>• EPA Drinking Water Advice Notes No.s 1 to 15.</li> </ul>

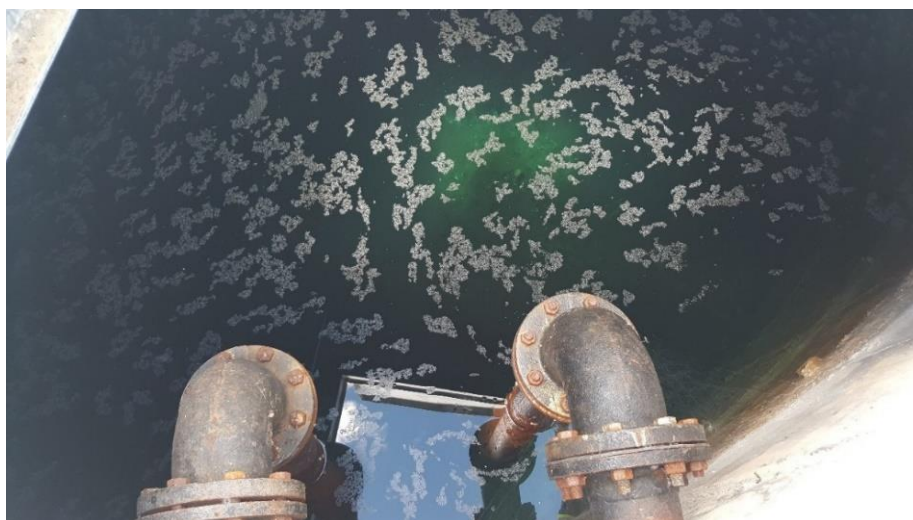
1.	<p><b>Source Protection</b></p> <ul style="list-style-type: none"> <li>a. A cover is present over the spring collection chamber which provides some protection of the spring. On the day of the audit material was visible floating on the water surface (Photo No. 1). Following the audit (30/05/19) Irish Water confirmed the material was grass seed as a result of grass cutting.</li> <li>b. The site is surrounded by agricultural land used for pasture. Sheep and cattle were observed grazing on the surrounding land on the day of the audit.</li> <li>c. Adjacent landowners were informed of their obligations under the GAP regulations [European Union (Good Agricultural Practice for the Protection of Waters) Regulation 2014 (S.I. No. 31 of 2014)] in 2009. The caretaker monitors activities within the buffer zones.</li> <li>d. A raw water monitoring programme is in place with monitoring taking place 3 times per year.</li> <li>e. The EPA's EDEN system indicates that there is no turbidity monitor at the site.</li> <li>f. The <i>Cryptosporidium</i> risk score was completed in 2009 with a risk score of 66 (moderate risk).</li> <li>g. The site is well fenced and secure.</li> <li>h. The raw water undergoes aeration but the reason for the aeration stage could not be confirmed at the audit.</li> </ul>

On the day of the audit material was observed floating on the water surface of the covered spring collection chamber. The presence of floating material indicates a potential issue with the integrity of the cover which should be examined and any necessary remedial measures undertaken to ensure the safety and security of the supply.

**Photograph No. 1:** Floating debris visible inside covered collection chamber

1. Irish Water should assess the integrity of the cover on the spring collection chamber to ensure it provides adequate protection of the source and undertake any required remedial measures.
2. Irish Water is requested to confirm if there is an online turbidity monitor in place at the WTP and provide details of the turbidity alarm set point.
