# Drinking Water Audit Report

<b>County:</b>	Tipperary	<b>Date of Audit:</b>	13/10/17
<b>Plant(s) visited:</b>	Cloughjordan Public Water Supply (Scheme Code 2800PUB1005)	<b>Date of issue of Audit Report:</b>	27/10/17
		<b>File Reference:</b>	DW2017/145
		<b>Auditors:</b>	Ms. Criona Doyle
<b>Audit Criteria:</b>	<ul style="list-style-type: none"> <li>• The <i>European Union (Drinking Water) Regulations 2014 (S.I. 122 of 2014)</i>.</li> <li>• <i>The EPA Handbook on the Implementation of the Regulations for Water Services Authorities for Public Water Supplies (ISBN: 978-1-84095-349-7)</i></li> <li>• The recommendations specified in the <i>EPA Drinking Water Report</i>.</li> <li>• EPA Drinking Water Advice Notes No.s 1 to 15.</li> <li>• The recommendations in any previous audit reports.</li> </ul>

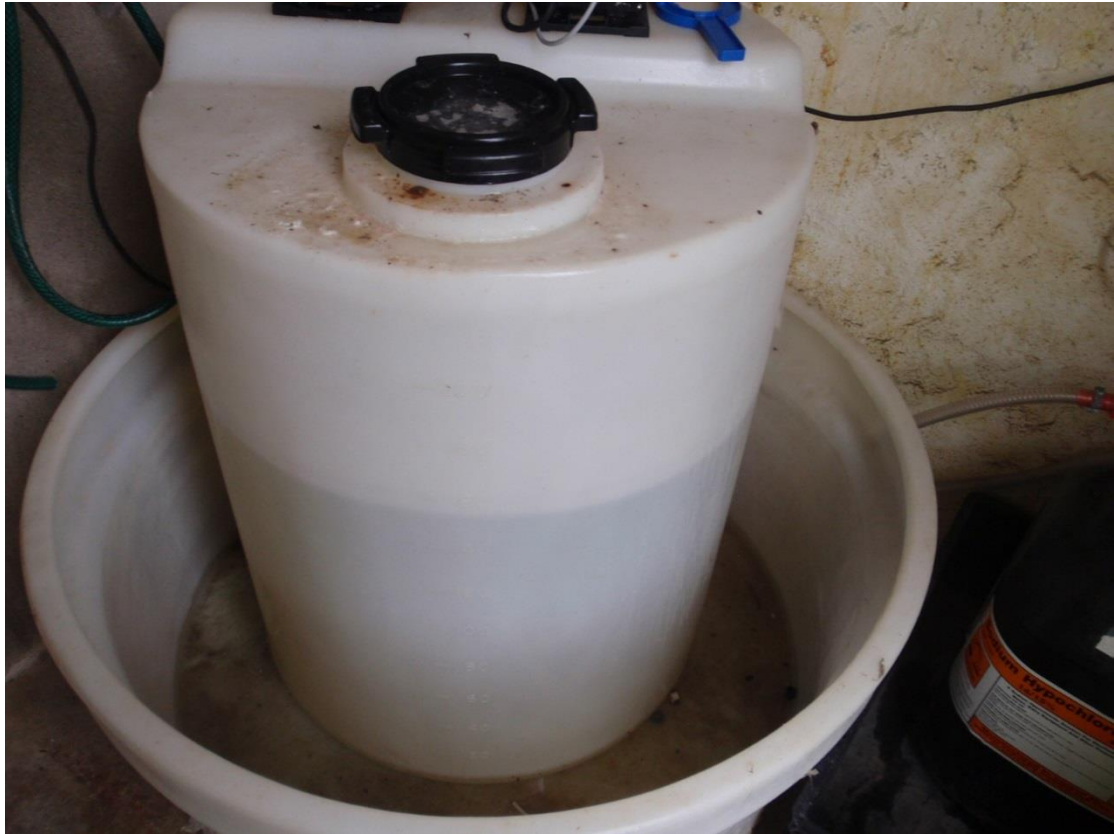
**Photograph No.1** : Build Up of Liquid in Chlorine Day Tank Bund.

4. Irish Water should ensure that the bund on the chlorine day tank is cleaned out and any build up of liquid in the bund is removed.
