# Drinking Water Audit Report

| <b>County:</b> | Tipperary | <b>Date of Audit:</b> | 2 <sup>nd</sup> November 2015 |
| <b>Plant(s) visited:</b> | Galtee Regional Water Treatment Plant | <b>Date of issue of Audit Report:</b> | 24 <sup>th</sup> November 2015 |
| | | <b>File Reference:</b> | DW2015/156 |

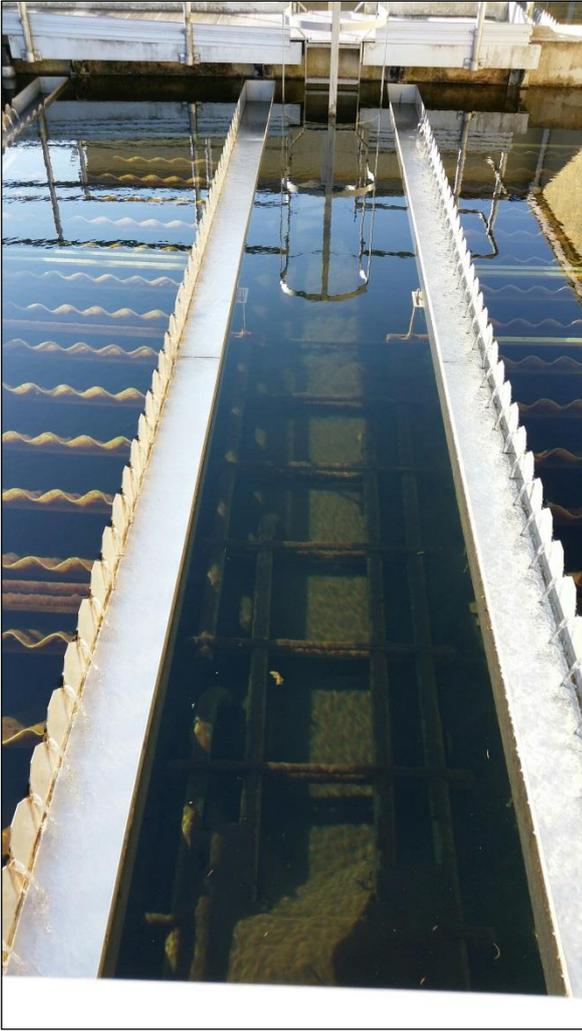
Photograph 1: Floc on surface of water in clarifier

3. Irish Water should review the coagulant mixing process to ensure that there is adequate mixing and contact time of the coagulant prior to entry into the clarifier. Irish Water should implement the following actions as discussed during the audit;
  - i. Install a new static mixer after coagulant dosing; and
  - ii. Install a flocculation tank at the water treatment plant.
4. Irish Water should review the operation of the clarifiers to ensure that they are operating as effectively as possible and producing a stable floc blanket. The following items should be reviewed;
  - i. The installation of a cover on the clarifiers to reduce wind interference; and

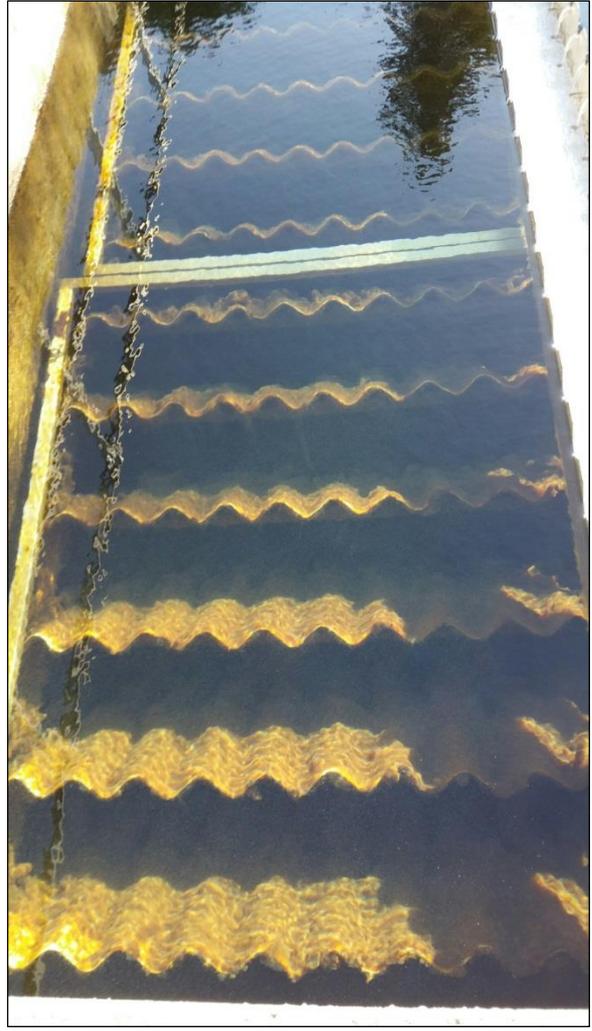
Photograph 2: Floc breaking off lamellae plates

- ii. The use of the retro-fitted lamellae plates in the clarifiers.
