Drinking Water Audit Report

County:	South Tipperary	Date of Audit:	28 th May 2014
Plant visited:	Graigue (2900PUB0205)	Date of issue of Audit Report:	
		File Reference:	DW2008/374
		Auditor:	Nigel Hayes
Audit Criteria:	 The European Union (Drinking Water) Regulations 2014 (S.I. 122 of 2014). The EPA Handbook on the Implementation of the Regulations for Water Services Authorities for Public Water Supplies (ISBN: 978-1-84095-349-7) The recommendations specified in the EPA Report on The Provision and Quality of Drinking Water in Ireland. The recommendations in any previous audit reports.

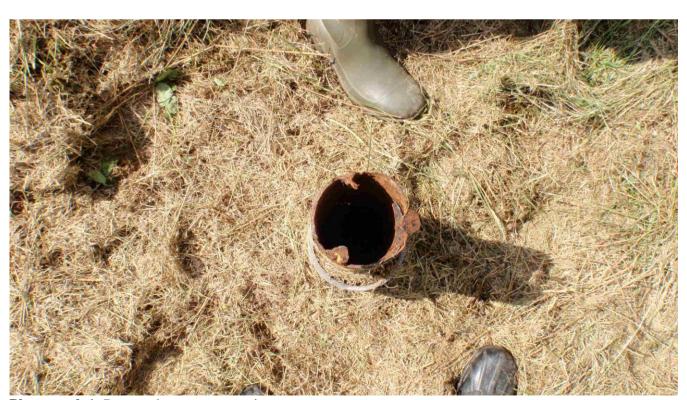
- a. Two access hatches on the reservoir were unsecured and unlocked.
- b. An air vent on the reservoir was damaged (see Photograph 1).

Photograph 1: Damaged vent on reservoir

- 1. The Water Services Authority should carry out an integrity assessment of reservoir to ensure that there is no ingress into the reservoir.
- 2. The Water Services Authority should ensure that all vents on the reservoir are secured against ingress of animals or deliberate introduction of any contaminant or acts of vandalism.
- 3. The Water Services Authority should ensure that sealed and lockable hatches are installed on all inspection points on the reservoir.
- 4. The Water Services Authority should remove all vegetation from the sides and cover of the reservoir to ensure that the reservoir can be visually inspected on all sides and also prevent damage to the integrity of the reservoir.

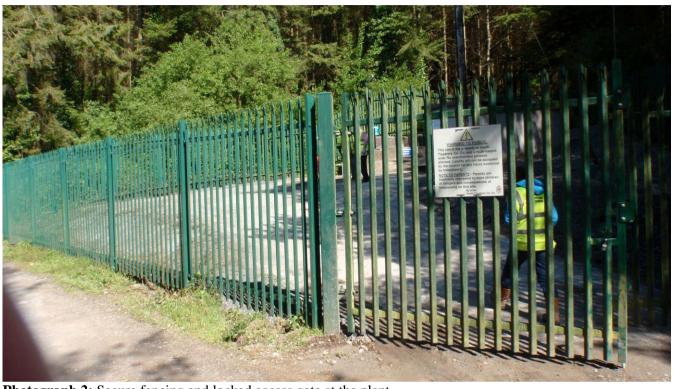
- a. The plant is secured with palisade fencing and a locked access gate (see Photograph 2).
- b. A raw water turbidity meter is in place at the intake and the readings are linked to scada.

Photograph 2: Secure fencing and locked access gate at the plant.
