Drinking Water Audit Report

County:	Tipperary	Date of Audit:	01/06/17
Plant(s) visited:	Springmount Water Supply (Scheme Code 2900PUB0153)	Date of issue of Audit Report:	14/06/17
		File Reference:	DW2017/50
		Auditors:	Ms. Criona Doyle Mr. Niall Dunne
Audit Criteria:	<ul style="list-style-type: none"> • The <i>European Union (Drinking Water) Regulations 2014 (S.I. 122 of 2014)</i>. • The <i>EPA Handbook on the Implementation of the Regulations for Water Services Authorities for Public Water Supplies (ISBN: 978-1-84095-349-7)</i> • The recommendations specified in the <i>EPA Drinking Water Report</i>. • EPA Drinking Water Advice Notes No.s 1 to 15. • The recommendations in any previous audit reports.

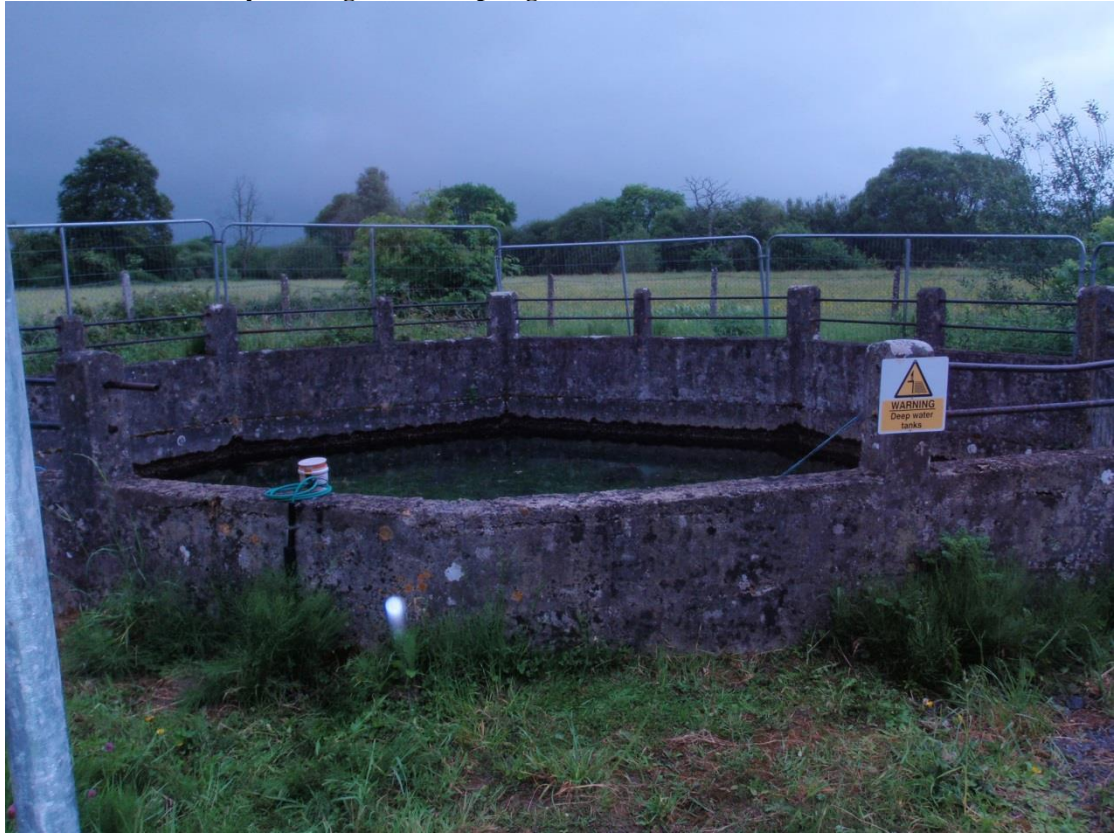
Photo No. 1 – Security Fencing Issue At Spring Chamber

3. Irish Water should liaise with Tipperary County Council to ensure that all landowners are made aware of the set back distances as per the *European Union (Good Agricultural Practice for the Protection of Waters) Regulations 2014 (SI No. 31 of 2014)* for the abstraction point.
4. Irish Water should take action to ensure the source is made secure and that the collection chamber is regularly cleaned. Irish Water should provide the Agency with an action plan for the installation of a cover on the spring collection chamber.

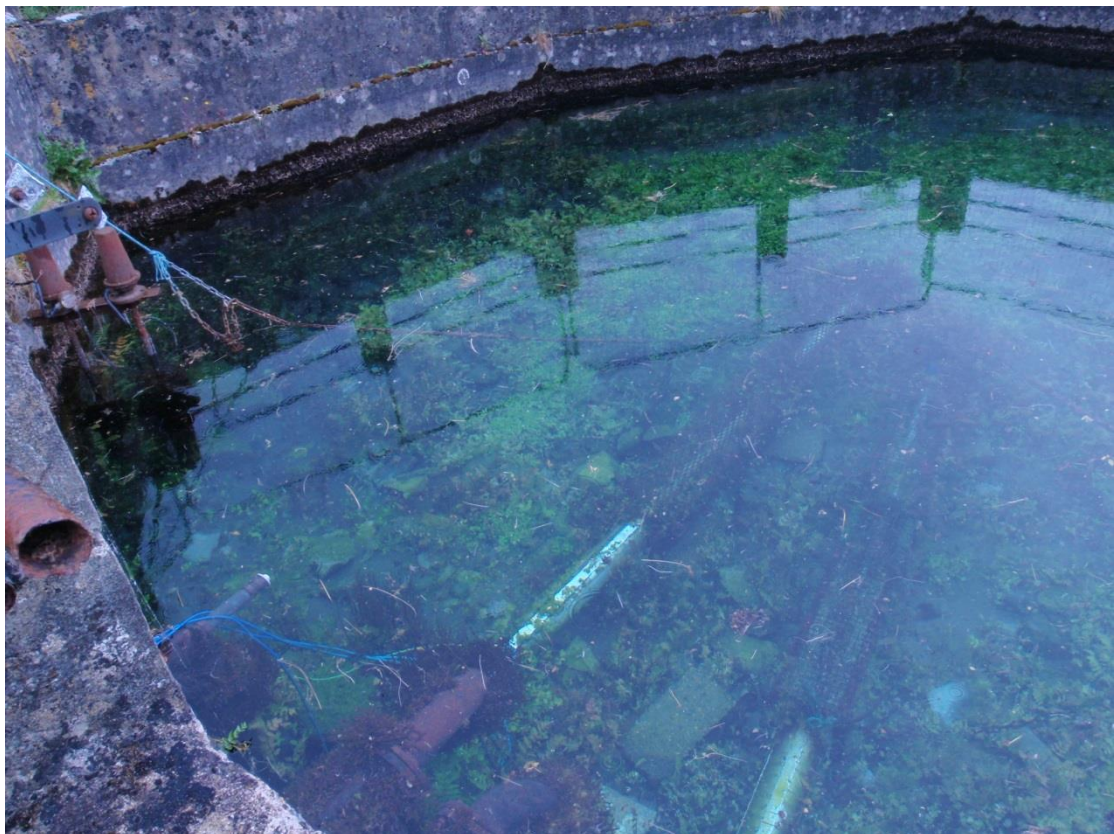
<p>2.</p>	<p>Source Protection</p> <ul style="list-style-type: none"> a. The landuse in the immediate vicinity of the spring is low intensity agricultural land. The area is susceptible to flooding. A shutoff mechanism is in place during flood conditions. Details of the Zone of Contribution were not available on site at the time of the audit. A copy of the Source Protection Map for Springmount was provided by Irish Water on 13/06/17. b. The Cryptosporidium Risk Screening Score is 55 (moderate risk). c. Tipperary County Council provided a copy of the general source protection activities undertaken in 2016 in County Tipperary. Activities included septic tank inspections. In 2010 landowners within 200m of all abstractions in South Tipperary were contacted and visited to inform them of their responsibilities under the GAP regulations. d. No raw water monitoring programme is in place due to resource issues. Historic raw water monitoring data from 2012 to 2015 was provided by Irish Water on 13/06/17 e. UVT monitoring of the raw water has been in operation at the site for the last 6 months as part of the Irish Water Monitoring Programme. A UVT reading of 99.14% and a turbidity of 0.06 NTU was observed during the audit. The high level turbidity alarm on the raw water is set at 1NTU. It generates a text alert but it is not linked to an automatic plant shutdown. f. The spring collection chamber is uncovered. The security fencing on site is poor (Photograph No. 1). It was reported that it is cleaned twice per year to remove weed growth. On the date of the audit a significant build-up of vegetation was evident (Photograph No. 2).

Photo No. 2 –Build Up of Vegetation in Spring Collection Chamber
