Drinking Water Audit Report

County:	Tipperary	Date of Audit:	29/05/18	
Plant(s) visited:	Tipperary Town Drinking Water Treatment Plant	Date of issue of Audit Report:	15/06/18	
	(Scheme Code	File Reference:	DW2018/53	
	2900PUB0123)	Auditors:	Ms. Criona Doyle	
Audit Criteria:	• The European Union (Drinking Water) Regulations 2014 (S.I. 122 of 2014) (as amended).			
		ion of the Regulations for Water lies (ISBN: 978-1-84095-349-7)		
	The recommendations specified in the EPA <i>Drinking Water Report</i> .			
	EPA Drinking Water Advice Notes No's 1 to 15.			
	• The recommendations in any previous audit reports.

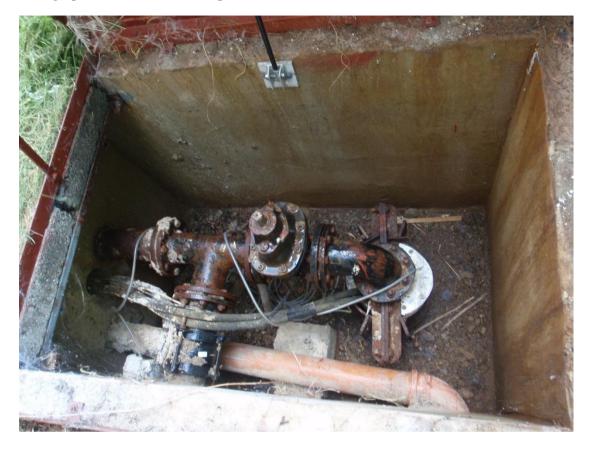
Photograph No. 1: Well Head Completion

- b. The boreholes are located in secure locked chambers to the rear of the pump house.
- c. While the chamber provides protection from the ingress of surface water runoff the wellhead completion is not fully in accordance with EPA Advice Note 14: Borehole Construction and Wellhead Protection. A gap was visible around the power cables on one of the boreholes and the annular seal was not visible at the top of the borehole (Photograph No. 1).

- confirm which source the historic raw water quality data relates to (Muskry Spring or Fawnagowan boreholes).
- 6. Irish Water should ensure that all borehole linings and seals are maintained in accordance with EPA Advice Note 14: Borehole Construction and Wellhead Protection. Irish Water should submit a copy of the borehole logs with the relevant construction details.
