Drinking Water Audit Report

County:	Waterford	Date of Audit:	22/03/2018
Plant(s) visited:	East Waterford Water Supply Scheme (Adamstown WTP) 3800PUB1110	Date of issue of Audit Report:	17/04/2018
		File Reference:	DW2018/43
		Auditors:	Mr Niall Dunne
Audit Criteria:	<ul style="list-style-type: none"> • The <i>European Union (Drinking Water) Regulations 2014 (S.I. 122 of 2014), as amended.</i> • The <i>EPA Handbook on the Implementation of the Regulations for Water Services Authorities for Public Water Supplies (ISBN: 978-1-84095-349-7)</i> • The recommendations specified in the <i>EPA Drinking Water Report.</i> • EPA Drinking Water Advice Notes No.s 1 to 15. • The recommendations in any previous audit reports.

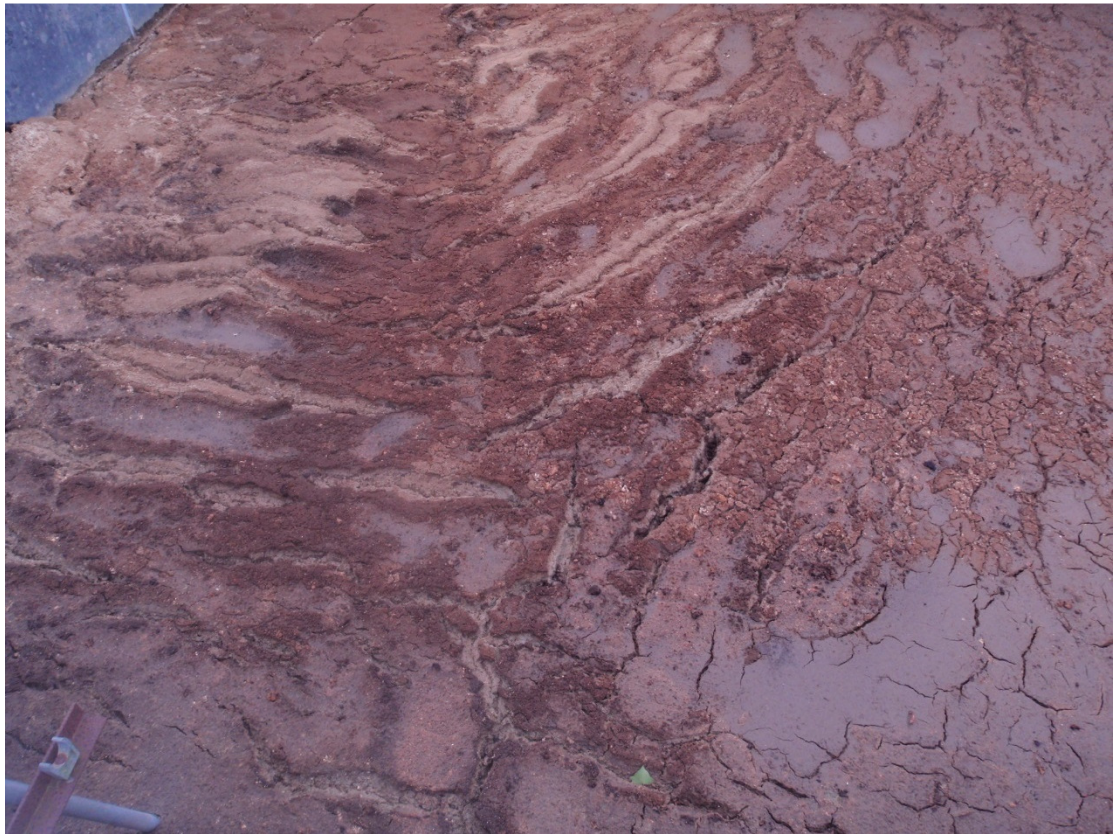
2.	<p>Coagulation, Flocculation and Clarification</p> <p>a. The coagulant used at the plant is aluminium sulphate. Dosing is controlled via a streaming current monitor. WCCC carry out floc tests every few weeks to confirm the coagulant dose is correct.</p> <p>b. Poly is used as a coagulant aid. A scum was observed in the mixing chamber after the coagulant aid was added, (see photograph 1).</p> <p>c. There are eight clarifiers in use at this plant. WCCC stated that they have difficulty with clarification in four clarifiers due to the distance from the splitter chamber.</p> <p>d. The clarifiers are flat bottomed and are drained and cleaned out every two months.</p> <p>e. Pin floc and surface scum were on the clarifiers. There was algae in some decanting channels, (see photograph 2).</p>

Photograph 1: Scum formed on surface of splitter chamber when coagulant aid is added.

3. Irish Water should investigate the cause of the scum where the coagulant aid is added to the treatment stream to determine whether this poses a potential risk to the treatment process and the quality of the treated water. If there is an associated risk, Irish Water should then implement appropriate remedial measures.

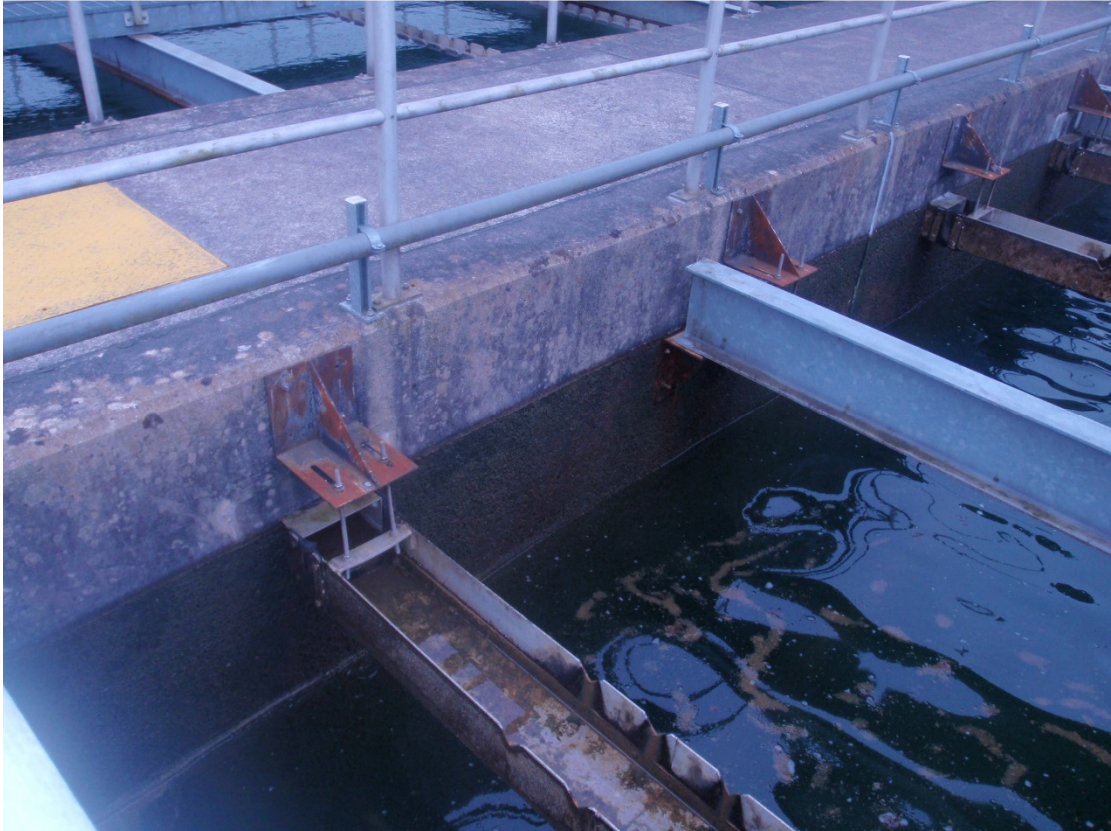
Photograph 2: Scum noted on surface of clarifier and algae noted in decanting channels.

4. Irish Water should ensure that the decanting channels and the clarifiers are cleaned on a regular basis to prevent build-up of algae.
5. Irish Water should;

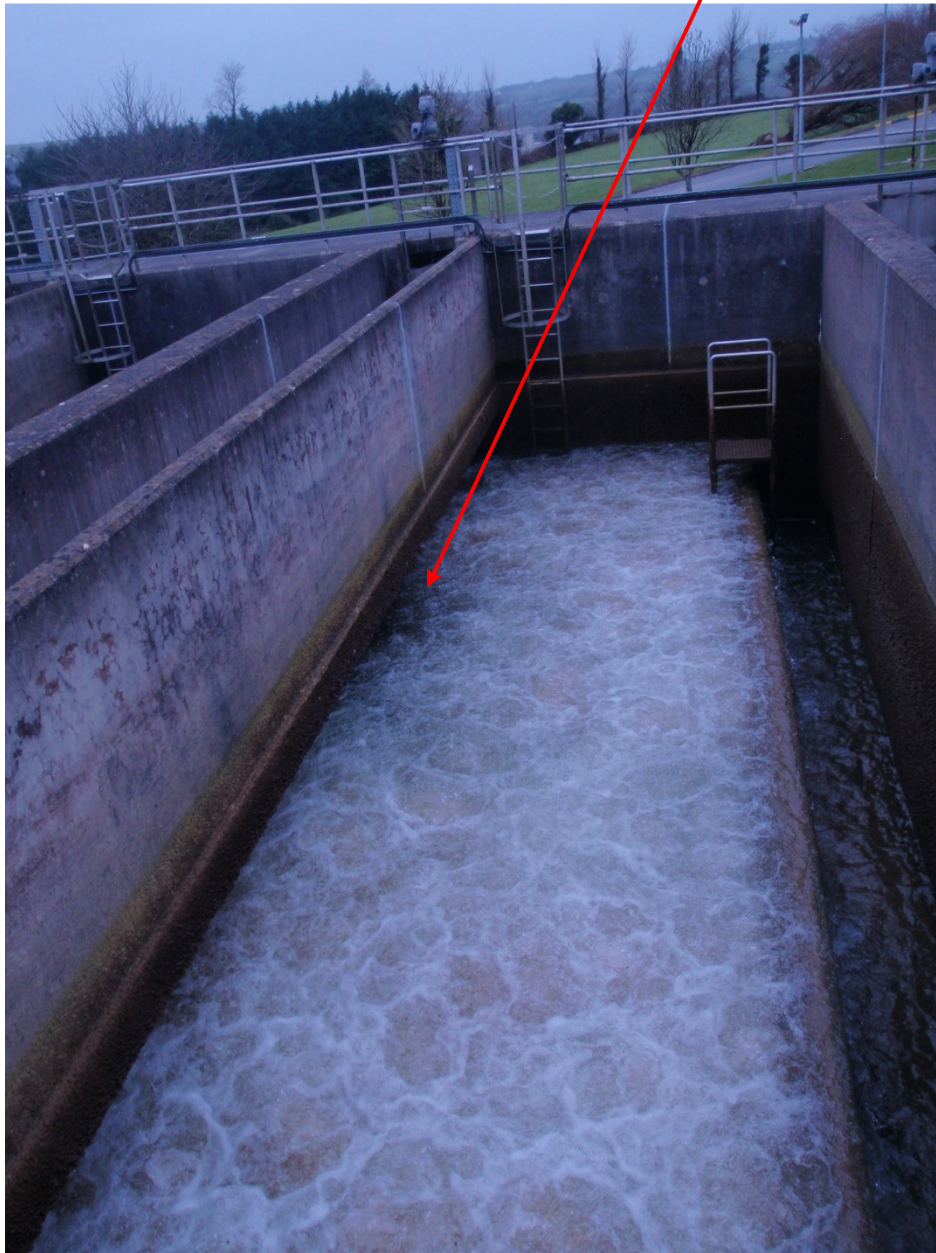
3.	<p>Filtration</p> <p>a. According to WCCC, two of the eight filters are not in service, filters two and eight. Filters five to eight, inclusive, are to be refurbished in Q4 2018. WCCC stated that there are no immediate plans to refurbish filters 1 to 4, but stated that the sand in the filters is replaced approximately every five years.</p> <p>b. A filter back-wash was observed in filter number 3, a dead spot was noted during the filter cycle, (see photograph 3). There appeared to be a crack in the filter and sand was noted in the filter channel. Scum was noted on the walls of the filter, (see photograph 4).</p> <p>c. Scum was observed on some of the filters, according to WCCC it was aluminium carryover, (see photograph 5).</p> <p>d. There were no sand depth gauges in any of the filters.</p>

Photograph 3: Dead spot noted during filter no. 3 back wash cycle.

6. Irish Water should;
 - a. investigate the cause of the filter media loss into the filter channel and take appropriate action to prevent this loss.
 - b. investigate the cause of the cracks in the filter media and take appropriate action to optimise the operation of the filter.
 - c. ensure that the air/water backwash is even across all filters and should ensure that air nozzles are fully functional and not blocked or damaged.

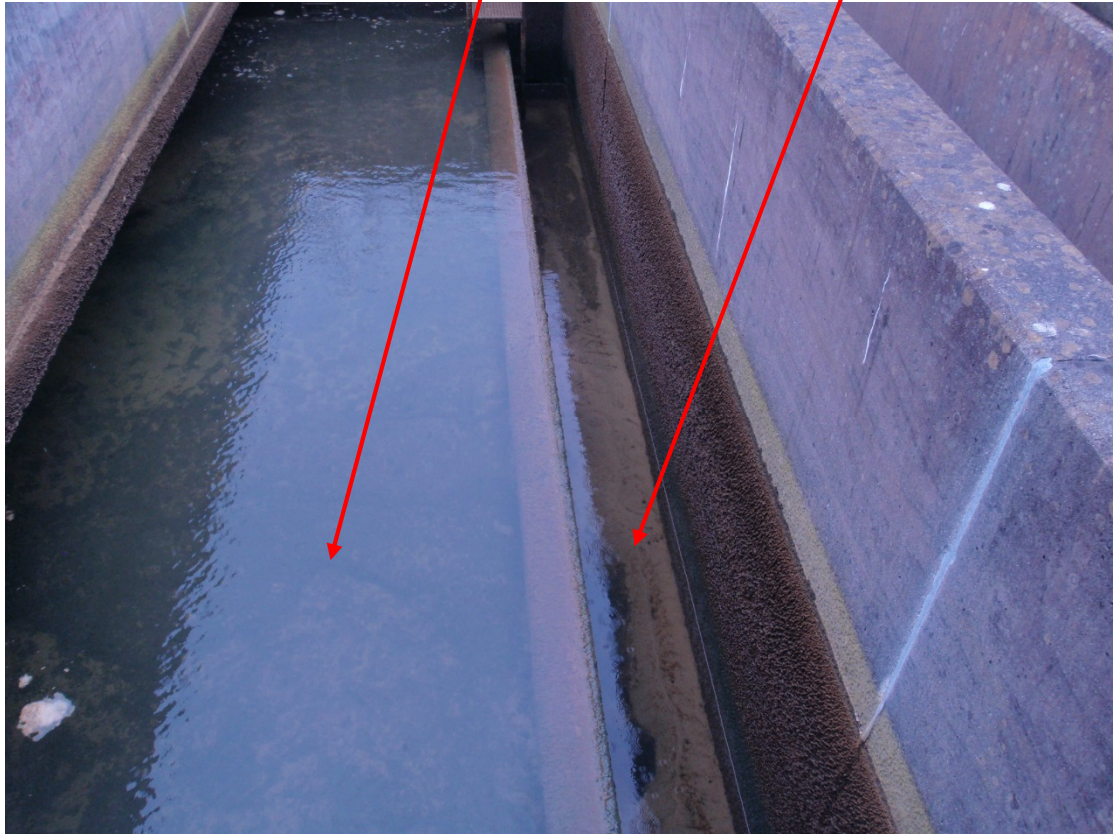
Photograph 4: Appearance of crack in filter, and sand loss in filter channel.

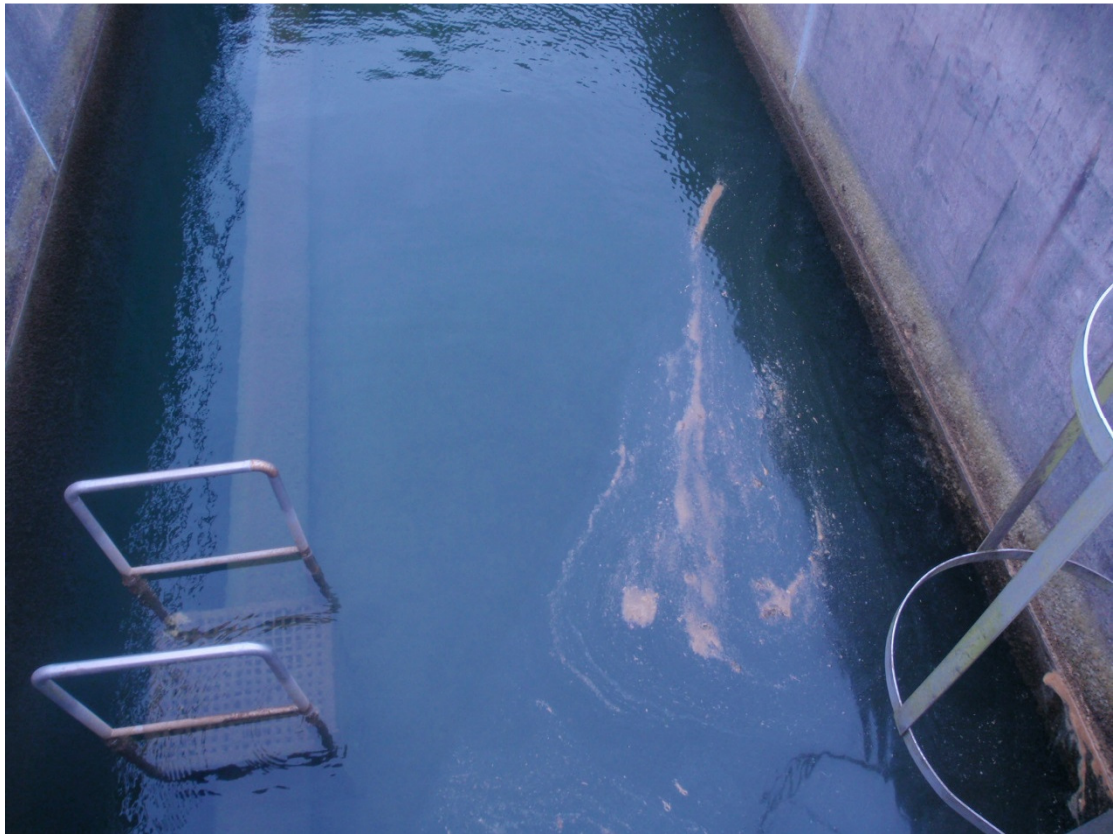
Photograph 5: Appearance of aluminium carry over on water surface in the filter.

- b. investigate the cause of the pin floc formation within the clarifiers and the cause of floc carryover onto the filters. In carrying out these investigations Irish Water should have regard to the EPA Water Treatment Manual: Coagulation, Flocculation and Clarification and EPA Advice Note No. 15: Optimisation of Chemical Coagulant Dosing. Filtration (General)

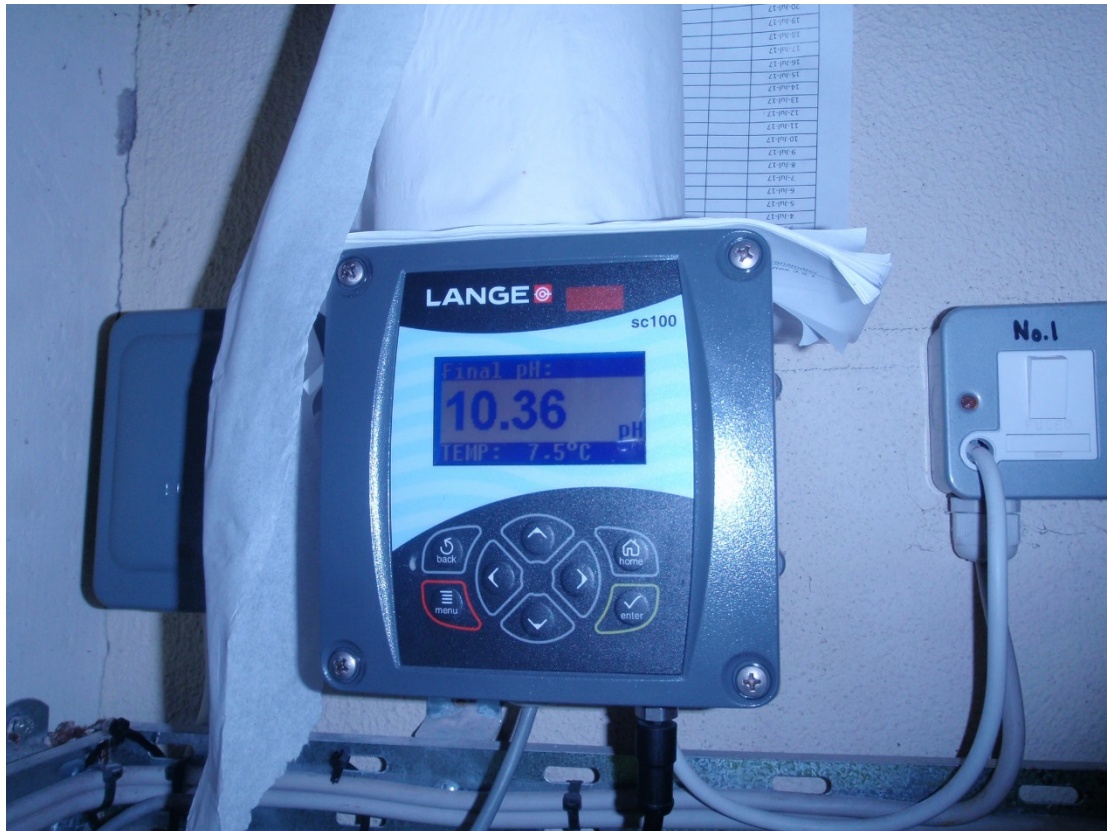
5.	<p>Management</p> <p>a. During the incident, manual monitoring results taken for both chlorine on the treated water and ammonia on the raw water were documented incorrectly.</p> <p>b. During the audit, the pH of the final water was observed to be 10.36, (see photograph 6). WCCC in an email subsequent to the audit stated that this pH reading was incorrect and the pH monitor required calibration. The final pH reading was confirmed as 8.88.</p>

Photograph 6: pH monitor reading 10.36 in the final water.

9. Irish Water should ensure that there are regular checks on essential automated monitoring equipment and that all monitoring equipment is regularly checked and calibrated to ensure plant operators will be appropriately alerted in the event of an incident.
10. Irish Water should put procedures in place to ensure that monitoring results are being properly recorded and documented.
