Drinking Water Audit Report

County:	Waterford	Date of Audit:	17/02/2017
Plant(s) visited:	Ballyogarty PWS (3100PUB1018)	Date of issue of Audit Report:	09/03/2017
		File Reference:	DW2017/18
		Auditors:	Mr Niall Dunne Ms Criona Doyle
Audit Criteria:	<ul style="list-style-type: none"> • The <i>European Union (Drinking Water) Regulations 2014 (S.I. 122 of 2014)</i>. • The <i>EPA Handbook on the Implementation of the Regulations for Water Services Authorities for Public Water Supplies (ISBN: 978-1-84095-349-7)</i> • The recommendations specified in the <i>EPA Drinking Water Report</i>. • EPA Drinking Water Advice Notes No.s 1 to 15. • The recommendations in any previous audit reports.

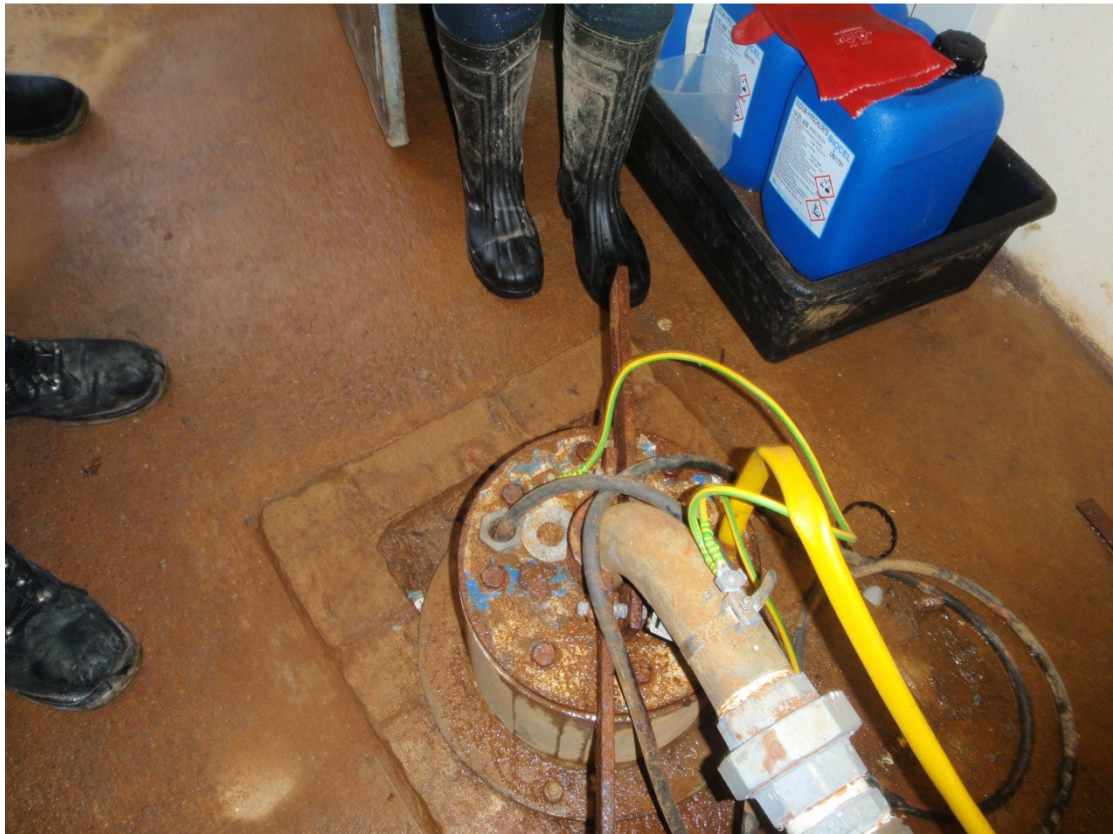
1.	Source Protection <ul style="list-style-type: none">a. This supply is feed from a borehole which is located within the treatment building, see photograph 1. The borehole was capped. IW was not aware of the depth of casing or whether the borehole was lined. WCC stated that the borehole was approximately 68 feet deep.b. WCC stated that they have notified farmers of their obligations under the GAP regulations as they have had issues previously with farmers spreading slurry within the catchment.c. The <i>Cryptosporidium</i> risk assessment score was not available at the time of the audit.

Photograph 1: Capped borehole in the treatment plant.

- Irish Water should submit the *Cryptosporidium* risk score for this supply.
- Irish Water should undertake a survey of the borehole casing to determine its condition.

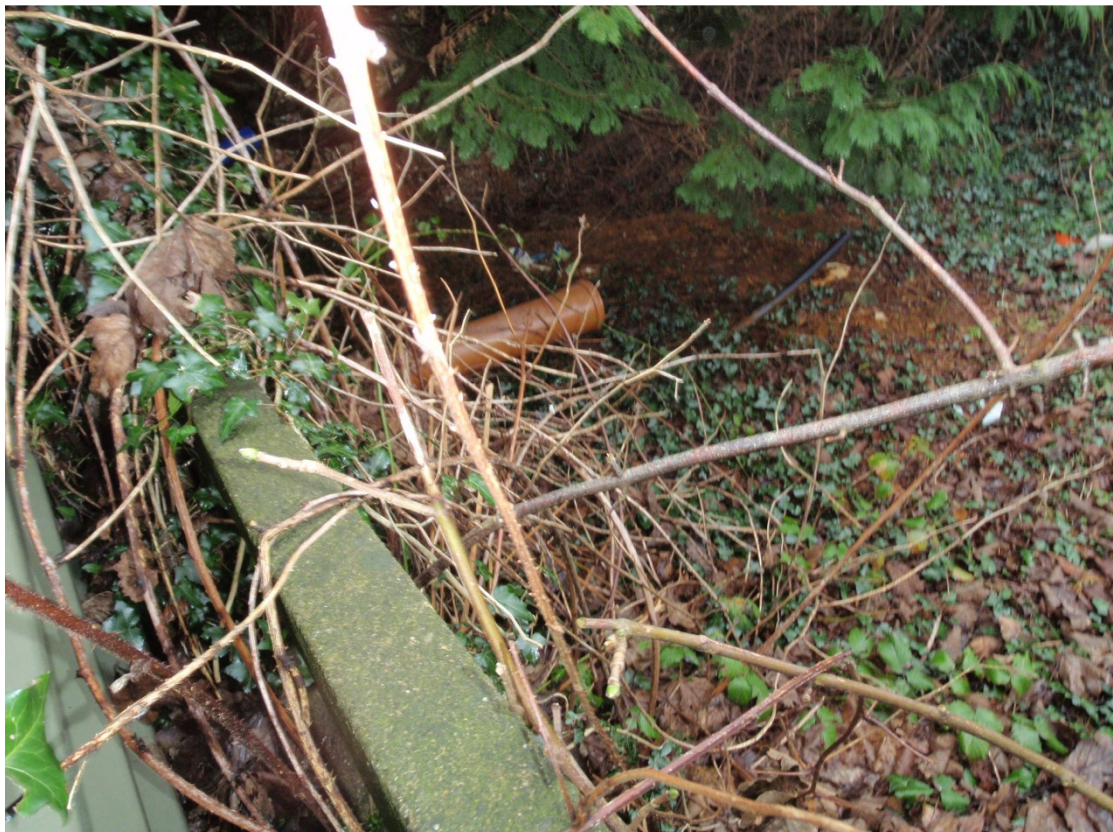
2.	Filtration <ul style="list-style-type: none">a. There are two arsenic filters with Bayoxide media in place, as according to WCC there are elevated levels of arsenic in the raw water.b. According to WCC the filters are set to automatic backwash twice nightly, though there was no record of this or any procedure in place on site.a. WCC stated that the filter media is replaced once arsenic levels in the treated water go above 1µg/l which is approximately every six months, arsenic is sampled monthly within the supply.c. At the time of the audit there were no filter maintenance records available and there were no services stickers on the filter tanks.d. The outlet from the filter media was an uncovered open pipe, see photograph 2.

Photograph 2: Outfall pipe from arsenic filter, potential access for vermin.

- Irish Water should ensure that the out flow from the arsenic filter is such that vermin access is restricted.
- Irish Water should ensure that a filter logbook for each of the arsenic filters is maintained, containing the following:
 - A record of completed back washes.
 - A record of all maintenance work and inspections carried out on the filter;
 - Details of the media replacement;
 - Details of any changes or required changes to filters.
