Drinking Water Audit Report

County:	Waterford	Date of Audit:	26 th February 2015
Plant(s) visited:	LCB Lismore PWS	Date of issue of Audit Report:	19 th March 2015
		File Reference:	DW2015/1
		Auditors:	Ms Yvonne Doris
Audit Criteria:	<ul style="list-style-type: none"> • The <i>European Union (Drinking Water) Regulations 2014 (S.I. 122 of 2014)</i>. • The <i>EPA Handbook on the Implementation of the Regulations for Water Services Authorities for Public Water Supplies (ISBN: 978-1-84095-349-7)</i> • The recommendations specified in the <i>EPA Drinking Water Report</i>. • The recommendations in any previous audit reports.

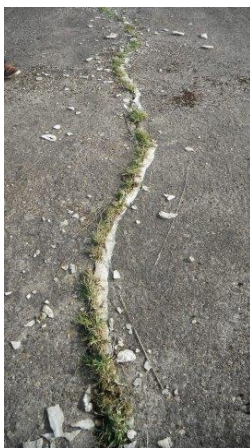
4.	Treated Water Storage <ul style="list-style-type: none">a. The reservoir was built in the 1950s and has a capacity of 580m³, approximately one day storage. The reservoir was cleaned and integrity tested about 3 years ago and was not found to be leaking. A new floor was laid to improve scouring. Repairs were made to the roof) and walls.b. A new crack in the roof of the reservoir needs to be repaired (photograph 1).c. New vents were installed about 3 years ago and new locked access hatches about 1.5 years ago.

Photograph 1: Repaired crack in reservoir roof in need of further repairs.

11. Irish Water should ensure that the crack in the roof of the reservoir is repaired as soon as possible.
