Drinking Water Audit Report

County:	Westmeath	Date of Audit:	16 February 2018
Plant(s) visited:	Athlone Water Treatment Plant	Date of issue of Audit Report:	28 February 2018
		File Reference:	DW2018/17
		Auditors:	Ms Aoife Loughnane Ms Derval Devaney
Audit Criteria:	<ul style="list-style-type: none"> • The <i>European Union (Drinking Water) Regulations 2014 (S.I. 122 of 2014) as amended.</i> • <i>The EPA Handbook on the Implementation of the Regulations for Water Services Authorities for Public Water Supplies (ISBN: 978-1-84095-349-7).</i> • The recommendations specified in the <i>EPA Drinking Water Report.</i> • EPA Drinking Water Advice Notes No.s 1 to 15. • The recommendations in any previous audit reports.

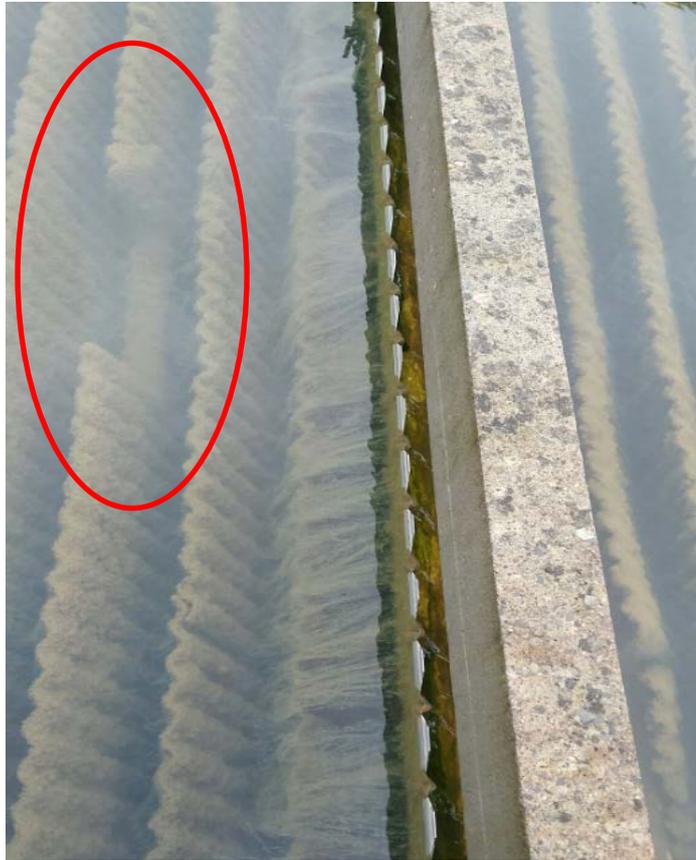
<p>2.</p>	<p>Coagulation, Flocculation and Clarification</p> <ul style="list-style-type: none"> a. Two inlet pumps (duty and standby) abstract water from the River Shannon. The plant is deigned to treat 535 m³/day and throughput ranges from 515 – 525 m³/day. b. Chemifloc 103 and poly are used in the coagulation process and is dosed in proportion to flow. The poly dosing point was moved since the last EPA audit in 2012 to above the splitting chamber tank. There was an even distribution of poly across the dosing line. c. Flow is then split amongst four clarifiers. There was significant sludge settlement on the lamellae plates in the clarifiers and accumulation of material on the walls and decanter channels (see Photo 1). This was also raised by the EPA during its last audit in 2012. Some lamellae plates were broken. Westmeath County Council representatives stated that the clarifiers were due a clean but the plant is under pressure with bursts in the distribution network and access to the lamellae plates for cleaning can be difficult due to the design of the structure. Notwithstanding this, there was no evidence of floc carryover onto the filters.

Photo 1 Sludge on clarifier and broken lamellae plate (circled)

2. Irish Water should ensure that the settled water outlet channels and clarifier walls are cleaned without delay to prevent build-up of algae on the weirs and on the walls of the clarifiers and to prevent build-up of excessive sludge on the lamellae plates. The broken lamellae plates should also be fixed. A regular programme of cleaning should be put in place to ensure excessive sludge and algae does not build up in the clarifiers.

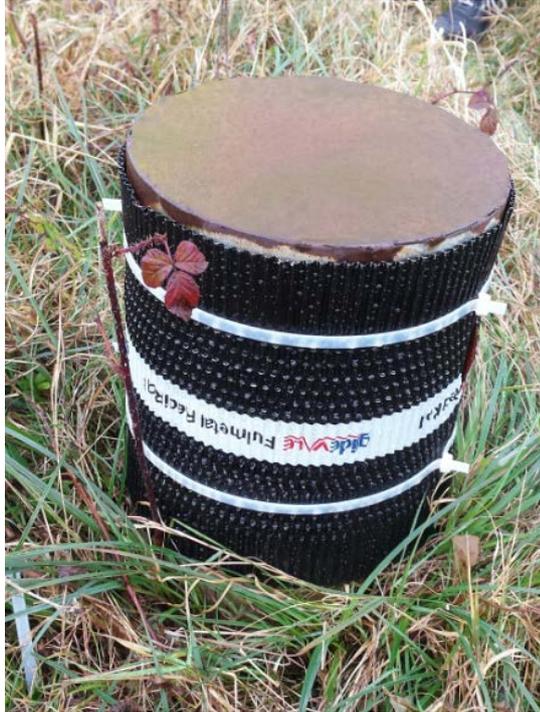
- iii. Coosan reservoir has been identified as a possible source of contamination of the water supply. Since the *Cryptosporidium* detections, Coosan Reservoir was drained down and was being bypassed on the day of the audit. Its roof had vegetation overgrowth and temporary meshes were recently installed on its vents for protection.

Photo 2 Temporary mesh on Coosan Reservoir vent

4. Irish Water should ensure that:
 - (a) all reservoir vents are permanently secured against ingress of animals or deliberate introduction of any contaminant or acts of vandalism;
 - (b) the Coosan reservoir is inspected and cleaned out and any maintenance and repairs completed as soon as possible;
 - (c) vegetation from the sides and cover of the Coosan reservoir is removed so that the reservoir can be visually inspected on all sides and to prevent possible damage to the integrity of the reservoir;
 - (d) an integrity assessment of the Coosan reservoir is carried out to ensure that there is no ingress into the reservoir.

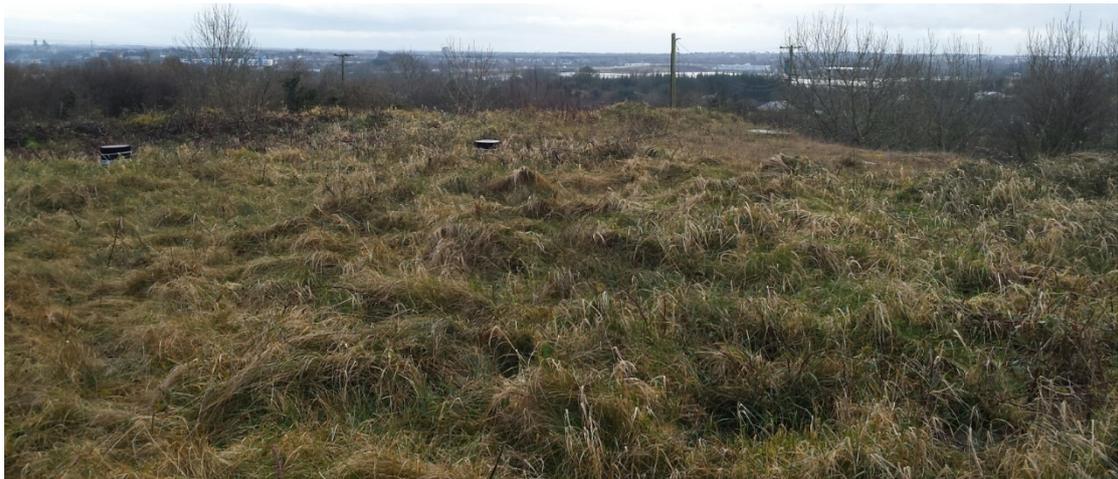
The auditors noted that Coosan reservoir was a possible source of contamination of the water supply. Works are needed to clean the reservoir and ensure it is adequately protected. Irish Water should ensure that all reservoirs serving this supply are structurally sound, free from vegetation overgrowth, adequately protected from ingress of contamination (for e.g. vents on all the reservoirs should have meshes in place) and regularly cleaned to ensure a safe and secure water supply.

Photo 3 Overgrowth of vegetation on the roof of Coosan Reservoir
