# Drinking Water Audit Report

<b>County:</b>	Westmeath	<b>Date of Audit:</b>	17 <sup>th</sup> February 2015
<b>Plant visited:</b>	Ballany WTP, Scheme codes 3200PUB1003 Ballany Low Level Reservoir, and 3200PUB1004 Ballany High Level Reservoir	<b>Date of issue of Audit Report:</b>	25 <sup>th</sup> February 2015
		<b>File Reference:</b>	DW2015/12
		<b>Auditors:</b>	Mr Darragh Page Ms Aoife Loughnane
<b>Audit Criteria:</b>	<ul style="list-style-type: none"> <li>• The <i>European Union (Drinking Water) Regulations 2014 (S.I. 122 of 2014)</i>.</li> <li>• The <i>EPA Handbook on the Implementation of the Regulations for Water Services Authorities for Public Water Supplies (ISBN: 978-1-84095-349-7)</i></li> <li>• The recommendations specified in the <i>EPA Drinking Water Report</i>.</li> <li>• The recommendations in any previous audit reports.</li> </ul>

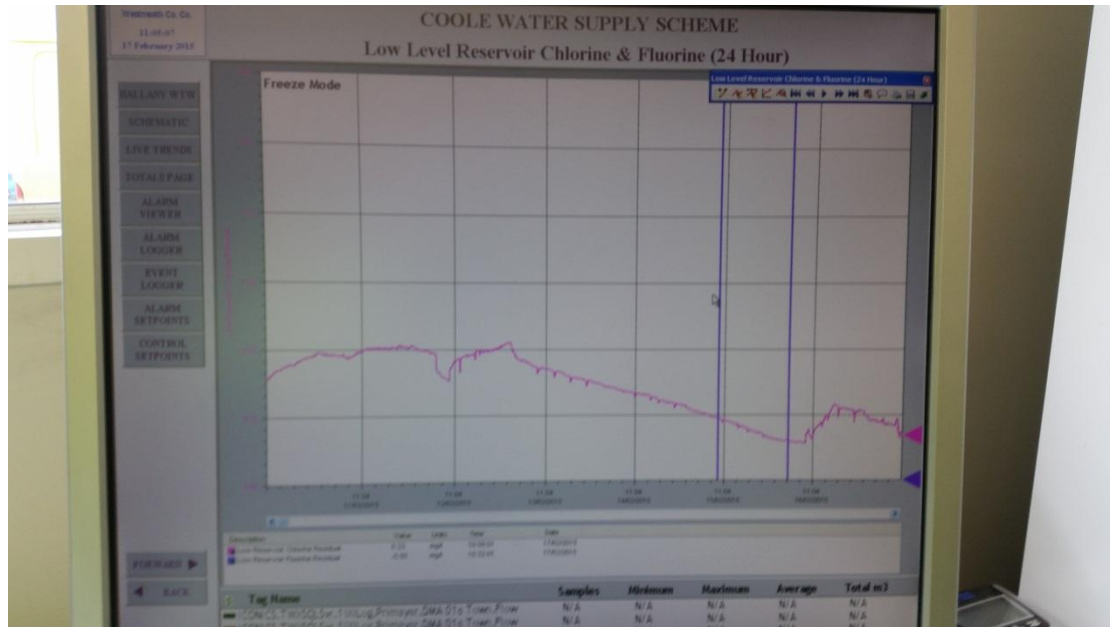
Photo 1: SCADA screenshot showing decreasing residual chlorine trend

7. Irish Water should ensure that there is at least 0.1 mg/l free residual chlorine in the network at all times. Irish Water should submit a report to the EPA outlining what steps are to be taken to ensure that this is the case.

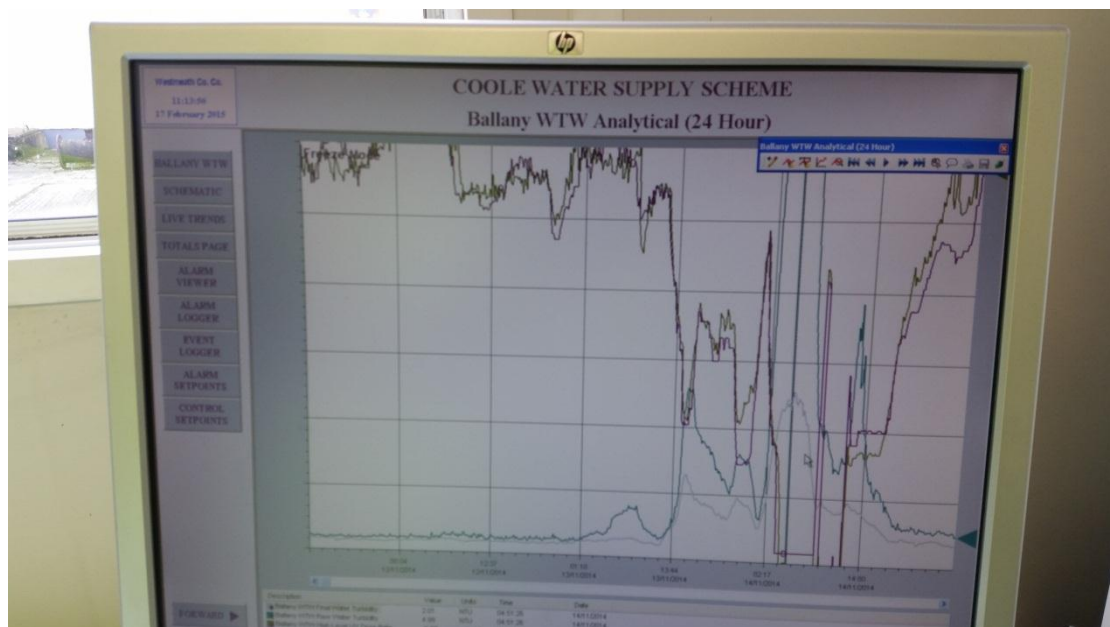
Photo 2: SCADA screenshot showing raw and final water turbidity and UVI trends during a period of raw water quality deterioration (14/11/2014)

9. Irish Water should investigate the robustness of the current treatment processes to deal with variations in raw water quality, and take appropriate measures to ensure that treatment is not compromised during periods of raw water quality deterioration. The investigation should include an assessment of the frequency of treated water turbidity > 1 NTU entering the distribution network.
10. Irish Water should review the critical alarm settings to ensure that the alarms provide the necessary forewarning to the plant operators.
11. Irish Water should update the documented alarm response procedure to define the actions to be taken in response to the different levels of alarm settings.
12. Irish Water should ensure that the online fluoride monitor is operational and linked to an appropriate alarm.
