Drinking Water Audit Report

County:	Wexford	Date of Audit:	7 th July 2017
Plant(s) visited:	Camolin Water Treatment Plant (3300PUB1779)	Date of issue of Audit Report:	11 th July 2017
		File Reference:	DW2017/91
		Auditors:	Mr. Darragh Page
Audit Criteria:	<ul style="list-style-type: none"> • The <i>European Union (Drinking Water) Regulations 2014 (S.I. 122 of 2014)</i>. • <i>The EPA Handbook on the Implementation of the Regulations for Water Services Authorities for Public Water Supplies (ISBN: 978-1-84095-349-7)</i> • The recommendations specified in the <i>EPA Drinking Water Report</i>. • EPA Drinking Water Advice Notes No.s 1 to 15. • The recommendations in any previous audit reports.

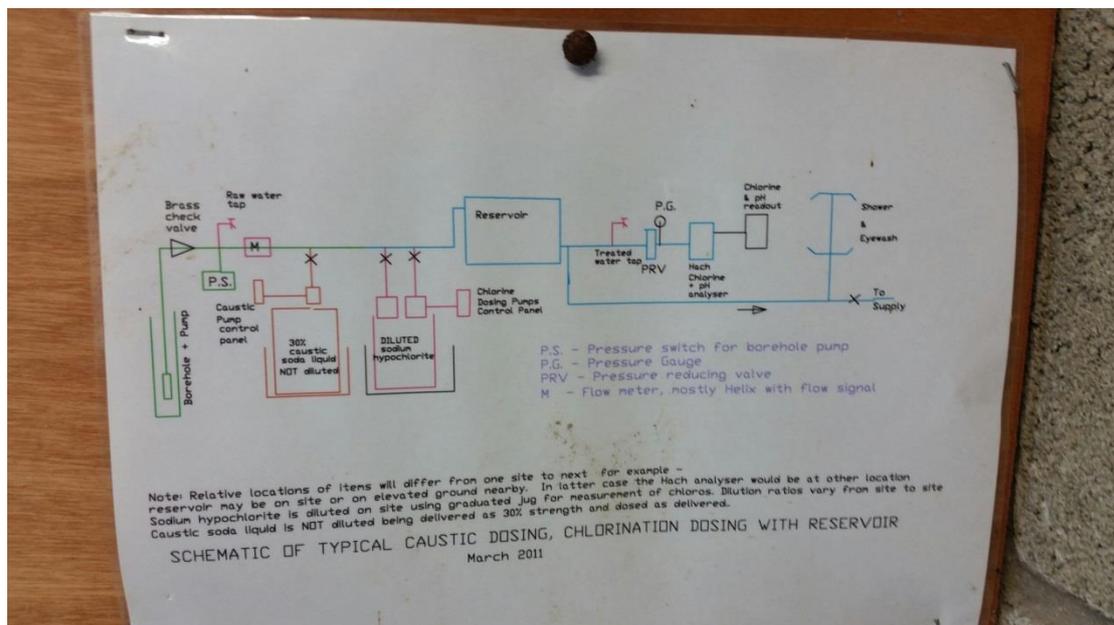
Photo 1. Schematic of the Camolin Water Treatment Plant.

1. Irish Water should review the schematic of Camolin water treatment plant and ensure that it represents the correct sequence of treatment processes at the plant.

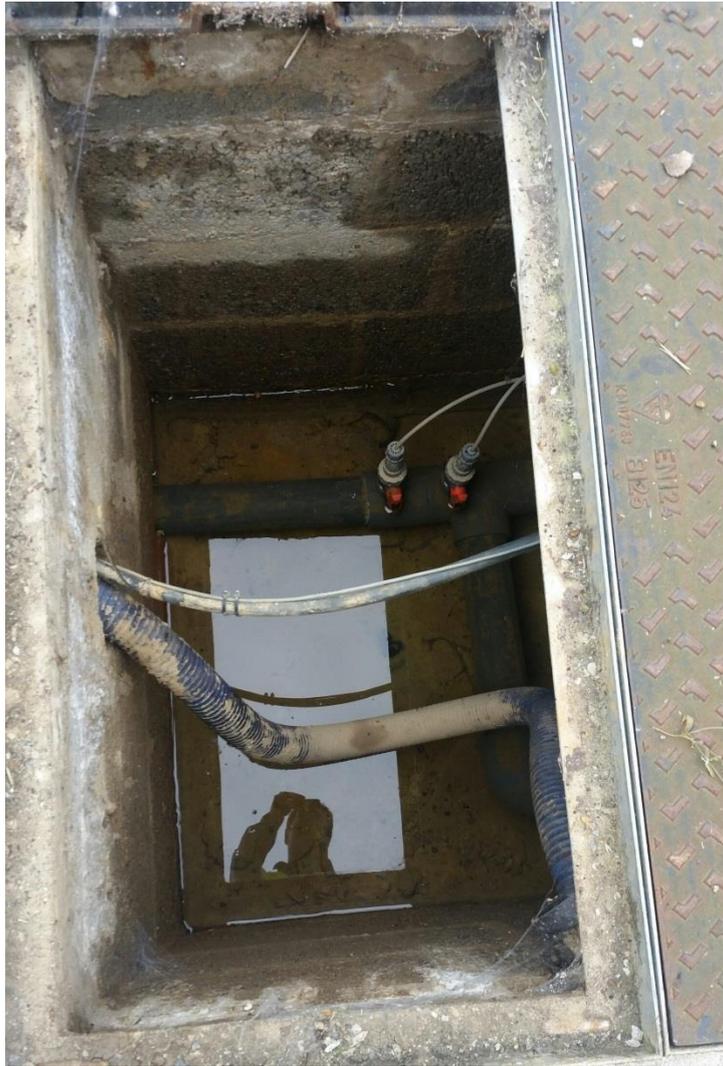
2.	<p>Disinfection</p> <ul style="list-style-type: none"> a. The raw water is pumped from the borehole to a storage reservoir and is chlorinated using sodium hypochlorite. b. The manholes entering and exiting the reservoir were lifted and there were three chemical dosing lines on both the inlet and outlet. The valves on all dosing lines (with the exception of the first dosing line on the inlet) were in the open position. Initially, neither Irish Water nor Wexford County Council were able to explain which dosing lines were sodium hypochlorite and which were sodium hydroxide (i.e. whether they were dosed on the inlet or outlet). The schematic for the plant (see Photo 1) indicated that the inlet dosing points were in use, however, the closed valve on the sodium hydroxide dosing point on the inlet indicated that this was not the case. A sample of water from the reservoir was analysed and chlorine was found to be present which confirmed that the inlet was disinfected. This was contrary to what Wexford County Council staff had thought (the caretaker for the plant was on leave and the plant was being run by the relief caretaker). It was therefore assumed that the chlorine dosing points on the outlet are redundant but have not been decommissioned. c. The chlorine levels on the chlorine monitor on the outlet appear to be stable with the exception of a period of 3 hours on 6th July where Wexford County Council stated that the power failed resulting in a loss of signal from the chlorine monitor. Water continued to be supplied to the village from the reservoir but no water was being pumped from the borehole to the reservoir and therefore it is likely that chlorine levels in the water supplied to consumers were adequate. d. The outlet chamber was partially filled with water (see Photo 2). e. There is a chlorine monitor and alarm and there was evidence that the alarm was functional in response to low chlorine levels.

Photo 2. Redundant Sodium Hypochlorite Dosing Points on the Outlet of the Reservoir (note the chamber is partially filled with water)

3. Irish Water should review the necessity for the sodium hypochlorite dosing points on the outlet of the reservoir, and if they are no longer required they should be decommissioned.

- Irish Water should empty the standing water in the outlet chamber where the redundant sodium hypochlorite dosing points are located, and determine if the water accumulation there is due to a leak. Any repairs should be completed as soon as possible after the need has been identified.
