Drinking Water Audit Report

County:	Wexford	Date of Audit:	12 th May 2015
Plant(s) visited:	Chestnut Grove, Holyfort 3300PUB1831	Date of issue of Audit Report:	19 th May 2015
		File Reference:	DW2015/65
		Auditors:	Ms Michelle Roche
Audit Criteria:	<ul style="list-style-type: none"> • <i>The European Union (Drinking Water) Regulations 2014 (S.I. 122 of 2014).</i> • <i>The EPA Handbook on the Implementation of the Regulations for Water Services Authorities for Public Water Supplies (ISBN: 978-1-84095-349-7)</i> • <i>EPA Water Treatment Manual: Disinfection</i> <p>The recommendations specified in the EPA <i>Drinking Water Report</i>.</p>

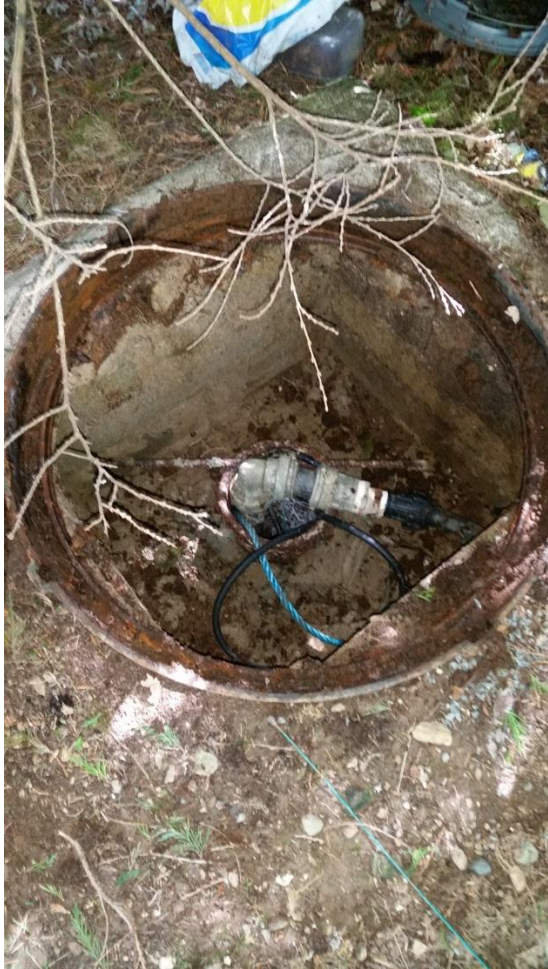
Photograph 1: Wellhead of eastern borehole

1. Irish Water should liaise with the relevant local authority in relation to the requirements of the *European Union (Good Agricultural Practice for the Protection of Waters) Regulations 2014 (SI No.31 of 2014)* to ensure, unless an alternative setback distance has been set as per Article 17 (2) (c) that:
 - i. Organic fertiliser or soiled water is not applied to land within 25 m of the abstraction point; and
 - ii. Farmyard manure held in a field prior to landspreading is not placed within 25 m of the abstraction point.
2. Irish Water should ensure that the wellheads on the two supply boreholes are raised above ground level, the wellheads are capped and sealed and a locked cover is installed at both boreholes.

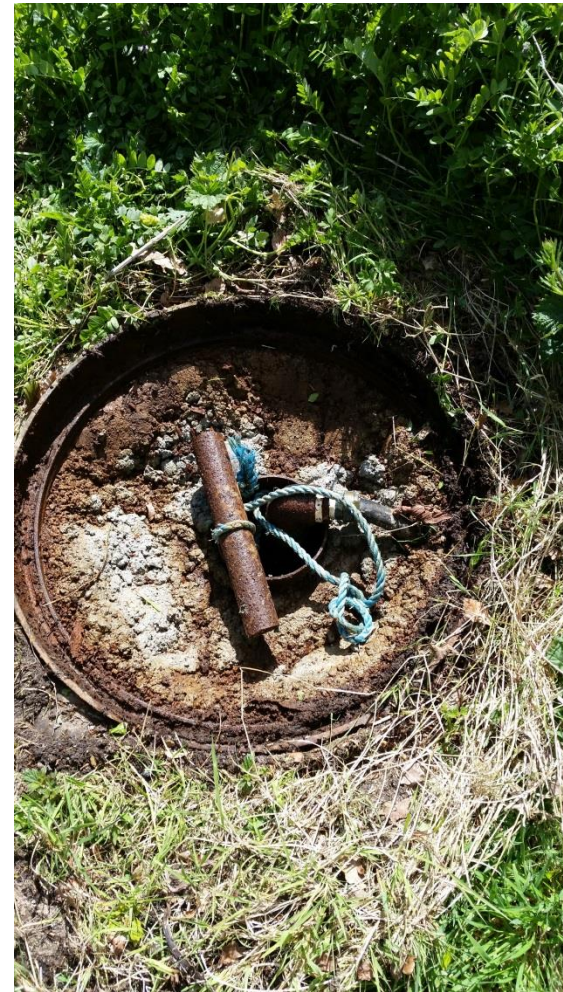
Photograph 2: Wellhead of northern borehole
