Drinking Water Audit Report

County:	Wexford	Date of Audit:	7 th May 2015
Plant(s) visited:	Craane 3300PUB1781	Date of issue of Audit Report:	25 th May 2015
		File Reference:	DW2014/347
		Auditors:	Ms Michelle Roche Ms Yvonne Doris
Audit Criteria:	<ul style="list-style-type: none"> • The <i>European Union (Drinking Water) Regulations 2014 (S.I. 122 of 2014)</i>. • The <i>EPA Handbook on the Implementation of the Regulations for Water Services Authorities for Public Water Supplies (ISBN: 978-1-84095-349-7)</i> • <i>EPA Water Treatment Manual: Disinfection</i> • The recommendations specified in the <i>EPA Drinking Water Report</i>. • The recommendations in any previous audit reports.

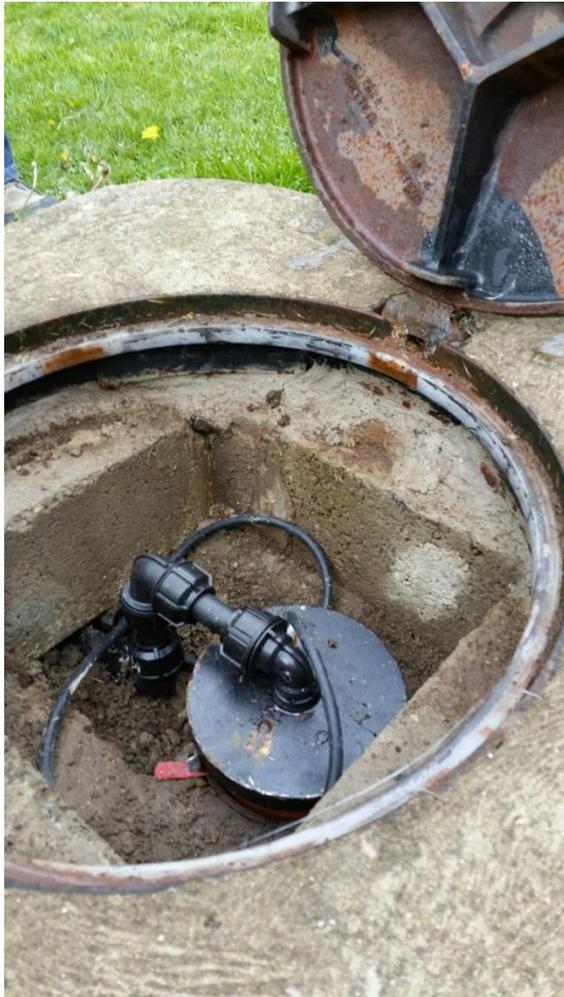
Photograph 1: Well head capped and sealed

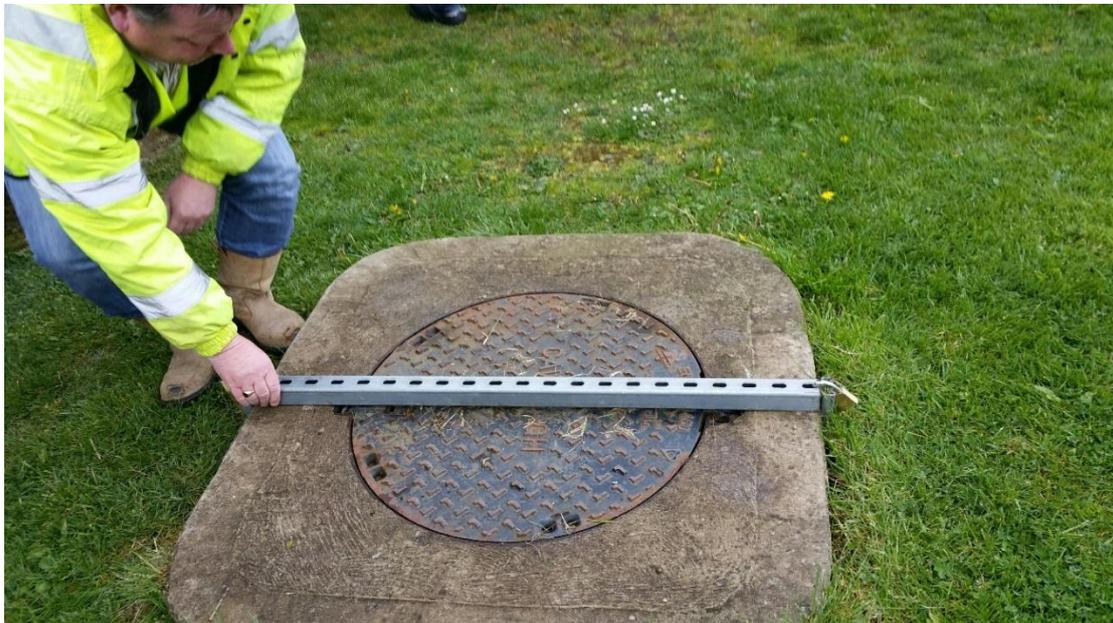
Photograph 2: Borehole cover with lock in place

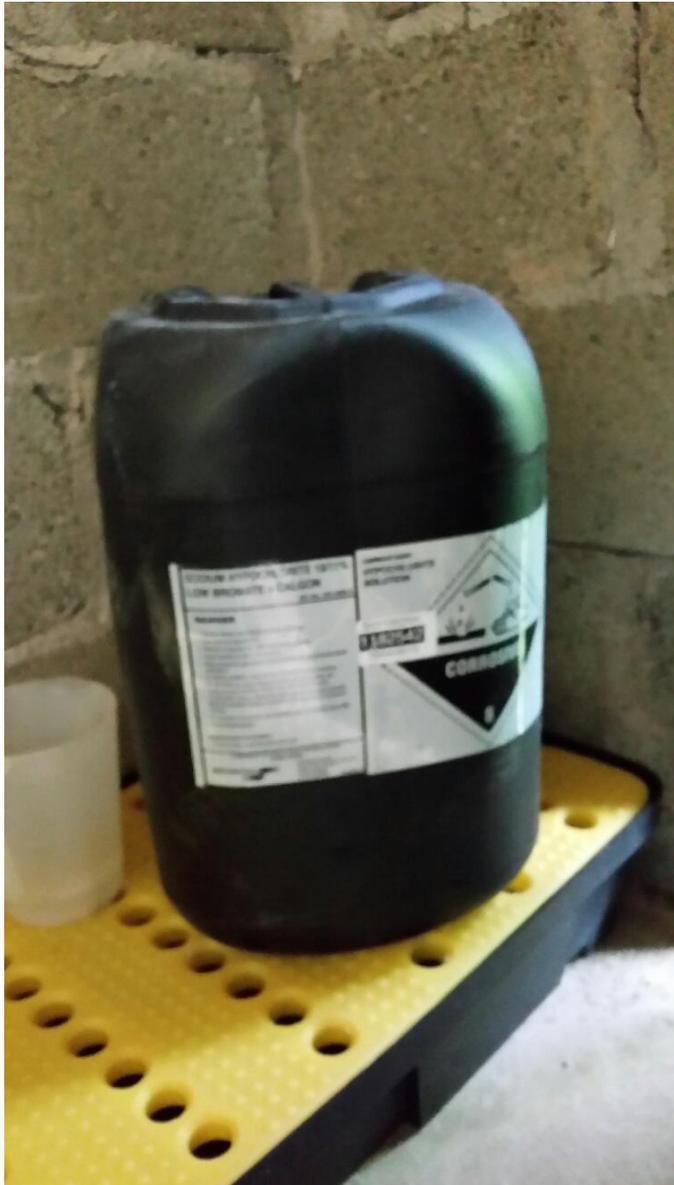
Photograph 3: Sodium Hypochlorite drum within bund
