# Drinking Water Audit Report

| <b>County:</b> | Wexford | <b>Date of Audit:</b> | 8 <sup>th</sup> October 2014 |
| <b>Plant(s) visited:</b> | Enniscorthy (Vinegar Hill) | <b>Date of issue of Audit Report:</b> | 10 <sup>th</sup> November 2014 |
| | | <b>File Reference:</b> | DW2014/300 |

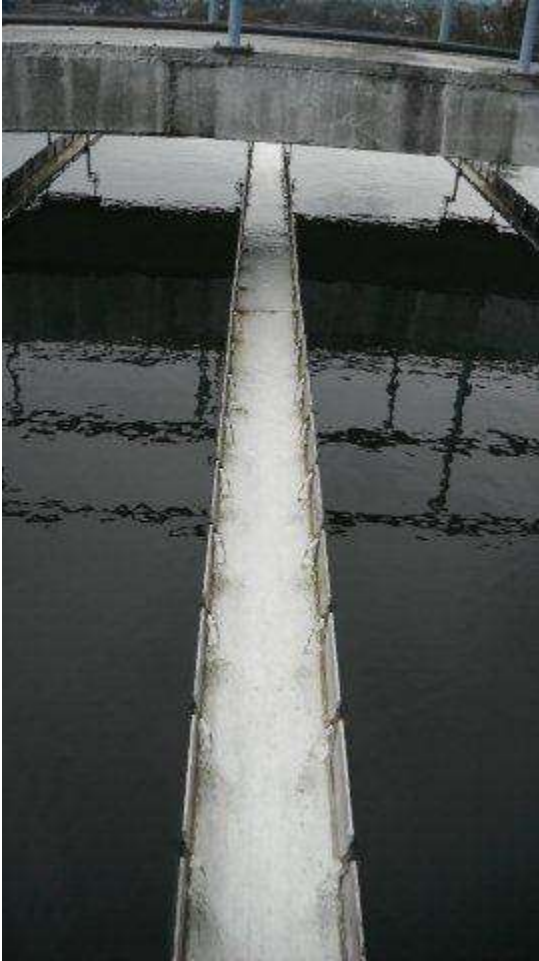
**Photograph 1: Uneven flow in clarifier channels**

4. The Water Services Authority should ensure that settled water outlet channels are level, free from blockage and flow into these channels is even. Repairs to the holes in the channels should be carried out.

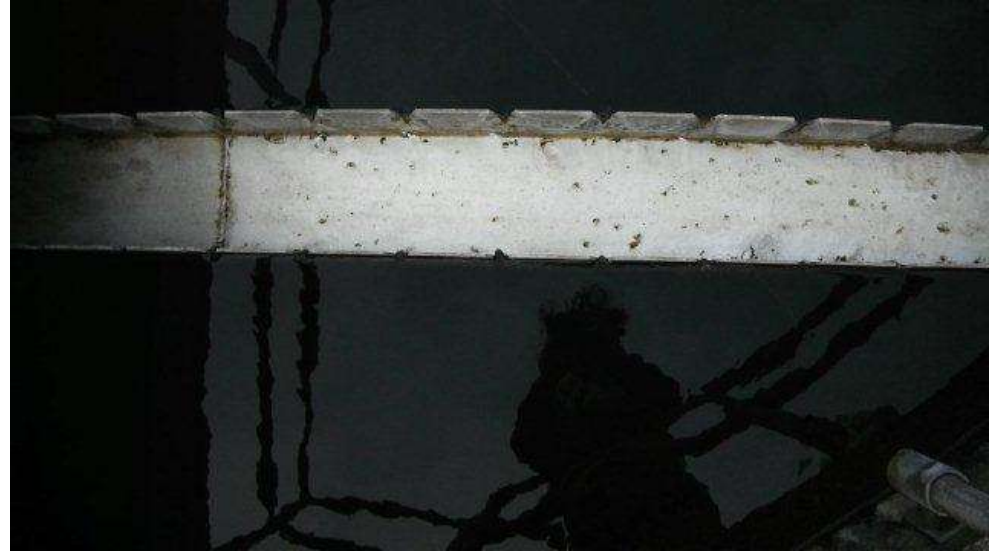
**Photograph 2: Holes in the clarifier channel**
