Drinking Water Audit Report

County:	Wexford	Date of Audit:	24 th July 2014
Plant(s) visited:	Wexford Town Public Water Supply (Newtown treatment plant)	Date of issue of Audit Report:	1 st September 2014
		File Reference:	DW2014/229
		Auditors:	Ms Yvonne Doris
Audit Criteria:	<ul style="list-style-type: none"> • The <i>European Union (Drinking Water) Regulations 2014 (S.I. 122 of 2014)</i>. • The <i>EPA Handbook on the Implementation of the Regulations for Water Services Authorities for Public Water Supplies (ISBN: 978-1-84095-349-7)</i> • The recommendations specified in the EPA Report on <i>The Provision and Quality of Drinking Water in Ireland</i>. • The recommendations in any previous audit reports.

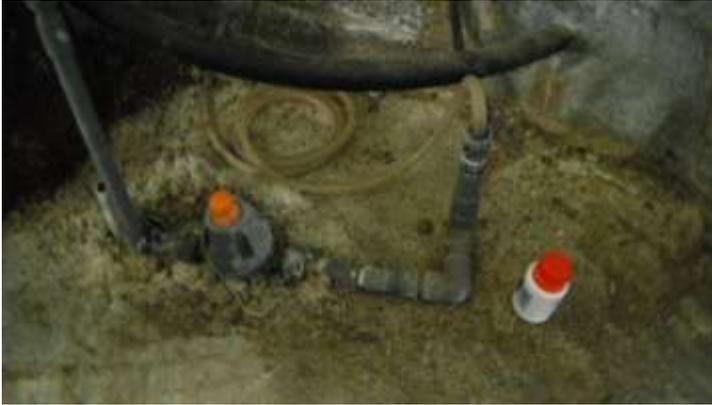
Photograph 1: Aluminium sulphate injection point – liable to being damaged by plant

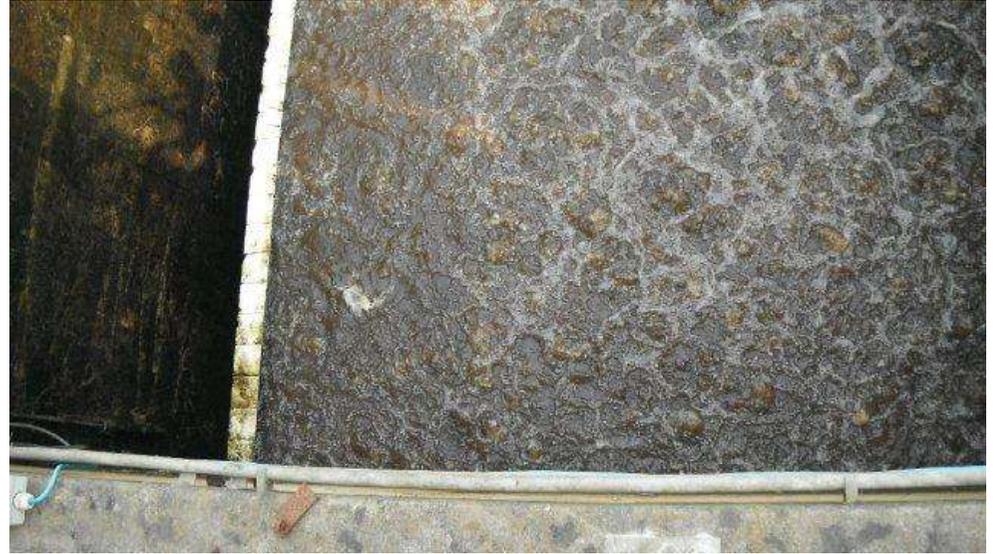
Photograph 3: Uneven air scour on Filter 1

8. The Water Services Authority should consider re-finishing of the filter walls to prevent excessive build-up of algae on the walls of the filters.
9. The Water Services Authority should take measures to ensure that the design depth (700-800mm) of sand in the filters can be maintained and take appropriate action to prevent this loss of media. This was a recommendation in the report of the EPA audit of November 2010.
10. The Water Services Authority should replace the sand in filter 1 and test the effectiveness of filter media in the other two filters, replacing media if required.
11. The Water Services Authority should ensure that the air/water backwash is even across the filter and should ensure that air nozzles are fully functional and not blocked or damaged.
