# Drinking Water Audit Report

<b>County:</b>	Wicklow	<b>Date of Audit:</b>	25 <sup>th</sup> February 2019
<b>Plant visited:</b>	Ballinaclash Water Treatment Plant  (Avoca Ballinaclash public water supply; Scheme code 3400PUB1024)	<b>Date of issue of Audit Report:</b>	26 <sup>th</sup> February 2019
		<b>File Reference:</b>	DW2019/44
		<b>Auditors:</b>	Aoife Loughnane Daryl Gunning
<b>Audit Criteria:</b>	<ul style="list-style-type: none"> <li>• The <i>European Union (Drinking Water) Regulations 2014 (S.I. 122 of 2014), as amended.</i></li> <li>• <i>The EPA Handbook on the Implementation of the Regulations for Water Services Authorities for Public Water Supplies (ISBN: 978-1-84095-349-7)</i></li> <li>• The recommendations specified in the <i>EPA Drinking Water Report.</i></li> <li>• EPA Drinking Water Advice Notes No.s 1 to 15.</li> <li>• The recommendations in any previous audit reports.</li> </ul>

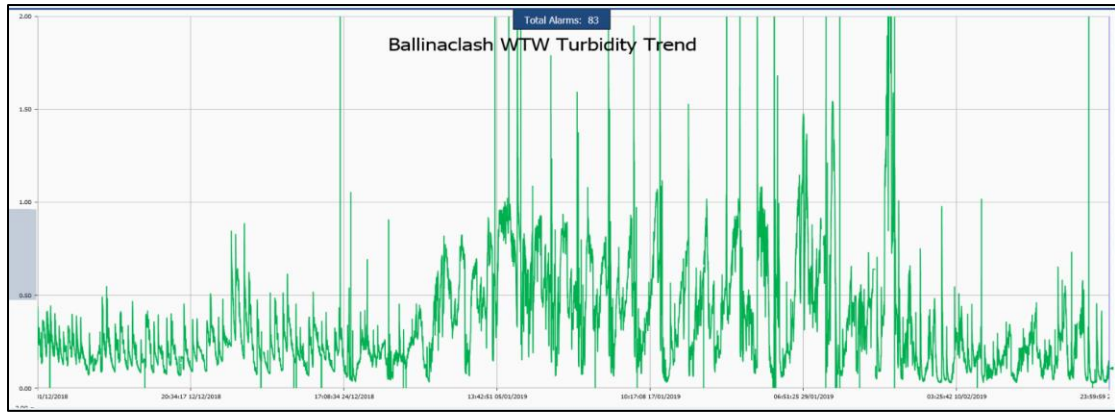
- a. **Lack of knowledge of chemical dosing controls and disinfection controls by the plant operators;**
  - b. **SCADA data shows significant operational difficulties at the plant in January & February 2019, with unstable final water turbidity levels spiking above 1 NTU and the UV Disinfection system operating below its minimum validated operating range, meaning that the *Cryptosporidium* barriers (DAFF & UV) have been compromised for a prolonged period.**

**Figure 1: SCADA graph of final water turbidity from 01/12/18 to 22/02/19 which shows unstable plant performance with many spikes above 1 NTU.**

7. Irish Water should review the reasons behind the fluctuating final water turbidity levels and drop in UVT levels (post DAFF) during January and February 2019, and ensure that appropriate actions are taken to improve the performance of Ballinaclesh water treatment plant.
8. In accordance with Irish Water's *Cryptosporidium* Monitoring Rationale, Irish Water should immediately commence *Cryptosporidium* monitoring of the treated water because the performance of the *Cryptosporidium* barriers at the plant could not be verified. If any oocysts are detected, Irish Water should consult with the HSE immediately regarding potential risk to public health.

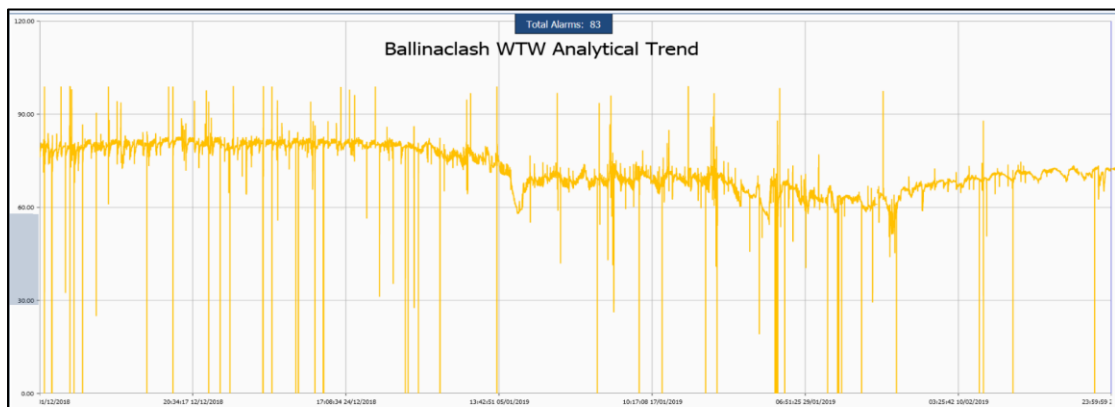
**Figure 2: SCADA graph of UVT (measured post DAFF unit) from 01/12/18 to 22/02/19 which shows water quality dropping below the 85% UVT validated operating range of the UV Disinfection system.**

5. UV Disinfection System
  - a. Irish Water must ensure that the UV disinfection system at Ballinaclesh Water Treatment Plant operates within its validated range at all times.

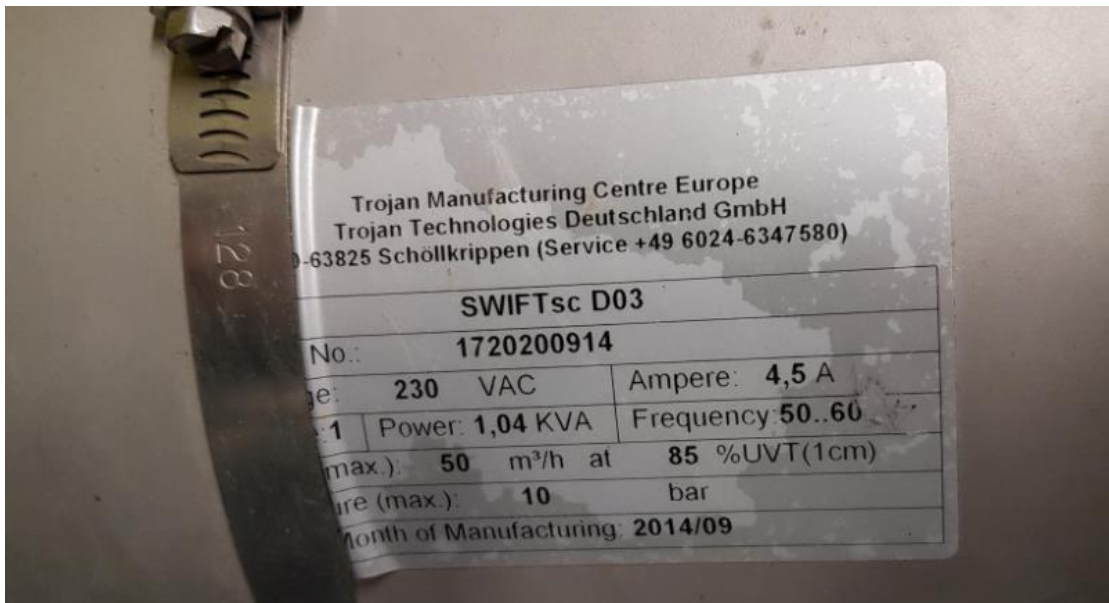
4.	<p><b>Disinfection - UV</b></p> <ul style="list-style-type: none"> <li>a. The water undergoes primary disinfection by UV treatment in duty/standby Trojan Swift D03 UV units. During the audit, the plant operator did not know the validated operating range of the UV system. However, the UV plates show a maximum flow of 50 m<sup>3</sup>/hr at a minimum of 85% UVT (see photo 1).</li> <li>b. The UV validation certificate was not available during the audit.</li> <li>c. During the audit, the plant operator did not know the alarm settings, if any, on the UV system.</li> </ul> <p><b>Disinfection - Chlorination</b></p> <ul style="list-style-type: none"> <li>d. The water undergoes secondary disinfection by chlorination at Ballinaclesh Reservoir.</li> <li>e. The chlorination system was upgraded as part of the National Disinfection Programme roll-out in County Wicklow and meets the EPA criteria for dosing arrangements.</li> <li>f. The normal dose setting is 0.6 mg/l. The low chlorine alarm is set at 0.3 mg/l. There is no high level chlorine alarm.</li> <li>g. The location of the chlorine injection points could not be confirmed by the audit attendees, however it is thought they may be located outside the secure chlorination compound, accessed via a manhole at the edge of the public road.</li> </ul>

**Photo 1: Label on the UV disinfection system which shows the validated operating range is up to 50 m<sup>3</sup>/hr flow at 85% UVT.**

- b. Irish Water should submit a copy of the validation certificate for the UV disinfection system. Irish Water should also confirm the following details:
