Drinking Water Audit Report

County:	Wicklow	Date of Audit:	26 th July 2016
Plant(s) visited:	Brittas Bay South (scheme code 3400PUB1050)	Date of issue of Audit Report:	17 th August 2016
	Brittas Bay North (scheme code 3400PUB1045)	File Reference:	DW2016/122 & DW2016/123
		Auditors:	Ms. Michelle Roche Ms. Pauline Gillard
Audit Criteria:	<ul style="list-style-type: none"> • The <i>European Union (Drinking Water) Regulations 2014 (S.I. 122 of 2014)</i>. • The <i>EPA Handbook on the Implementation of the Regulations for Water Services Authorities for Public Water Supplies (ISBN: 978-1-84095-349-7)</i> • The recommendations specified in the <i>EPA Drinking Water Report</i>. • EPA Drinking Water Advice Notes No.s 1 to 15.

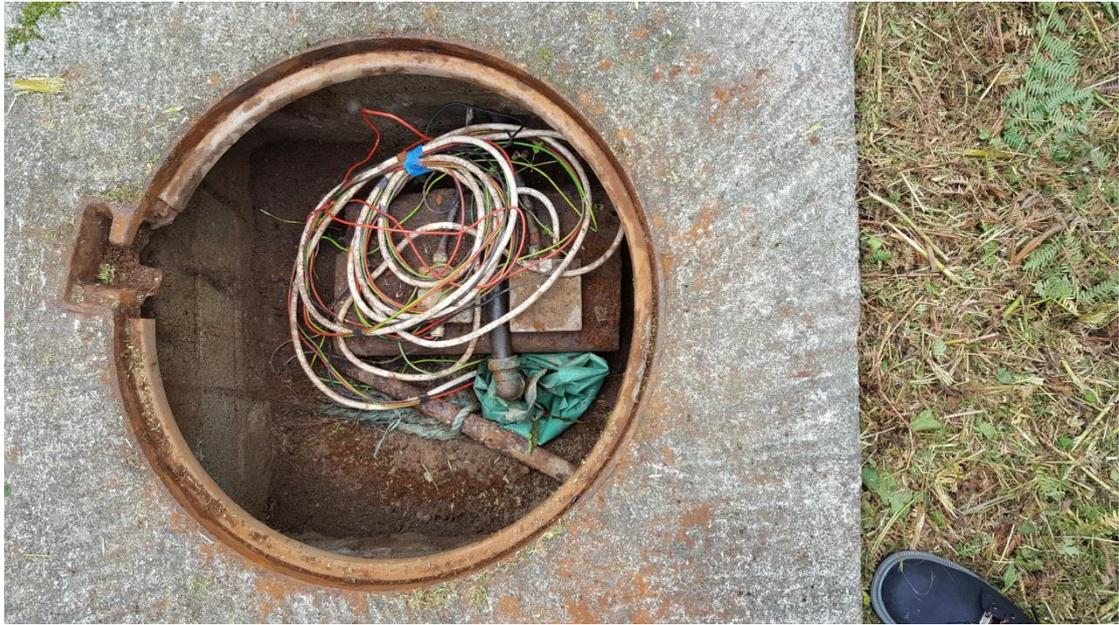
Photograph 1: Brittas Bay South Borehole

1.	<p>Source Protection</p> <ul style="list-style-type: none"> a. The Brittas Bay South Borehole is located behind the showers at the carpark. No borehole construction details are known. b. The borehole is located in a chamber but the chamber is not locked. The well head is below ground level and uncapped (Photograph 1). c. The Brittas Bay North Borehole is located behind the first north carpark, furthest from the beach. No borehole construction details are known. d. The borehole is located in a chamber but the chamber is not locked. The well head is below ground level however the casing extends approximately 0.15m up from the floor of the chamber. The wellhead is uncapped (Photograph 2).

- 2. Irish Water should install a borehole cap at both the Brittas Bay South and Brittas Bay North boreholes and ensure that all borehole linings, seals and caps are maintained in accordance with EPA Advice Note No. 14: Borehole Construction and Wellhead Protection.
- 3. Irish Water should install a locked chamber cover at both the Brittas Bay South and Brittas Bay North boreholes
