# Drinking Water Audit Report

County:	Wicklow	Date of Audit:	19 <sup>th</sup> September 2014
Plant(s) visited:	Glenealy PWS 3400PUB1021	Date of issue of Audit Report:	3 <sup>rd</sup> October 2014
		File Reference:	DW2014/319
		Auditors:	Mr Darragh Page
			Ms Aoife Loughnane
Audit Criteria:	<ul> <li>The European Union (Drinking Water) Regulations 2014 (S.I. 122 of 2014).</li> <li>The EPA Handbook on the Implementation of the Regulations for Water</li> </ul>		
	<ul> <li>Services Authorities for Public Water Supplies (ISBN: 978-1-84095-349-7)</li> <li>The recommendations specified in the EPA Report on The Provision and Quality of Drinking Water in Ireland.</li> </ul>		
	The recommendations in any previous audit reports.

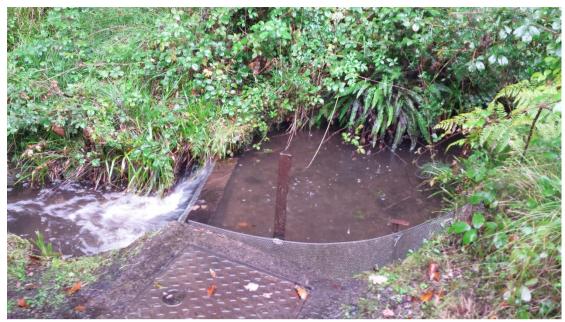
- a. The stream adjacent to Barnbawn water treatment plant is the source for the Glenealy public water supply (see photo 1). The stream is fast flowing and the raw water quality can deteriorate after heavy rainfall. Raw water monitoring results show that colour can be high on occasion (60 mg/l Hazen true colour was recorded on 11/10/2012 and 44 mg/l Hazen apparent colour was recorded on 20/03/2014). Wicklow County Council's representatives confirmed that no complaints have been received regarding the aesthetic quality of the treated water.
- b. The neighbouring land use is predominantly woodland. It is considered that the requirements under the European Communities (Good Agricultural Practice for the Protection of Waters) Regulations 2014 (SI No. 31 of 2014) are satisfied in this case.

Photo 1: Stream source and intake manhole adjacent to Barnbawn water treatment plant.

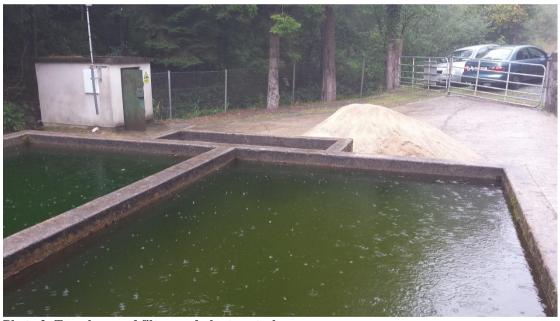
- a. There are two slow sand filters at the plant, each measuring 3.8 m x 6.1 m plan area with a liquid depth of approximately 1.3m (see photo 2).
- b. There are no turbidity monitors on the filters.
- c. The filters are normally cleaned at intervals based on the observations of the plant caretaker, e.g a lowering of the water level in the clear water tank.
- d. Replacement filter media (sand) is stored in a stockpile adjacent to the filters. The spent filter media is removed to Vartry water treatment plant for washing & reuse.
- e. There is no facility to run the filters to waste after cleaning.

Photo 2: Two slow sand filters and plant control room.

- 1. Irish Water should install continuous turbidity monitors on each slow sand filter and the final treated water at the water treatment plant. These monitors should be linked to a recording device and generate an alarm in the event of a deviation from the acceptable operating range of the filters.

- 2. Irish Water should establish documented quality criteria to outline when the slow sand filters are due to be skimmed or resanded and when they can be brought back into service following cleaning.

- 3. Irish Water should review procedures for the maintenance of the slow sand filters such that it is in accordance with the recommend procedure as specified in the *Water Treatment Manual: Filtration*.

- 4. Irish Water should ensure that, following skimming (i.e. removal of the schmutzdecke) or media replacement, the filters are run to waste for an appropriate period of time. This period of time should be determined on the basis of predetermined water quality criteria specific to the plant.

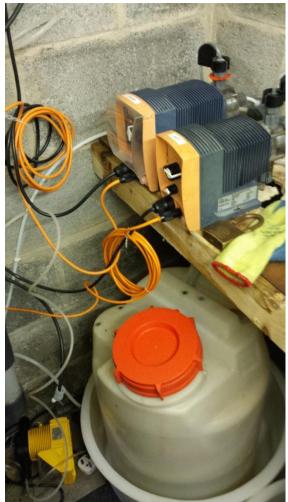
- a. The supply is disinfected by dosing sodium hypochlorite (14 15%) at the plant control room. Dosing is achieved using a recirculation loop with a set point of 0.61 mg/l. There is a duty and standby chlorine pump with automatic switch over in the event of the failure of one of the pumps (see photo 3).

- c. In the event of a power failure, water keeps flowing through the treatment plant but it is not chlorinated due to loss of power to the chlorine dosing pumps.

- d. There are no alarm settings on the disinfection system which creates a significant risk of un-disinfected or inadequately disinfected water entering supply.

Photo 3: Duty and standby chlorine dosing pumps.

- 5. Irish Water should ensure that the chlorine residual monitor on the final water is alarmed and linked to a recording device to ensure that either a sudden increase in chlorine demand or a failure of the chlorine dosing system is immediately detected.
- 6. Irish Water should review the use of disinfectants at the Glenealy PWS and all other public water supplies to ensure that all disinfectants are authorised in accordance with the EU Biocides Products Regulation (528/2012) and associated Irish regulations (*European Union (Biocidal Products) Regulations*, 2013.
