Drinking Water Audit Report

County:	Wicklow	Date of Audit:	12 th February 2015
Plant(s) visited:	Tinahely PWS	Date of issue of Audit Report:	18 th February 2015
		File Reference:	DW2015/9
		Auditors:	Mr Darragh Page Ms Aoife Loughnane
Audit Criteria:	<ul style="list-style-type: none"> • The <i>European Union (Drinking Water) Regulations 2014 (S.I. 122 of 2014)</i>. • <i>The EPA Handbook on the Implementation of the Regulations for Water Services Authorities for Public Water Supplies (ISBN: 978-1-84095-349-7)</i> • The recommendations specified in the EPA Drinking Water Report. • The recommendations in any previous audit reports.

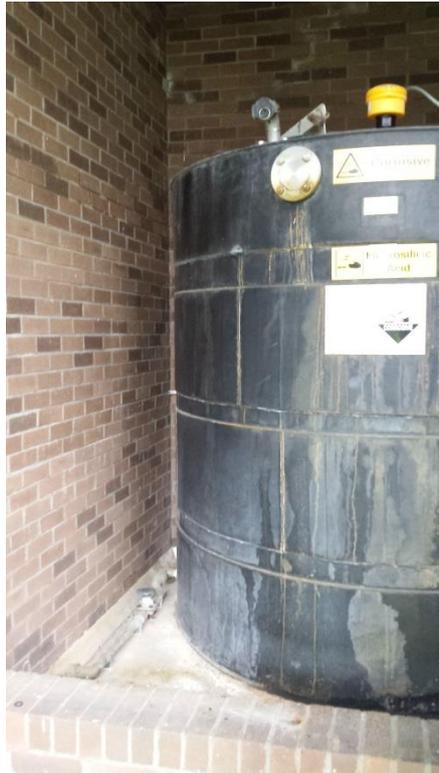
Photo 1. Fluoride Bulk Storage Tank.

5.	<p>Fluoridation</p> <ul style="list-style-type: none"> a. Fluoride is dosed into the final water. b. The bulk storage tank for fluoride was located in a locked area. There is a drain at the rear of the bunded area which drains to an underground storage tank. It was not clear if the base of the bund (which appeared to be concrete) was acid resistant though there did appear to be a liner underneath. Approximately 2 inches from the base of the bund was brickwork which was not acid resistant (see Photo 1).

4. Irish Water should review chemical storage arrangements at the treatment plant for the fluoride bulk storage tank to determine if the walls and floor of the storage compound are acid resistant and capable of containing any possible spills.
