Drinking Water Audit Report

County:	Wicklow	Date of Audit:	6 th November 2014
Plant(s) visited:	Cronroe Water Treatment Plant and Broomhall, Greenhills, Mariners Point, Ballyguile, Seacrest and Ballyneerin Reservoirs	Date of issue of Audit Report:	10 th November 2014
		File Reference:	DW2014/351
		Auditors:	Mr Darragh Page Ms Aoife Loughnane
Audit Criteria:	<ul style="list-style-type: none"> • The <i>European Union (Drinking Water) Regulations 2014 (S.I. 122 of 2014)</i>. • <i>The EPA Handbook on the Implementation of the Regulations for Water Services Authorities for Public Water Supplies (ISBN: 978-1-84095-349-7)</i> • The recommendations specified in the EPA Report on <i>The Provision and Quality of Drinking Water in Ireland</i>. • The recommendations in any previous audit reports.

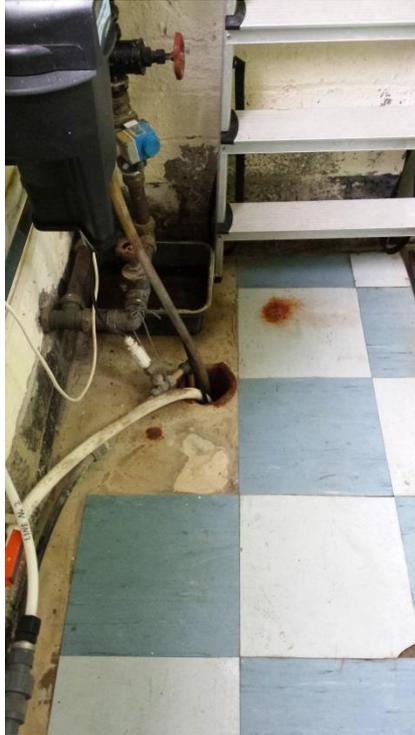
Photo 1. Hole observed in the floor of the Cronroe WTP leading to the filtered water channel.

8. Irish Water should provide for access to the SCADA at the Cronroe water treatment plant.
9. Irish Water should seal the hole in the floor of the water treatment works to reduce the potential for any spillages on the floor of the water treatment works entering the final treated water.

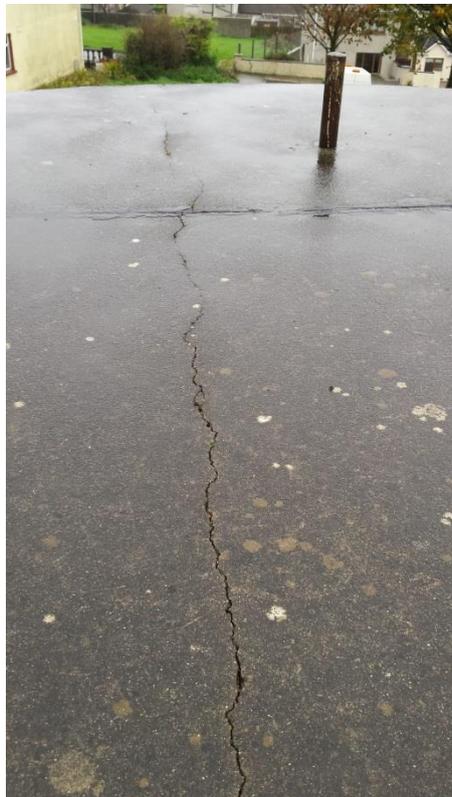
<p>the reservoir to deal with low residuals in the network. This is to be in place in Q1 2015.</p> <p>Ballyneerin Reservoir The Ballyneerin reservoir is located in the middle of a housing estate and supplies housing in the vicinity. There were cracks on the roof of the reservoir (Photo 2) though Wicklow County Council stated that there were no structural issues or ingress into the reservoir.</p> <p>Seacrest Reservoir The Seacrest reservoir is on higher ground and receives water from a sump adjacent to the Ballyneerin reservoir. There was evidence of material being burnt at the base of the reservoir (Photo 3) while there were also cracks in the roof of the reservoir (Photo 4).</p> <p>Wicklow County Council stated that they had originally applied to the Department of Environment, Community and Local Government several years ago to construct a single reservoir on higher ground to supply the entire area of Wicklow town but this had not been approved.</p> <p>Irish Water stated that a chlorine booster station was planned for water exiting the Broomhall Reservoir as this was a recommendation of the THM audit carried out previously and it was thought that this would enable the primary dose of chlorine at Cronroe WTP to be reduced. However, it was pointed out by the auditors that while this might address low residuals in the area supplied by the Broomhall reservoir it would not enable the primary dose to be reduced significantly as levels would need to be maintained for the area supplied by the Greenhills reservoir.</p> <p>Irish Water stated that it would review the effectiveness of the remedial works (reduced storage capacity, elimination of the Ballyguile reservoir) on the quality of the water in the area supplied by the Mariners Point reservoir and if this was not effective Irish Water would review whether a chlorine booster station was required. The auditors stressed the urgency of removing the boil water notice as soon as possible, and identified that temporary measures may be required to be implemented as the installation of a full booster station could take time especially as there was not a suitable electricity source on site.</p>

Photo 2. Crack observed in the roof of the Ballyneerin Reservoir.

4. Irish Water should replace the covers on the Mariners Point reservoir with secure, lockable covers that prevent ingress.
5. Irish Water should investigate the cracks in the Ballyneerin and Seacrest reservoir roofs to determine if they are enabling ingress into the reservoirs.

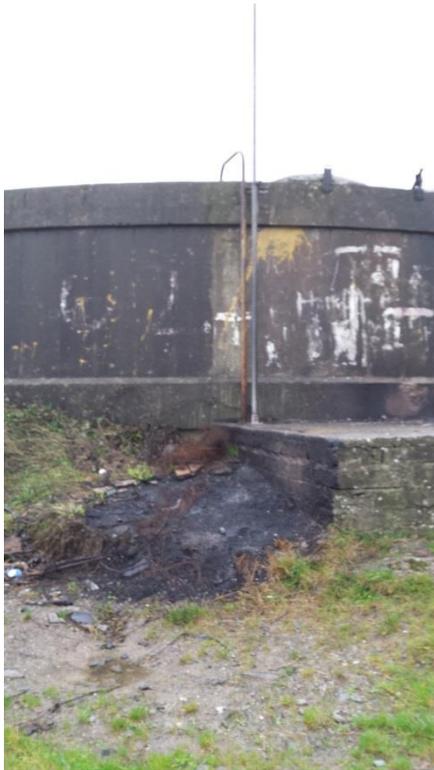
Photo 3. Evidence of burning at the Seacrest Reservoir.

7. Irish Water should take action to prevent burning or other illegal activity in the vicinity of the Seacrest reservoir. The area in the vicinity of Seacrest Reservoir should be cleaned up.

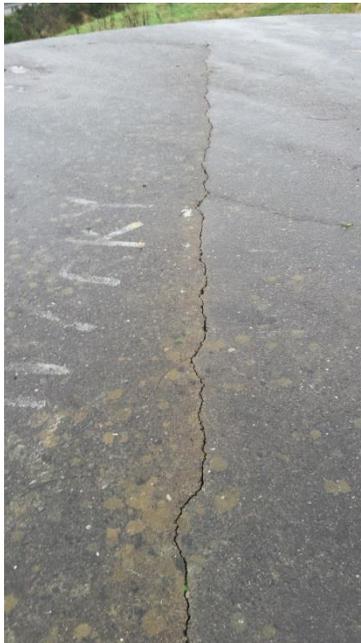
Photo 4. Crack observed in the roof of the Seacrest Reservoir.
