SITE VISIT REPORT

Purpose of Site Visit: Peat Extraction in Co. Kildare

Site Address: Ballinderry, Carbury, Co. Kildare

Date of Visit: 08/06/2022

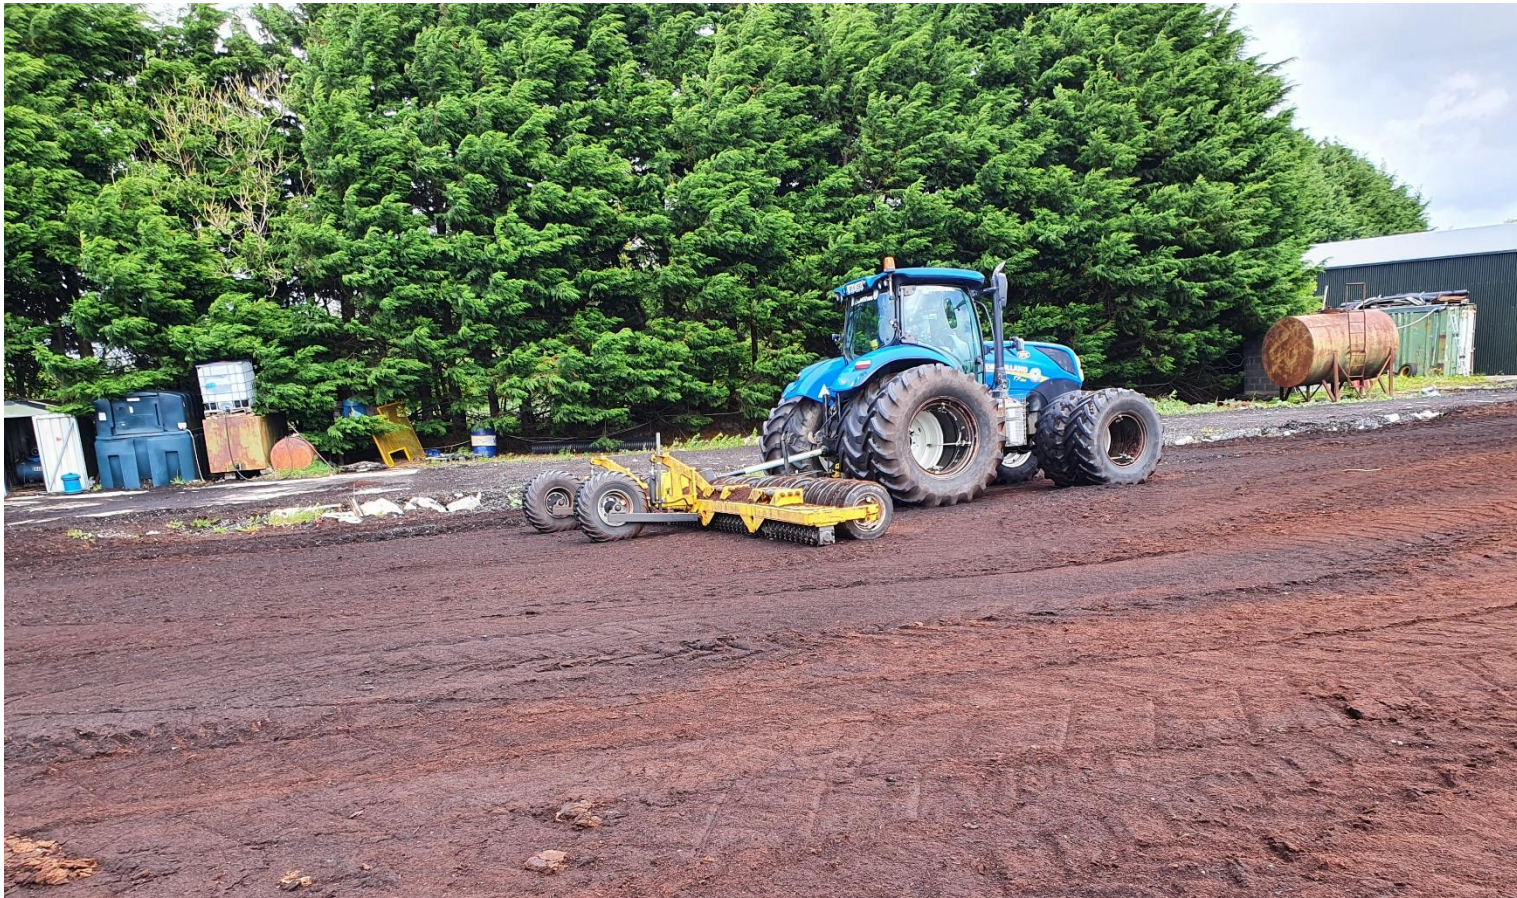
Appendix 2

- This is a milled peat harvesting operation and the scale of the activity and the area involved is on a commercial scale. A peat processing and bagging plant is also located at the site (Appendix 2).

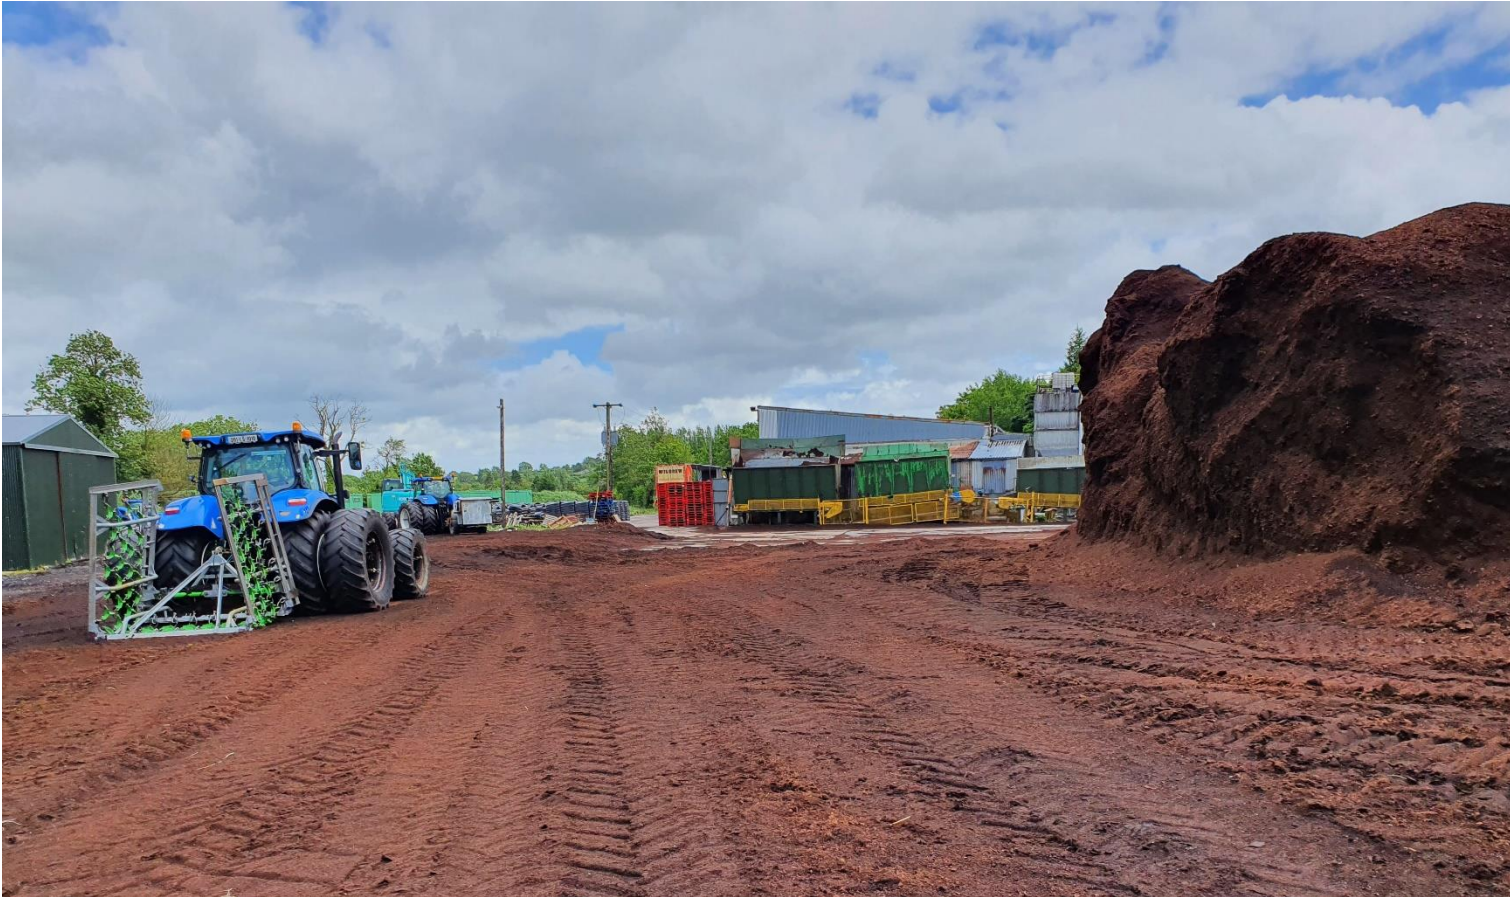
- Milled peat harvesting activity had recently taken place and machinery/equipment for harvesting peat was noted parked at the site and on the peatland. A tractor was working on the bog during the visit.

Photo 1: Peat harvesting equipment noted at the site.

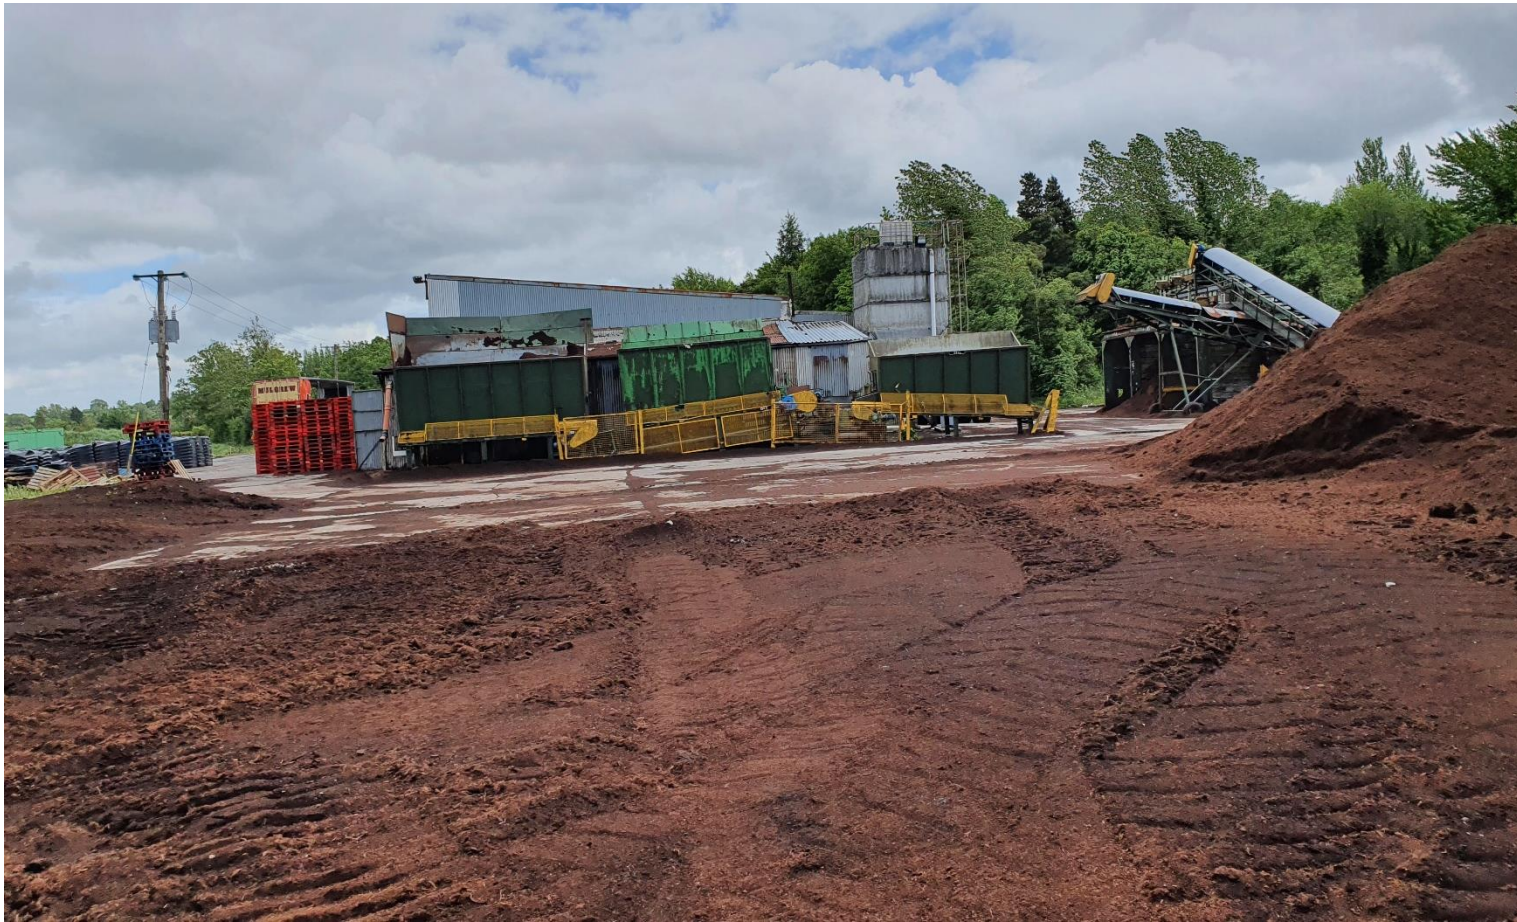
Photo 2: Peat harvesting equipment, peat processing/bagging plant and stockpile of peat noted at the site.

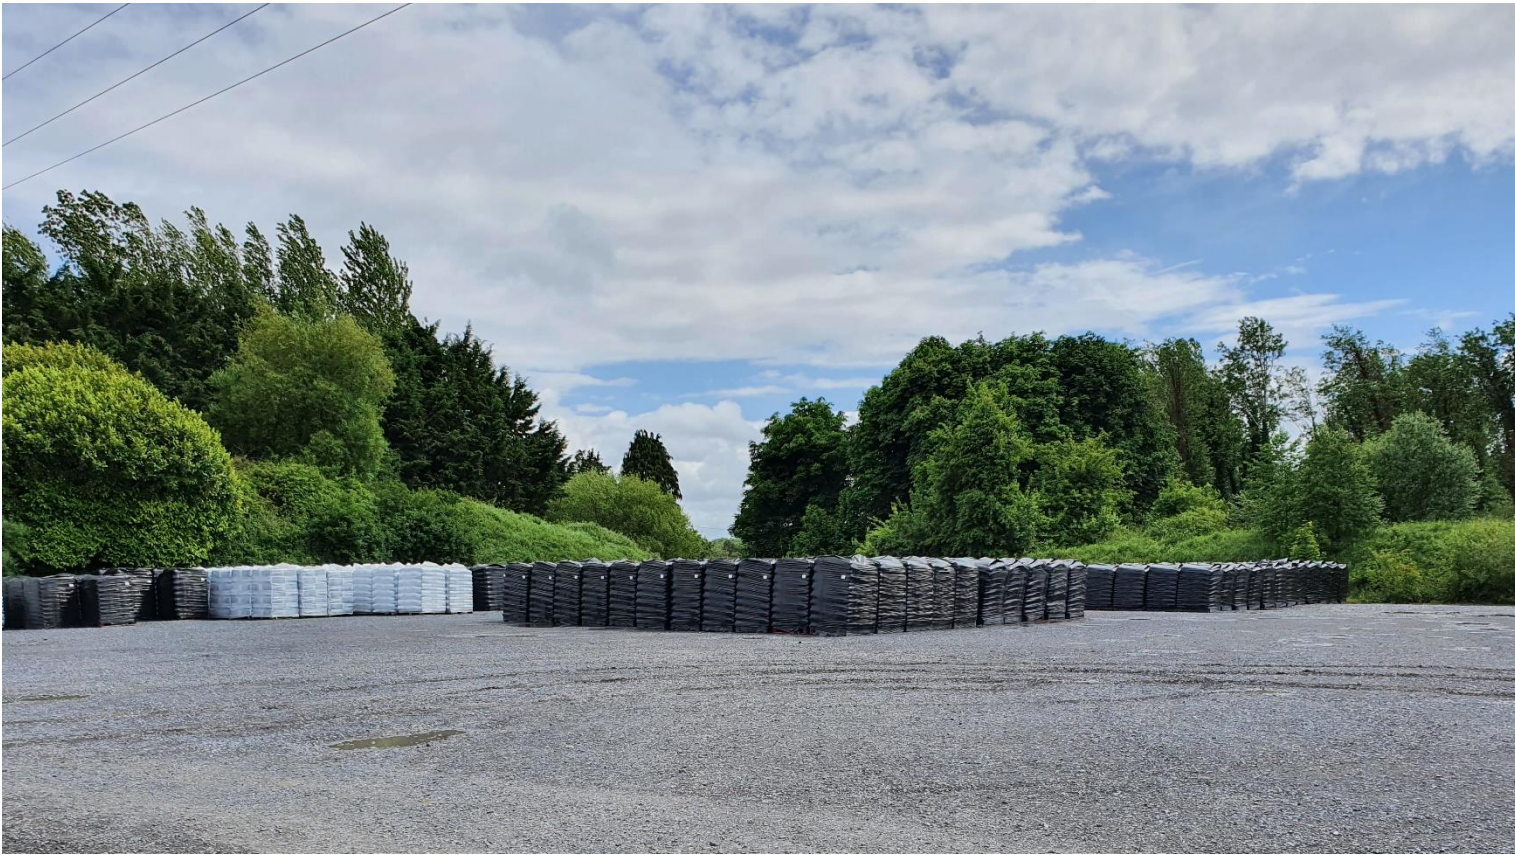
Photo 3: Peat processing/bagging plant at the site.

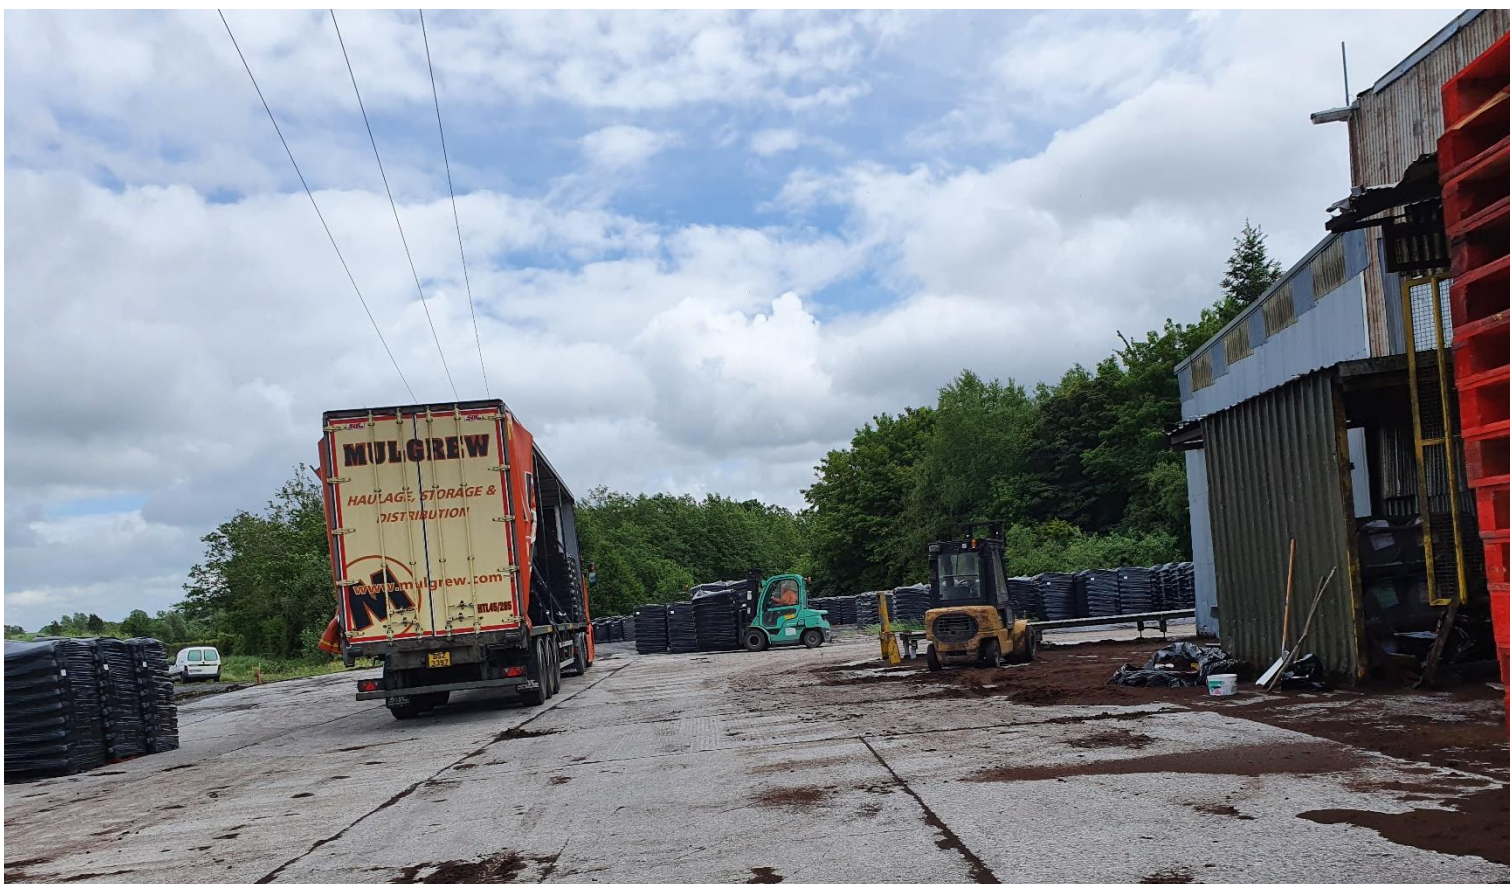
- Stockpiles of milled peat were noted at the site.
- Significant quantities of bagged material were stored at the site and an articulated vehicle was being loaded during the visit.

Photo 4: Bagged and wrapped materials stored at the site.

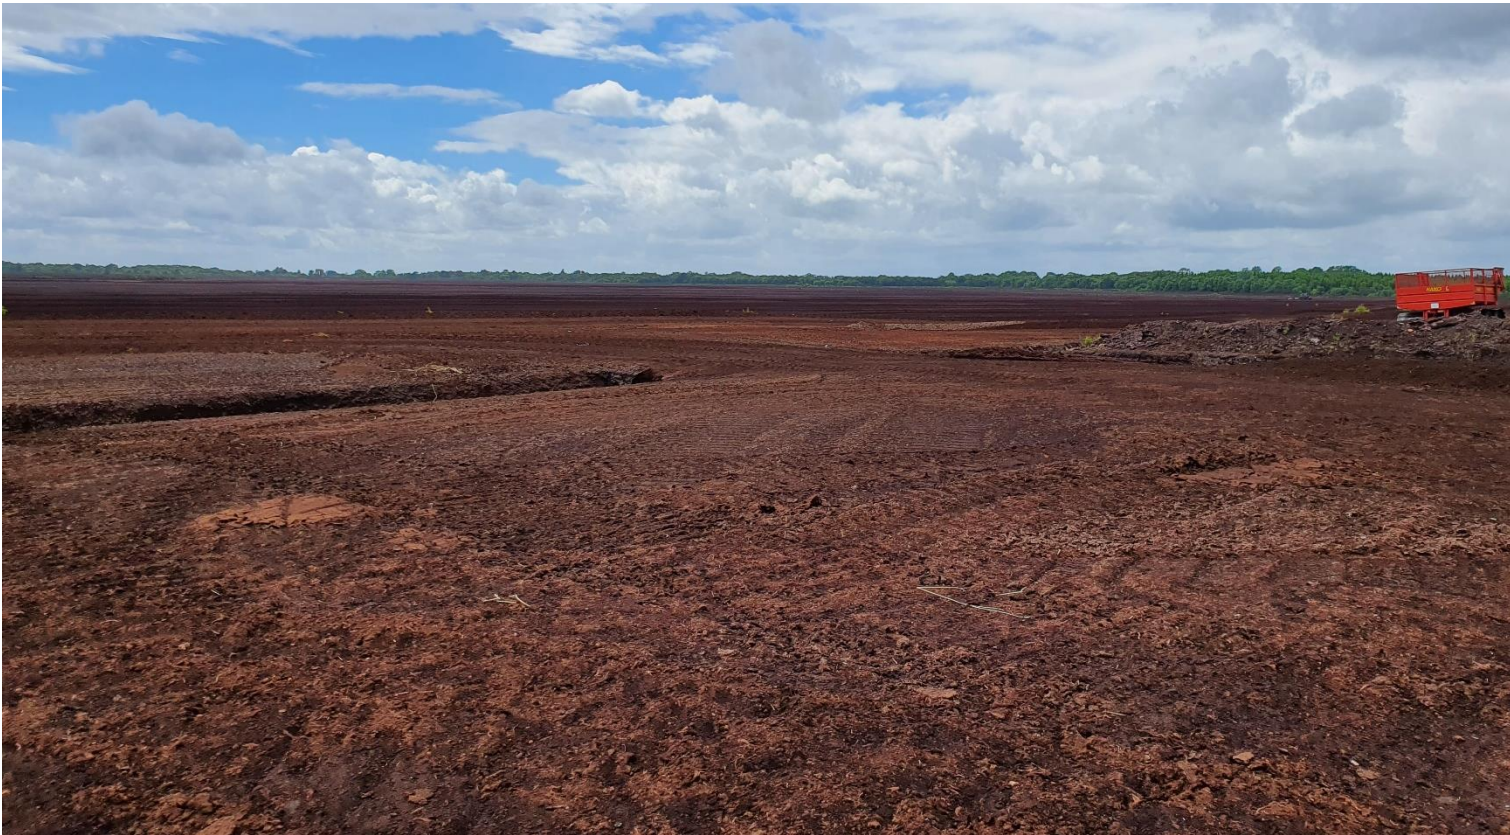
Photo 6: Peatland where milled peat was extracted recently.
