SITE VISIT REPORT

Purpose of Site Visit: Peat Extraction in Co Longford

Site Address: Derrymore, Ardagh Co Longford

Date of Visit: 16/09/2022

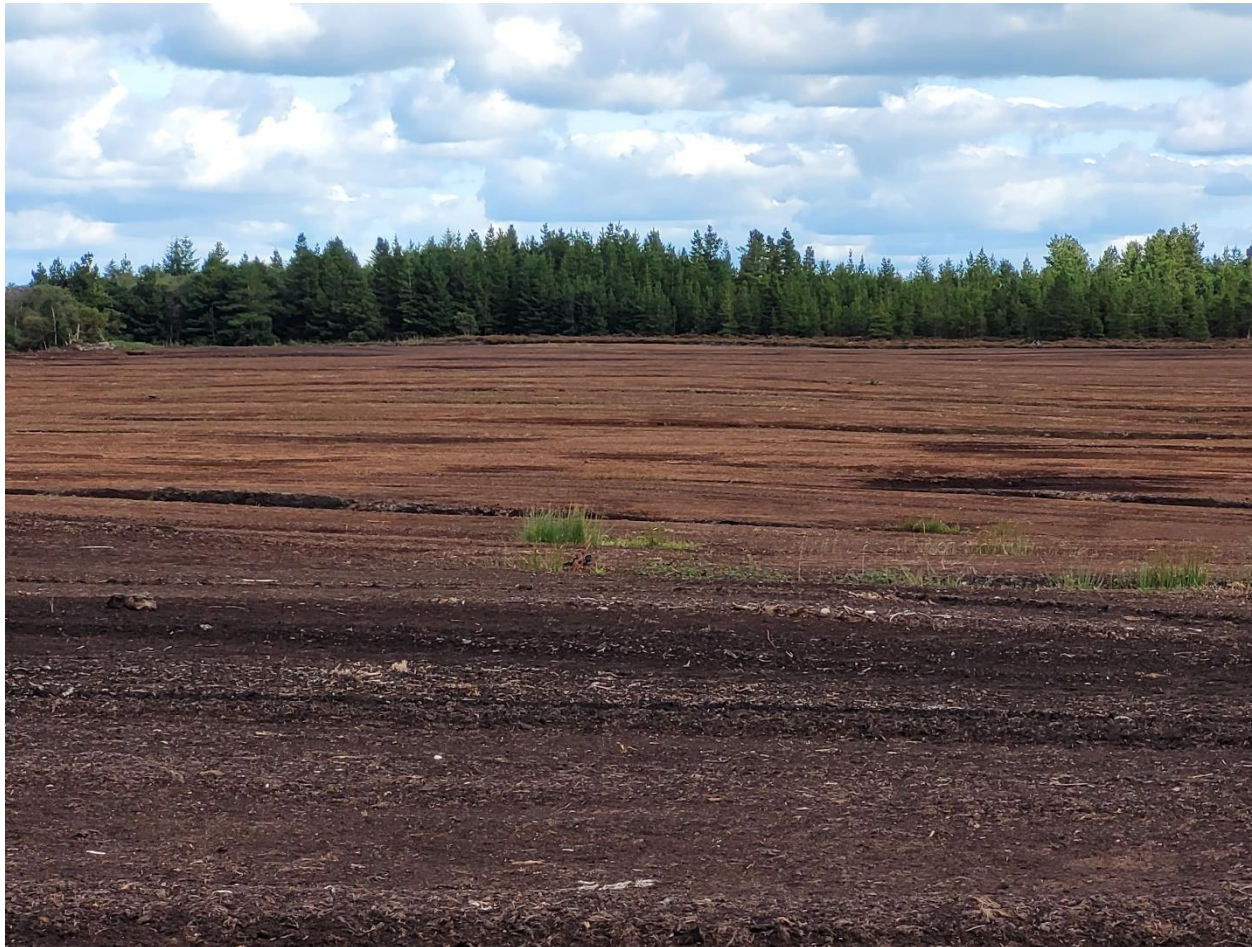
Photo 1: Recent milled peat area noted at the eastern side of the peatland.

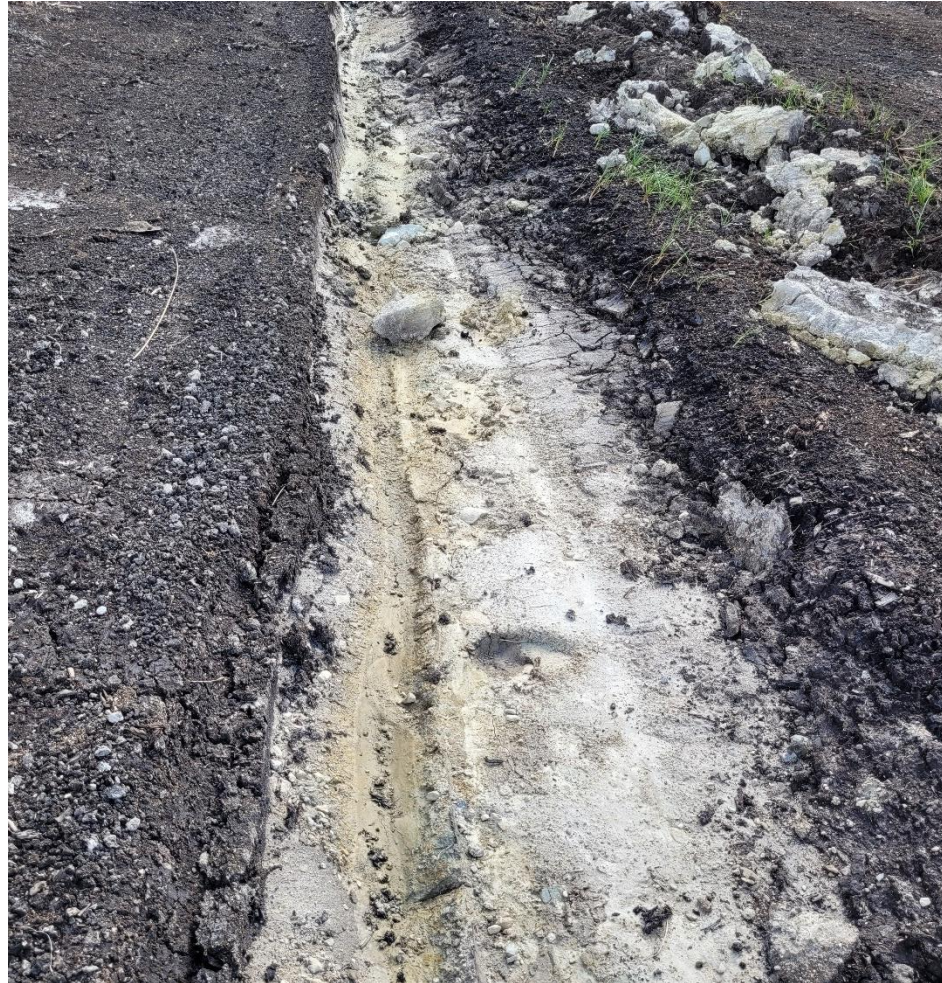
Photo 2: Exposed marl noted on the peatland.

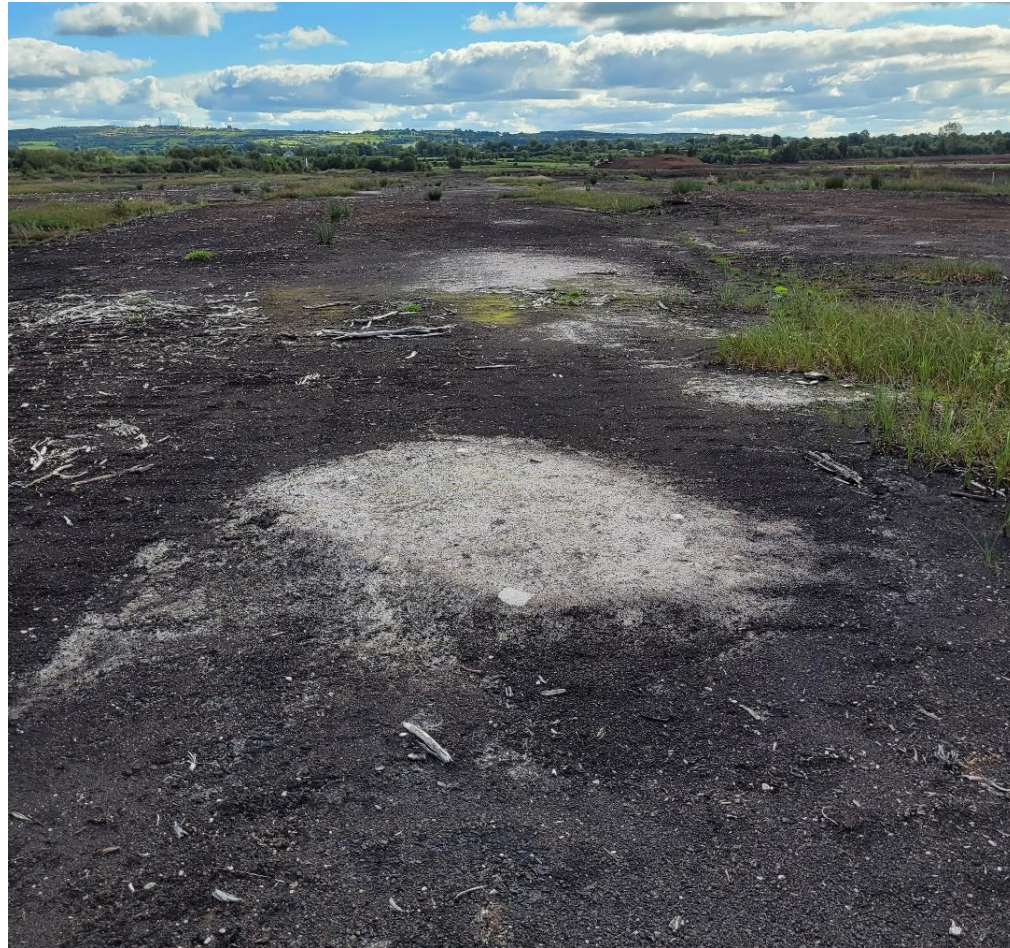
Photo 3: Marl exposed on the peatland.

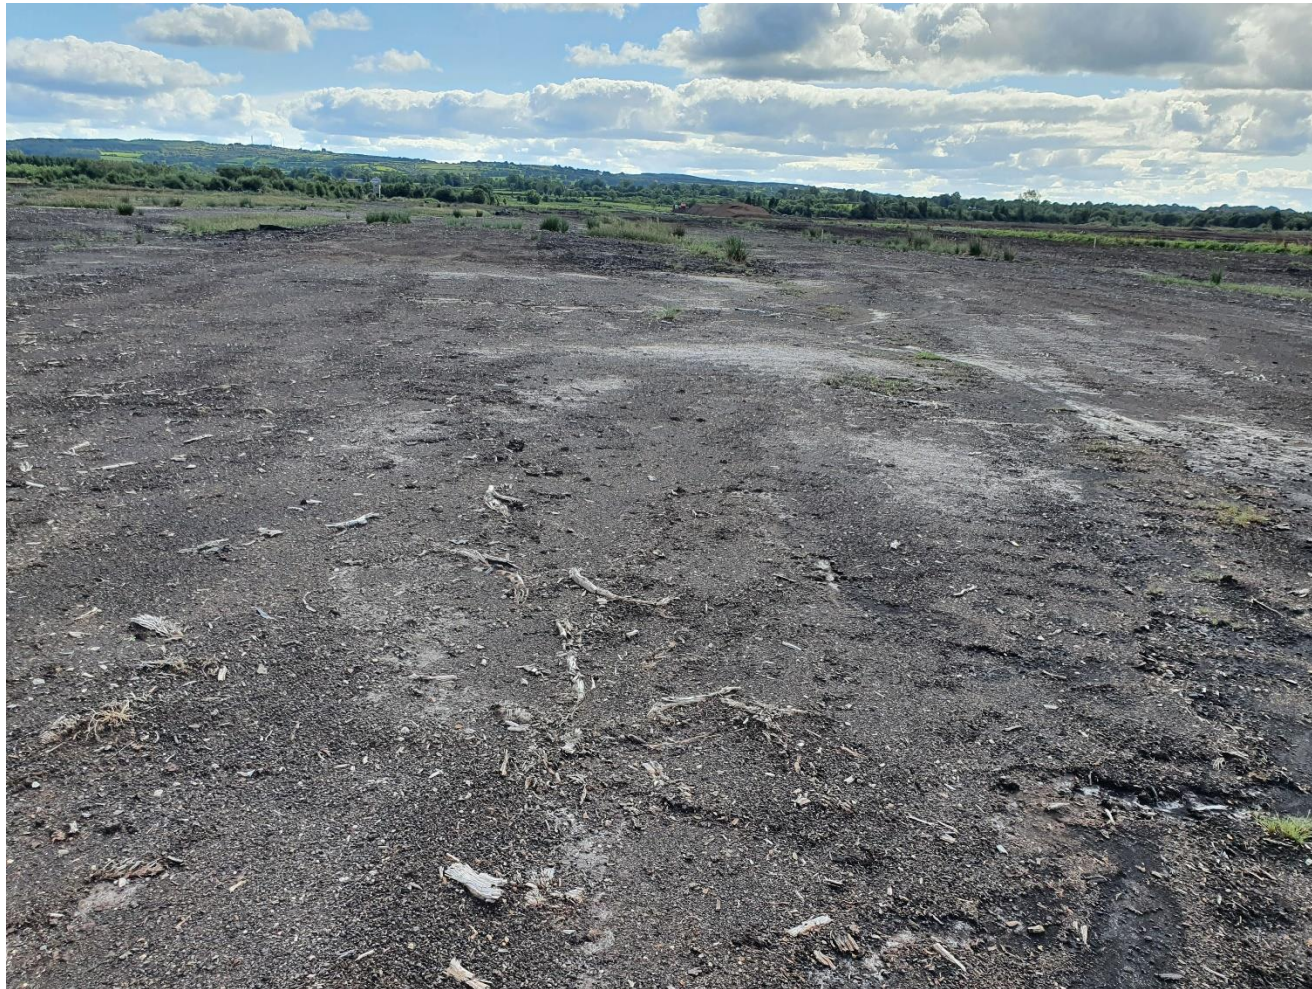
Photo 4: Marl exposed on the peatland.

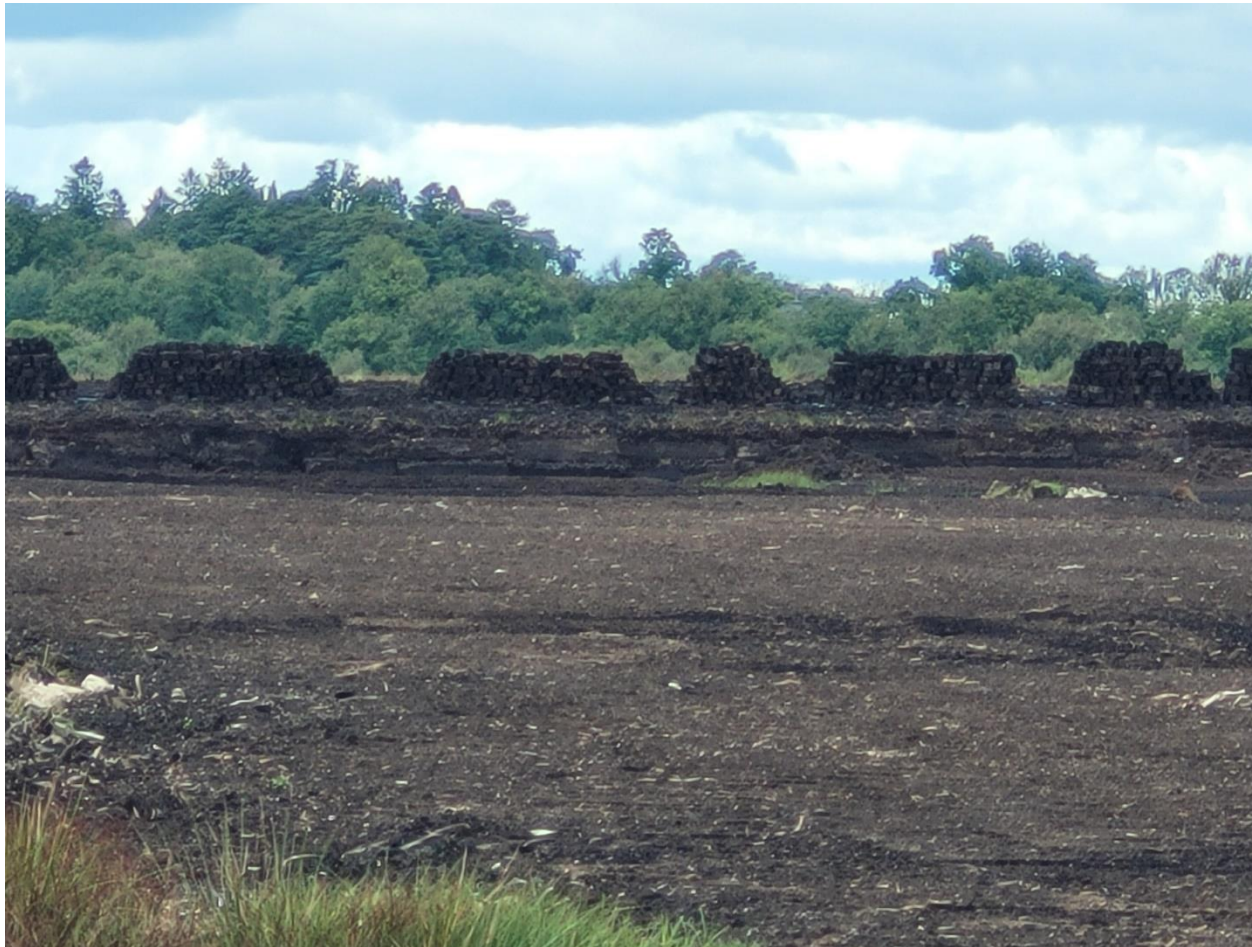
Photo 5: Excavated large sod peat left out on the peatland for drying.

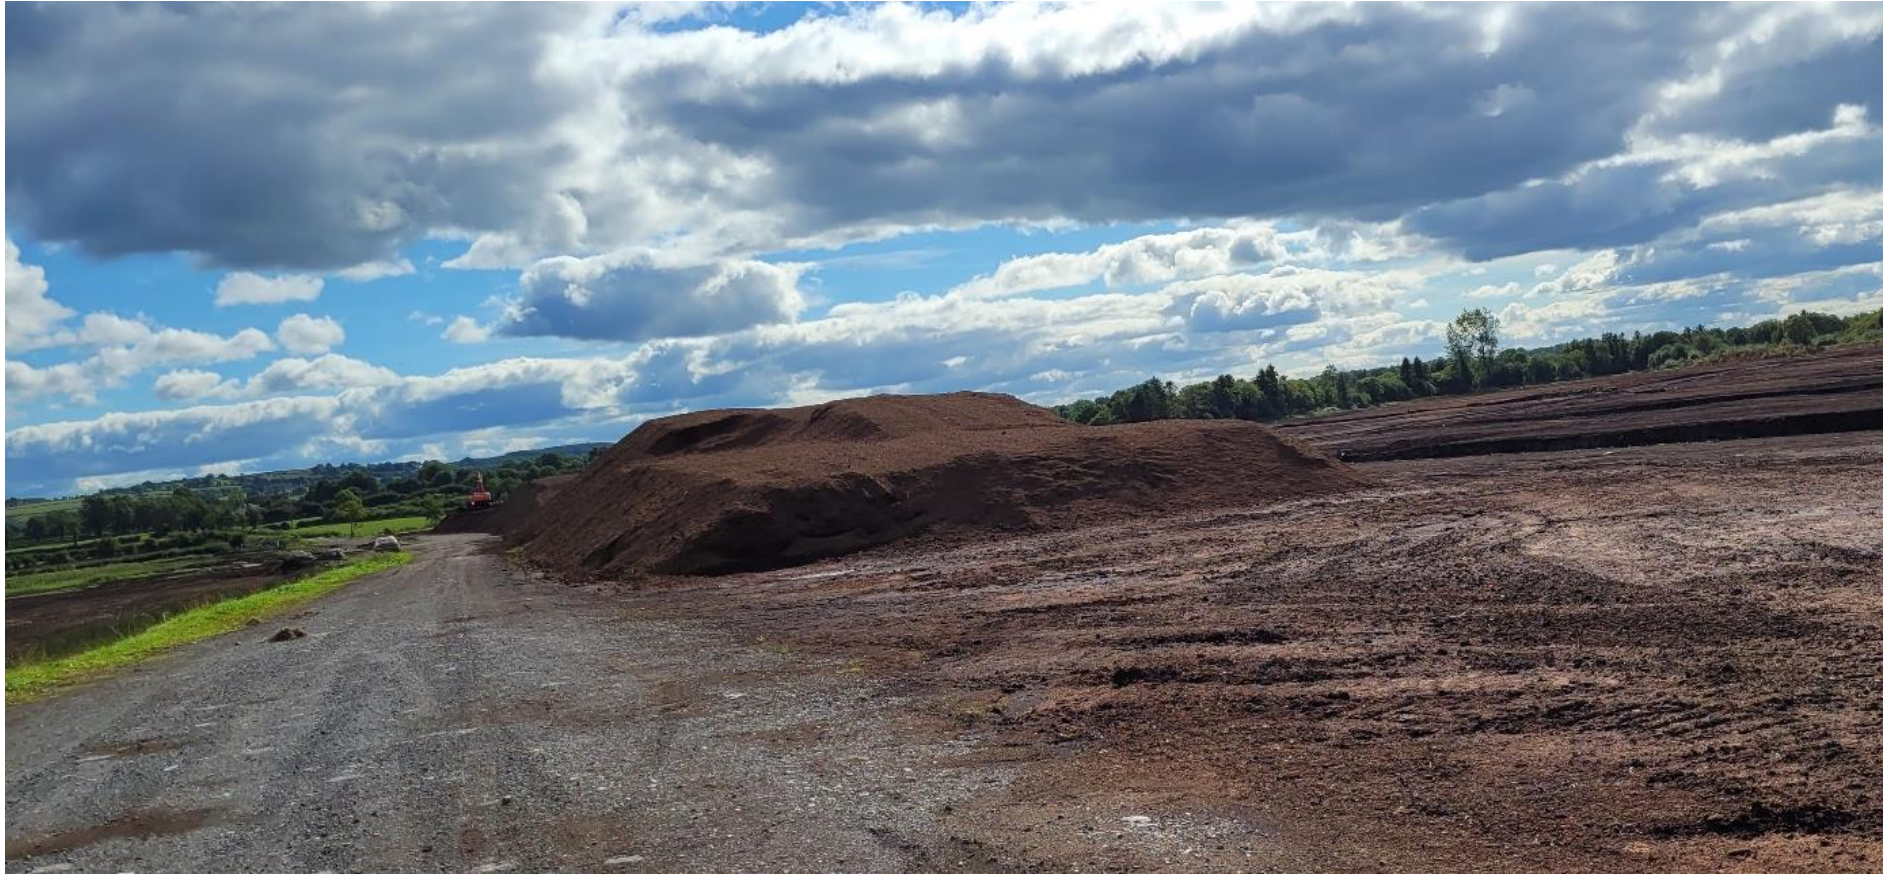
- No peat extraction/harvesting was taking place during the visit.
- Peat harvesting machinery was noted at the peatland and this included trailers, milling attachments, loaders/elevators, etc.
- Significant quantities of milled peat had been collected at the loading area since the previous visit in July 2022. Two large stockpiles of milled peat were noted at the loading area.
- It was noted that peat had been excavated down to the marl at the centre of the peatland and the marl was exposed at these locations.
- A quantity of sod-peat was noted at the nort/north west section of the peatland.
- A lorry with a North of Ireland registration (██████████) entered the area during the visit and parked alongside the milled peat stockpile. A digger for loading the peat was in place on top of the stockpile.

Photo 6: Significant stockpiles of milled peat noted during the visit.

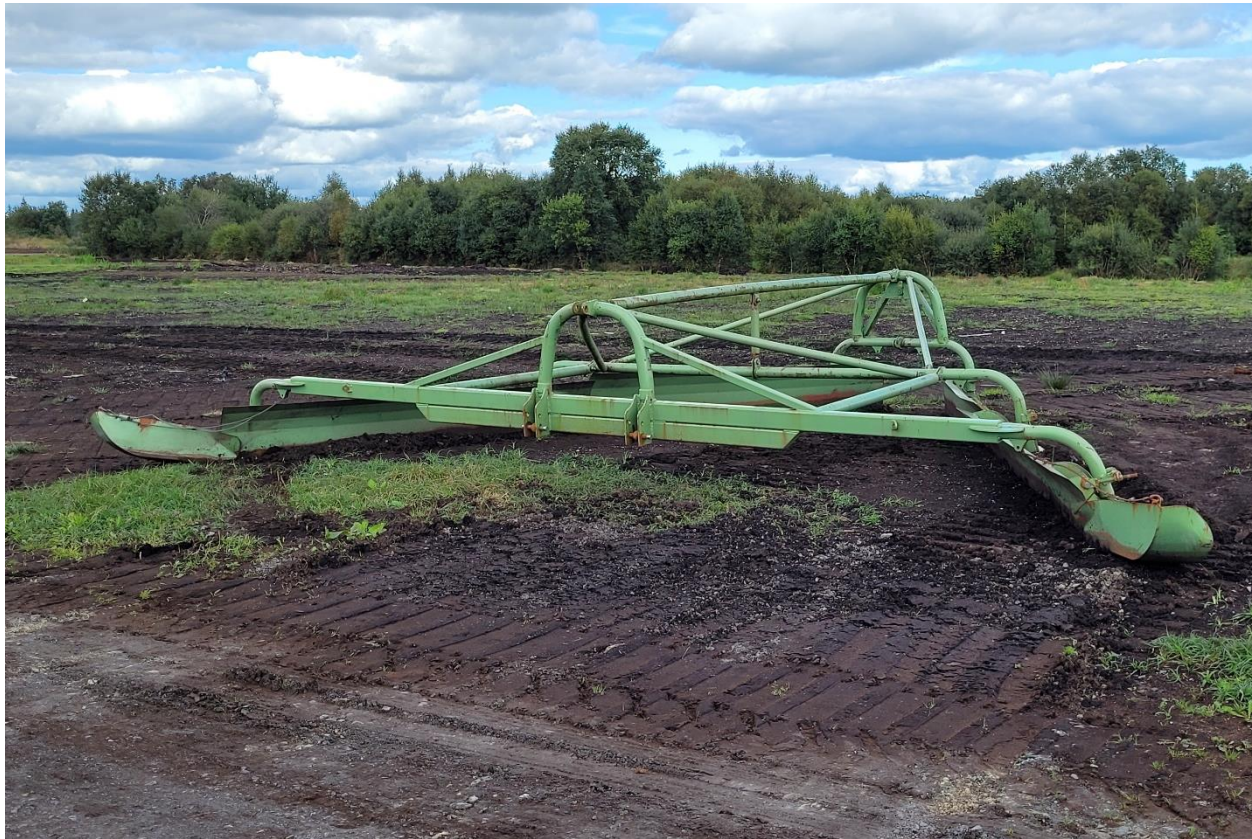
Photo 7: Milled peat harvesting machinery noted during the visit

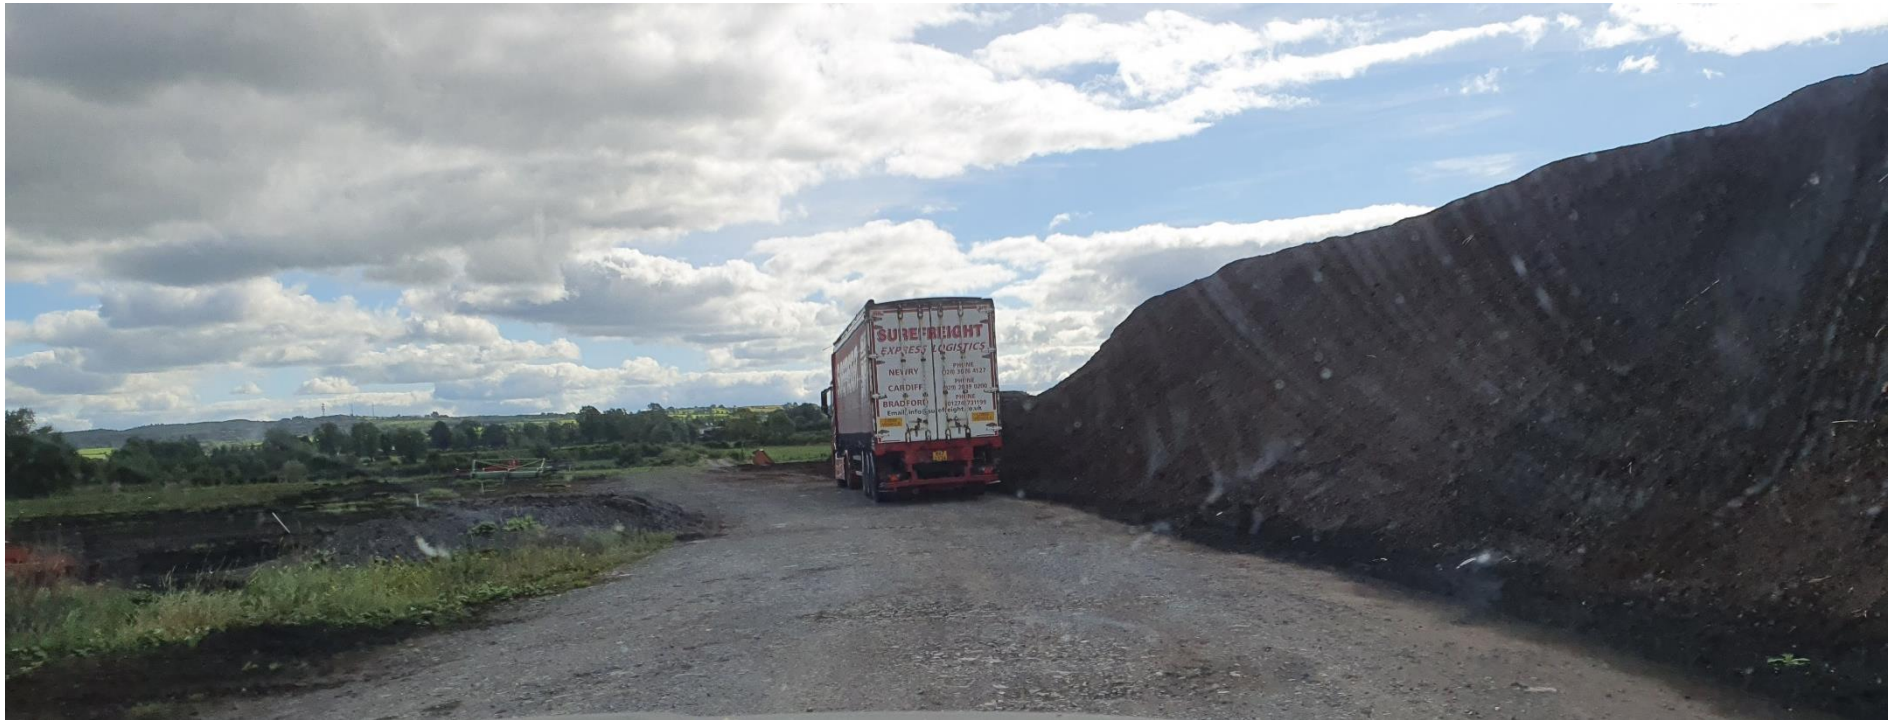
Photo 8: Lorry awaiting loading at the milled peat stockpiles.
