SITE VISIT REPORT

Purpose of Site Visit: Peat Extraction in Co Longford

Site Address: Derrymore, Ardagh Co Longford

Date of Visit: 27/04/2022

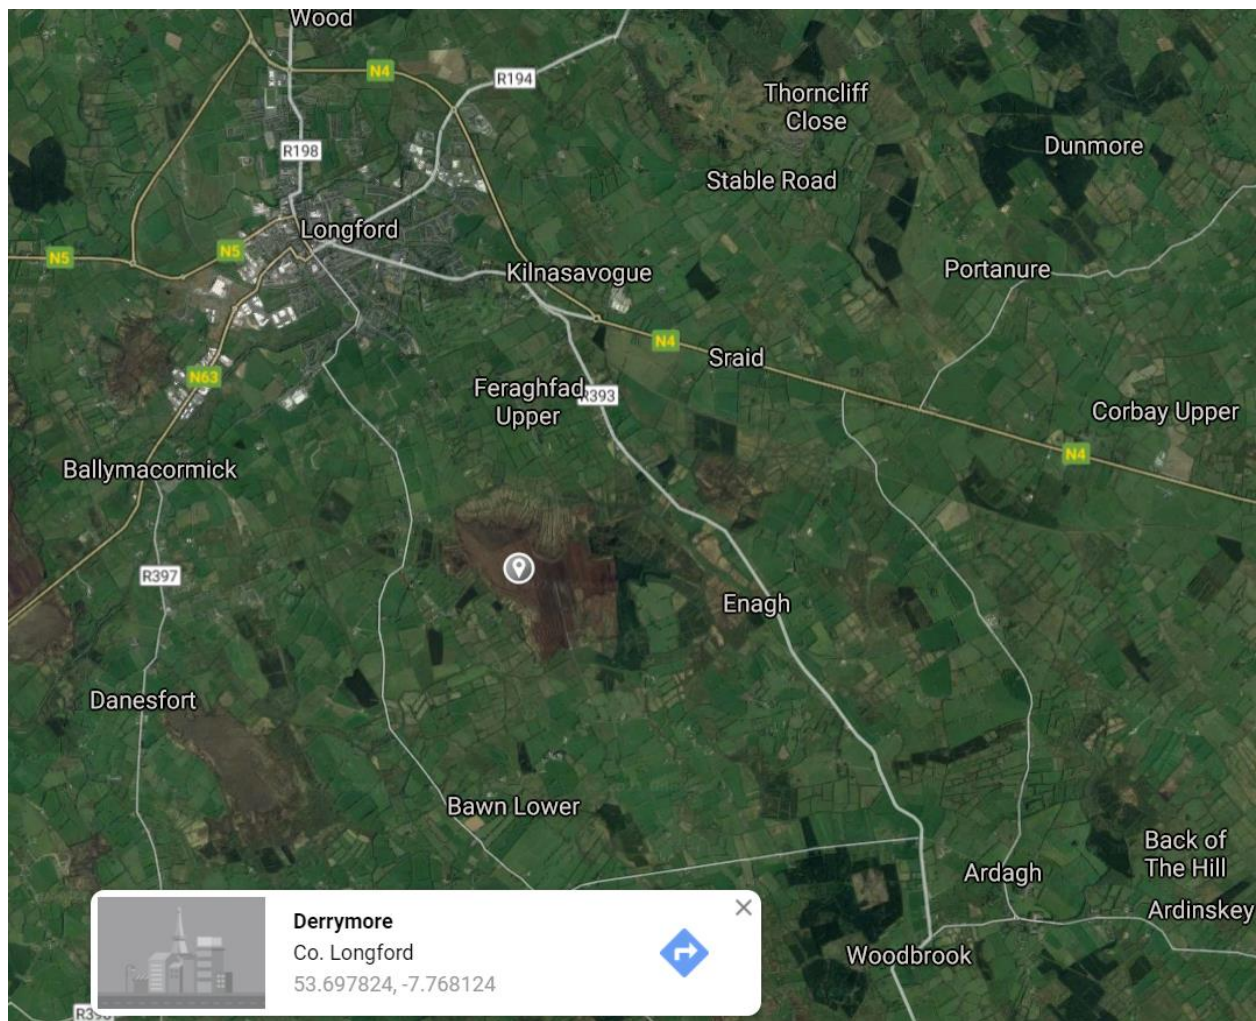
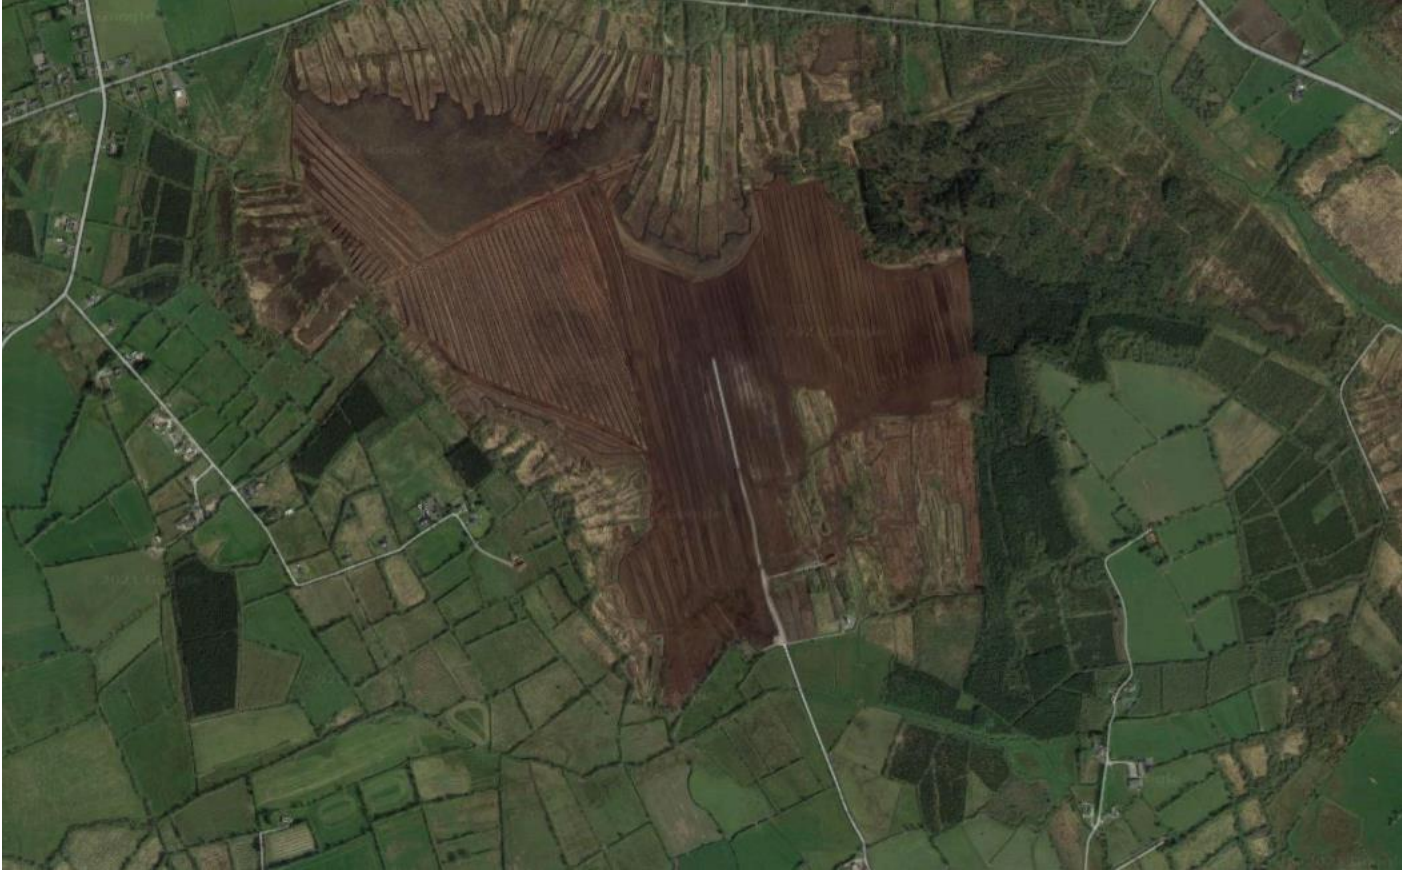
Appendix 1

- Peat excavation machinery was noted in the area (Appendix 1) at Derrymore townland where an extensive area of bog was being worked (sod peat and milling) for transport off-site.

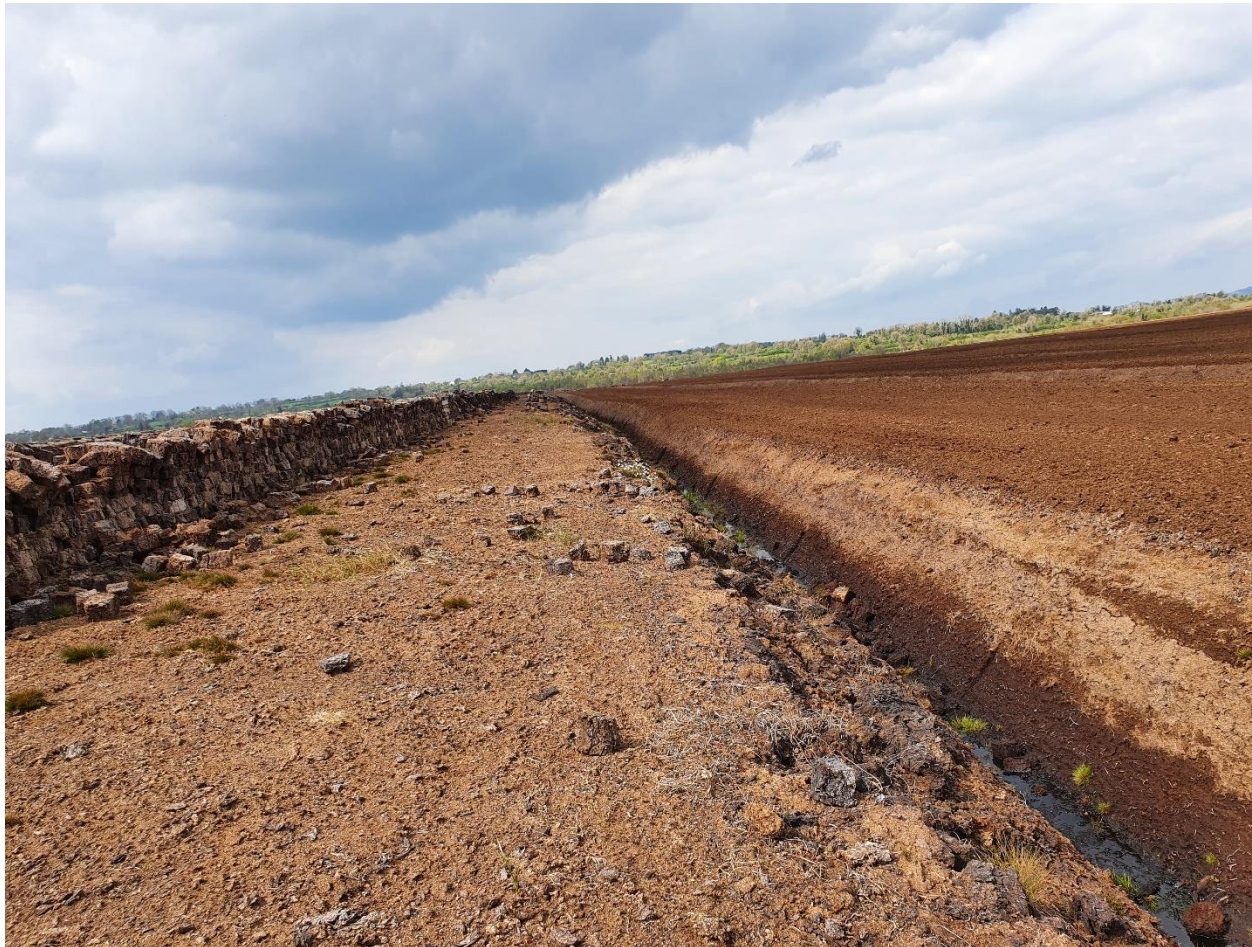
Photo 1: Sod peat walled prior to removal off the peatland noted.

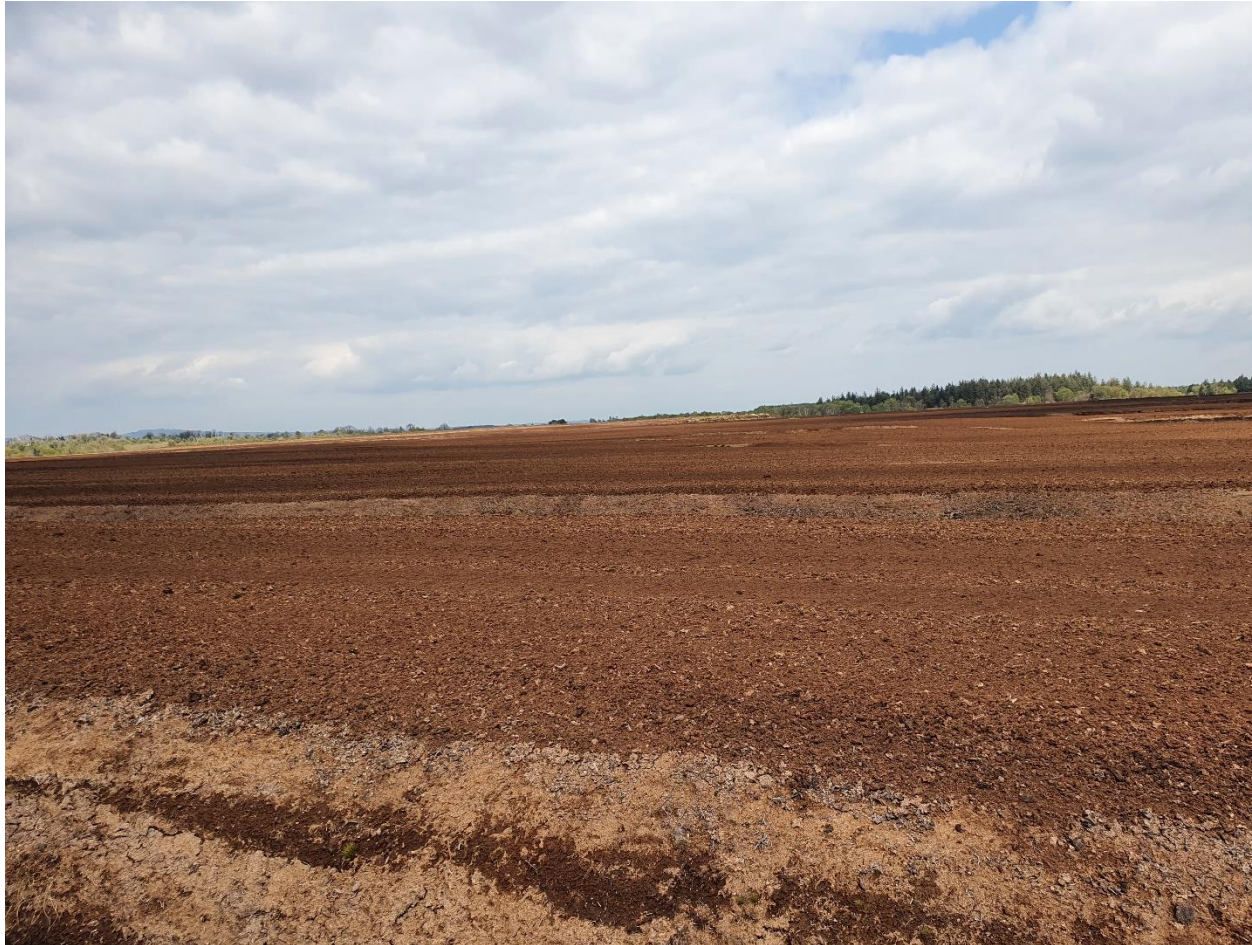
Photo 2: Recently milled peat area noted.

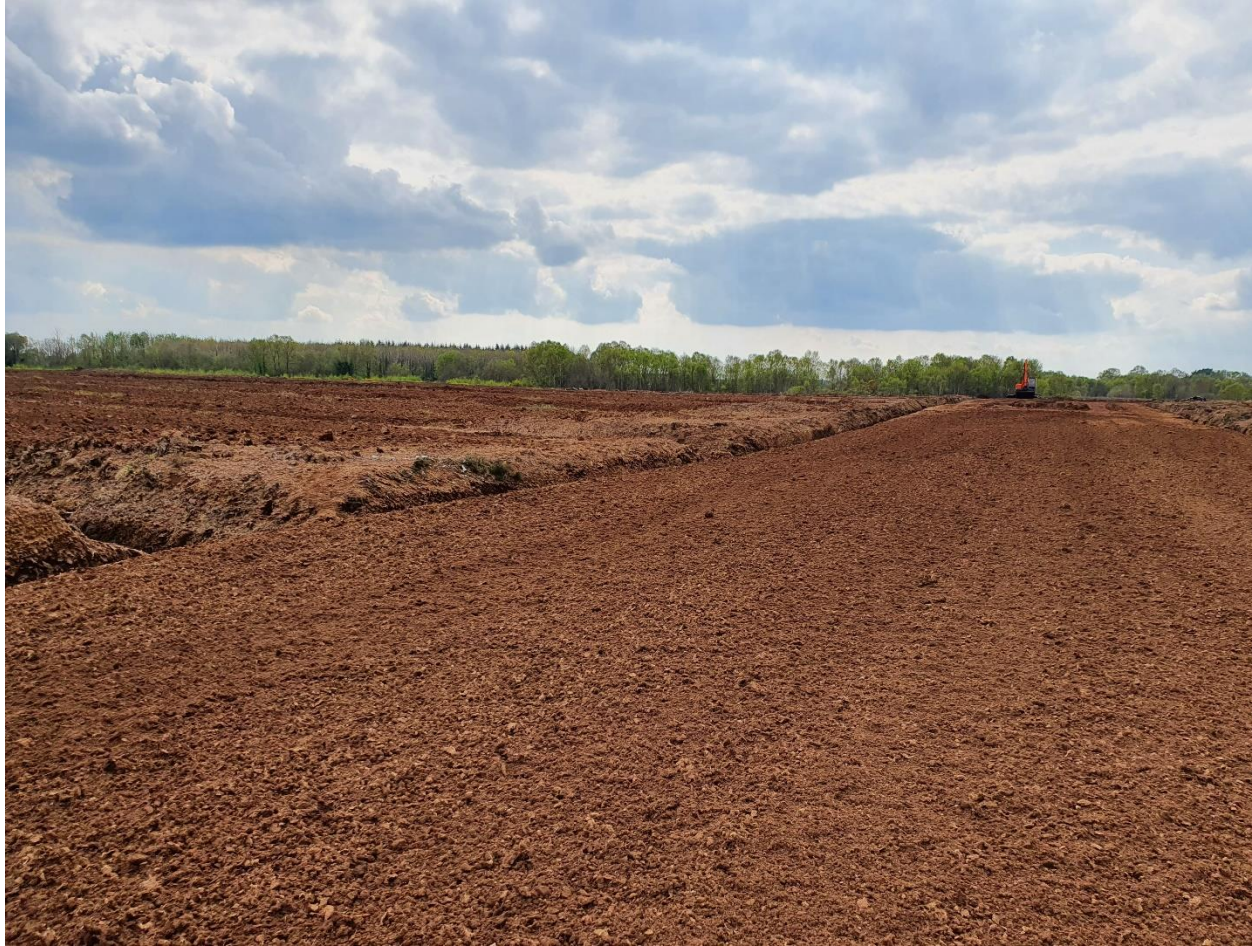
Photo 3: Milled peat with excavator in the distant background preparing for sod peat excavation noted

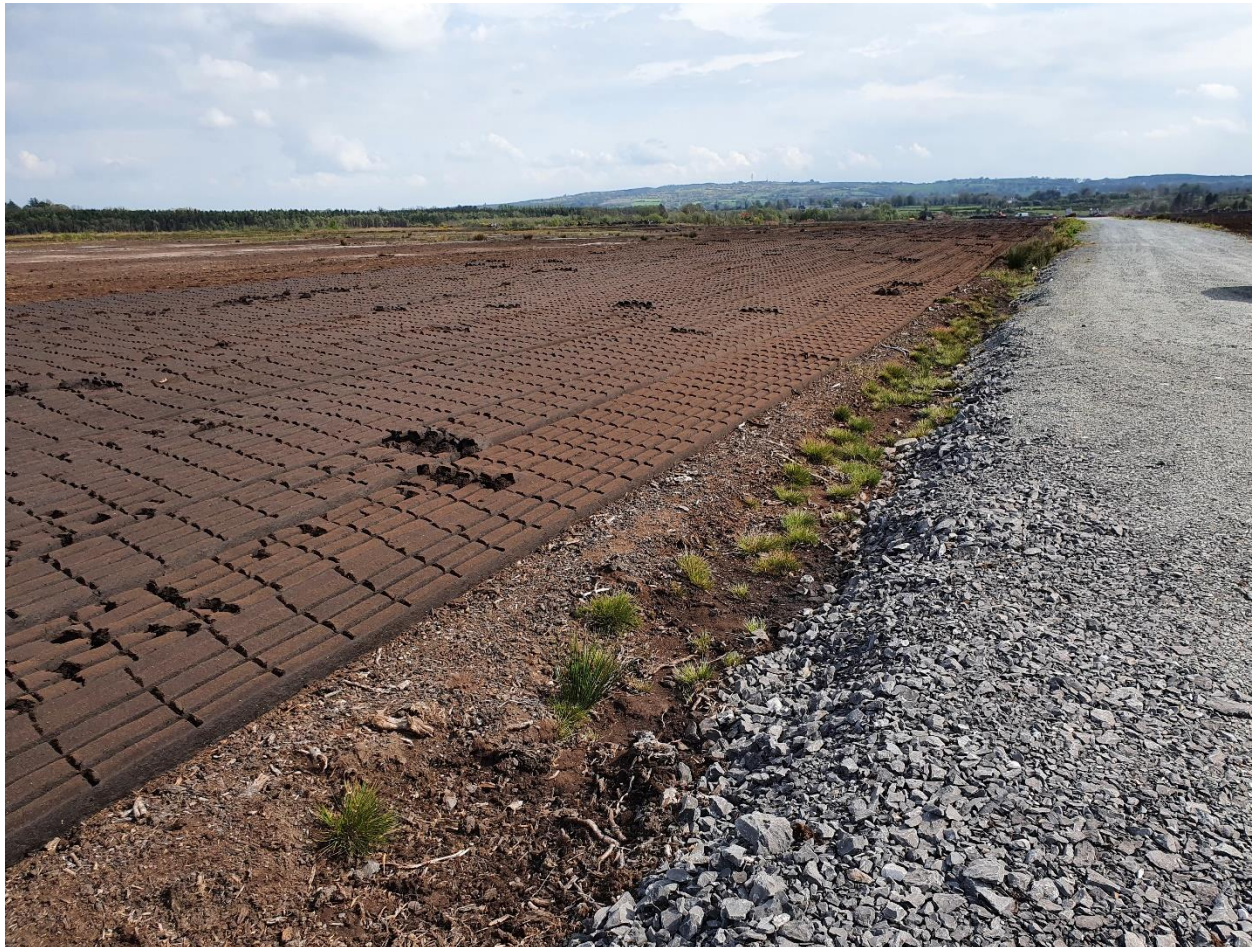
Photo 4: Recently excavated hopper peat spread out on the peatland for harvesting noted.

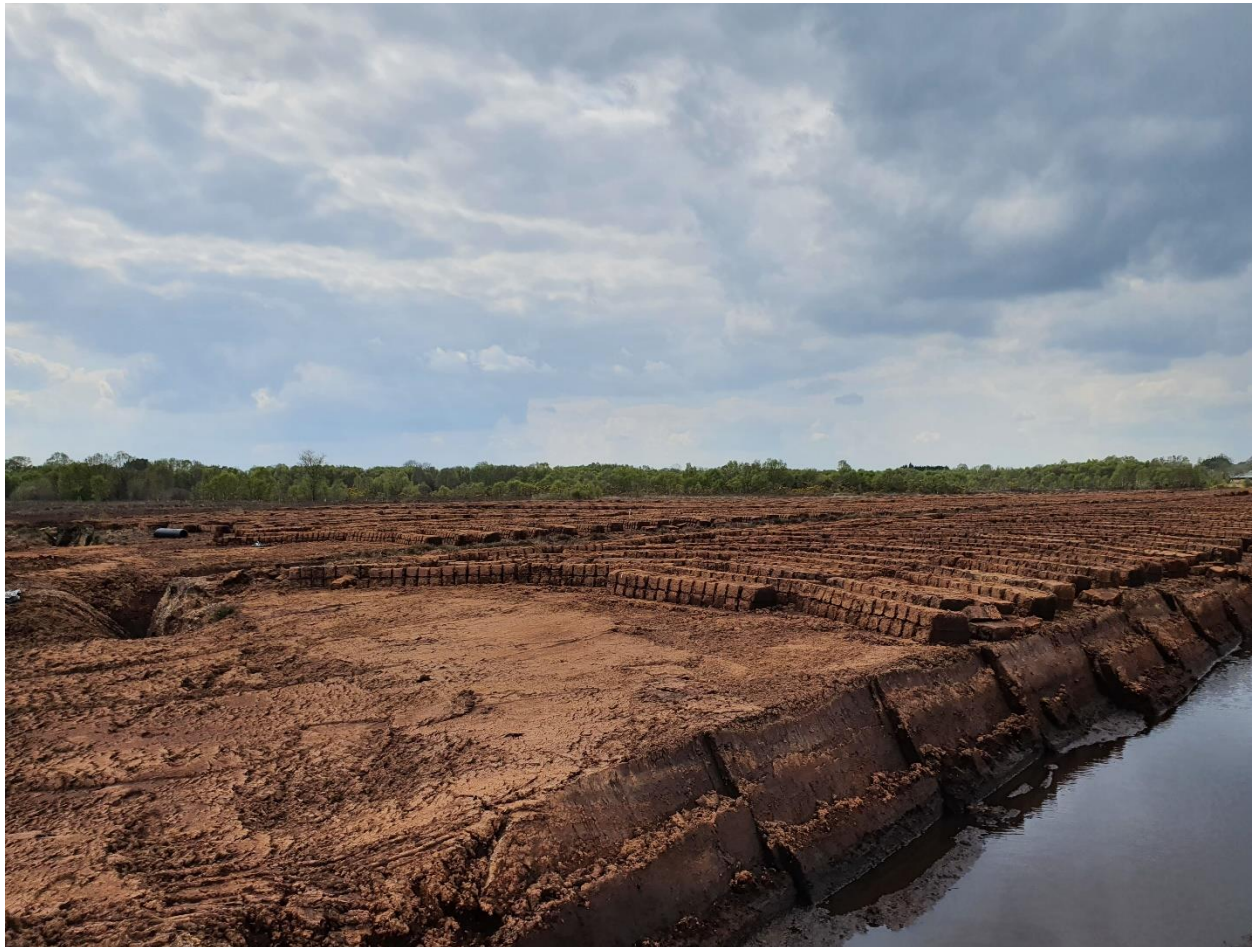
Photo 5: Recently excavated large sod peat noted
