# SITE VISIT REPORT

**Purpose of Site Visit:** Peat Extraction in Co. Kildare

**Site Address:** Ballinderry, Carbury, Co. Kildare

**Date of Visit:** 22/06/2023

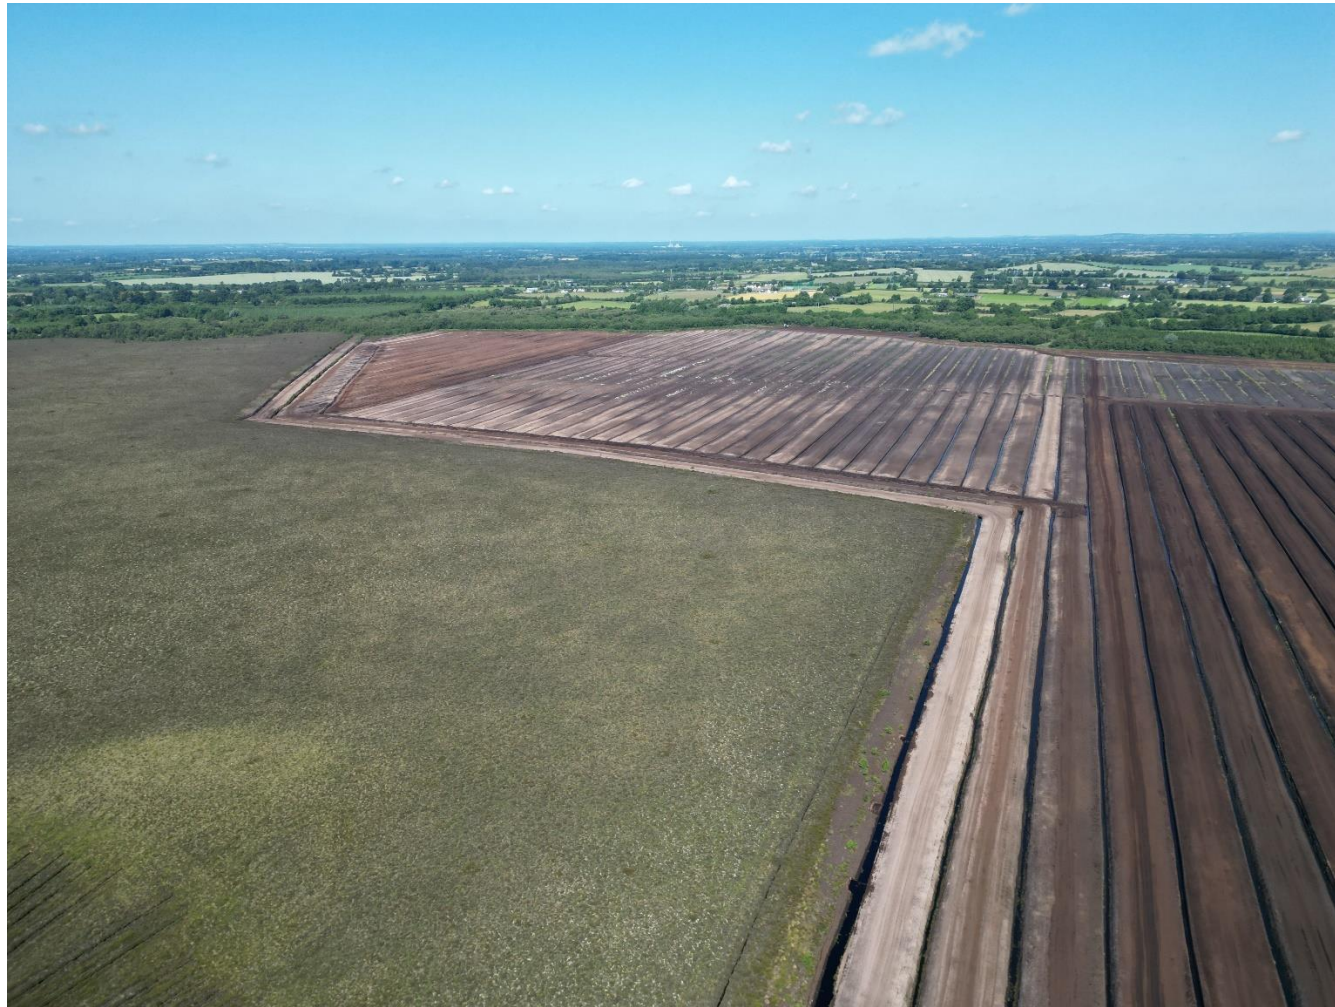
**Photo 2: Photograph of the ‘worked area’ of the peatland and the untouched adjacent peatland.**

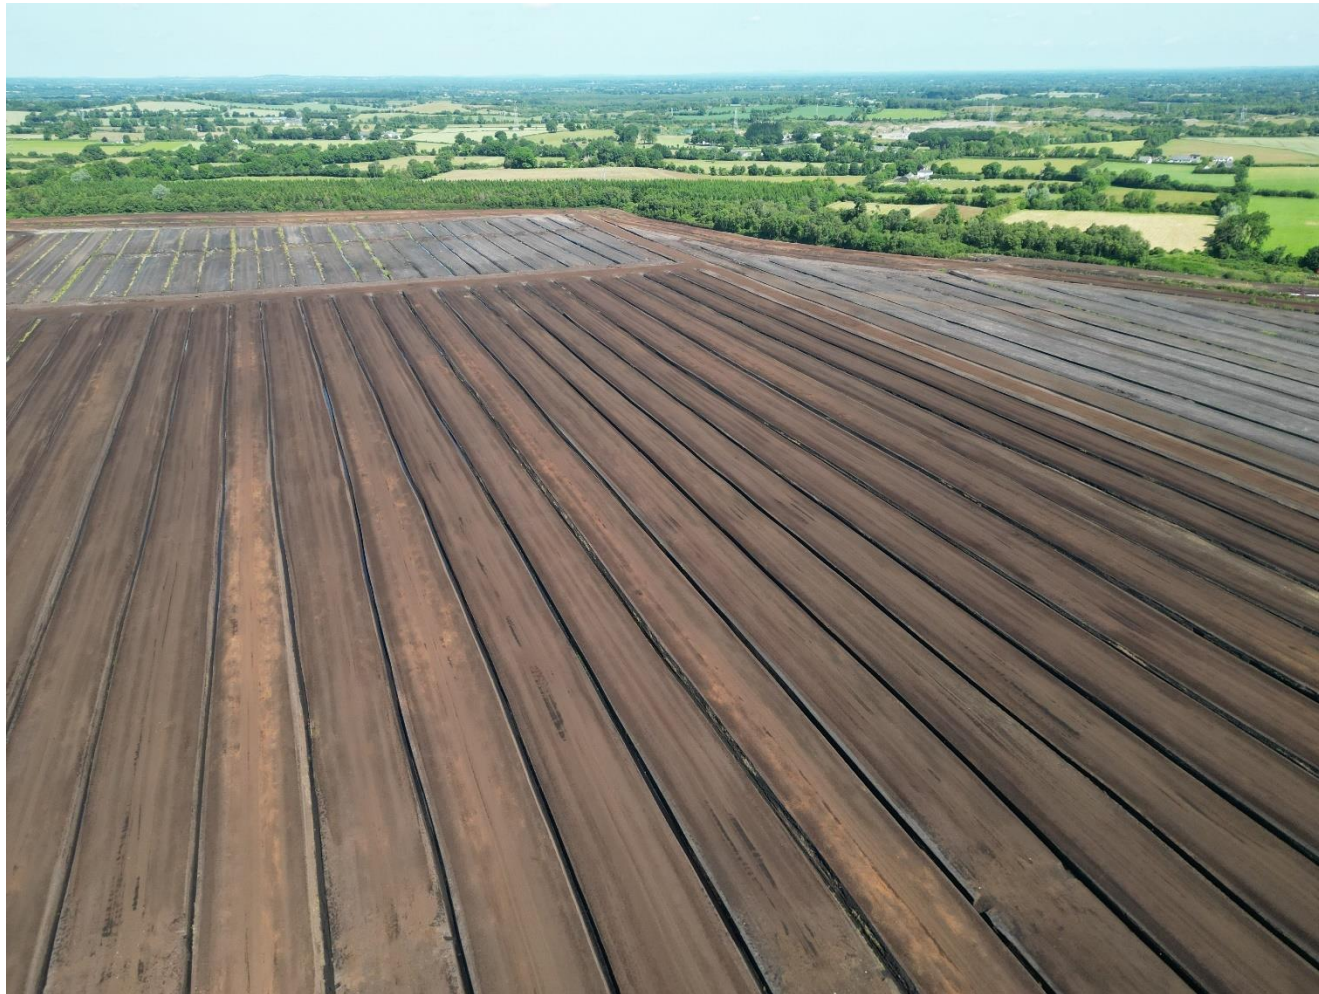
**Photo 3: Photograph of a section of the ‘worked area’ of the peatland showing peat extraction rows and drainage channels.**

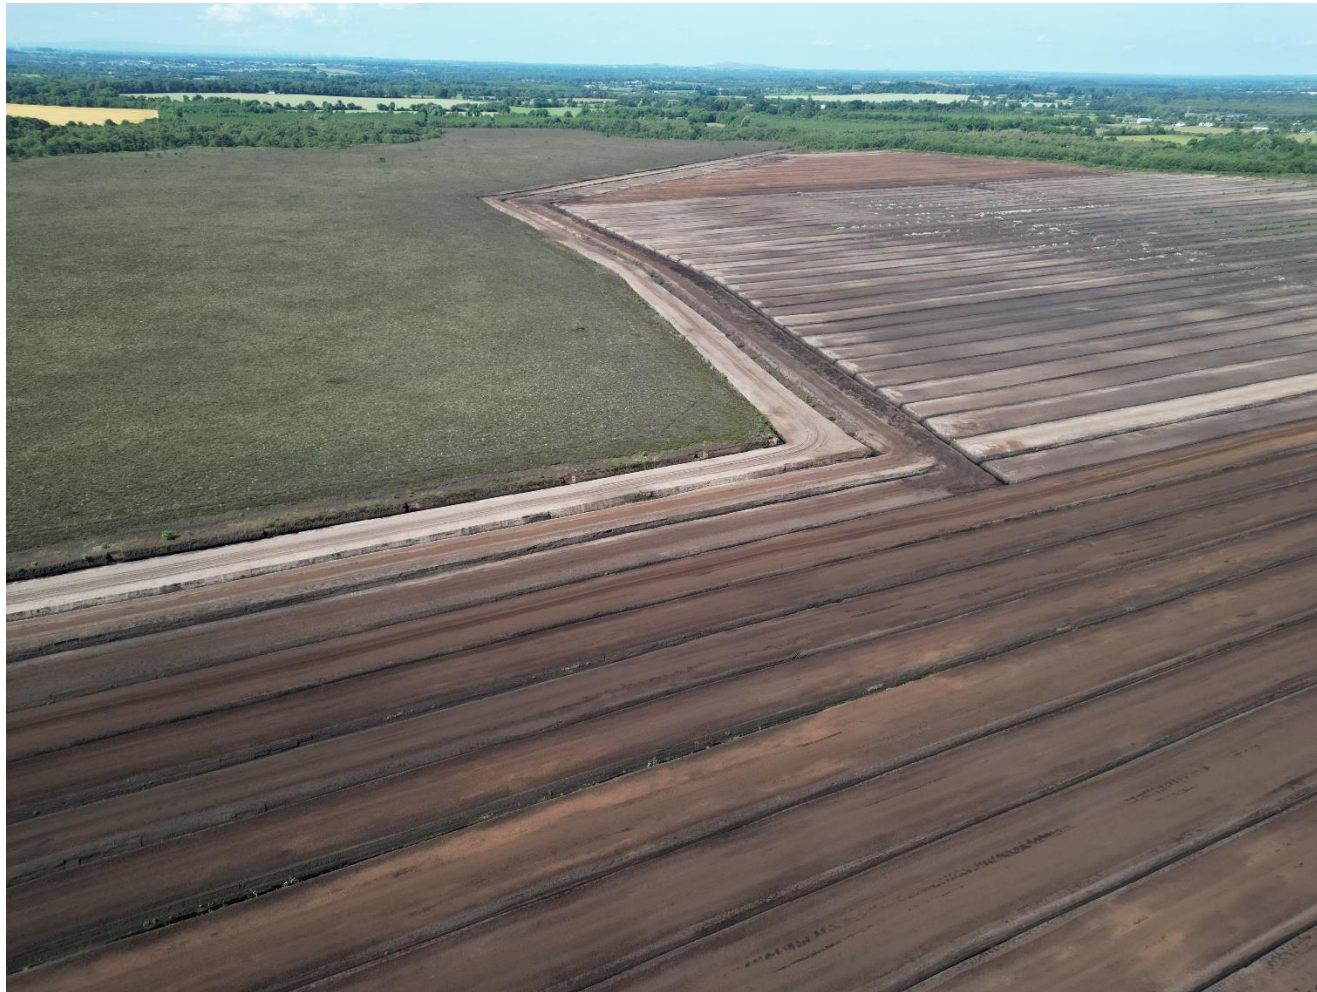
**Photo 4: Photograph of the ‘worked area’ of the peatland and the untouched adjacent peatland.**

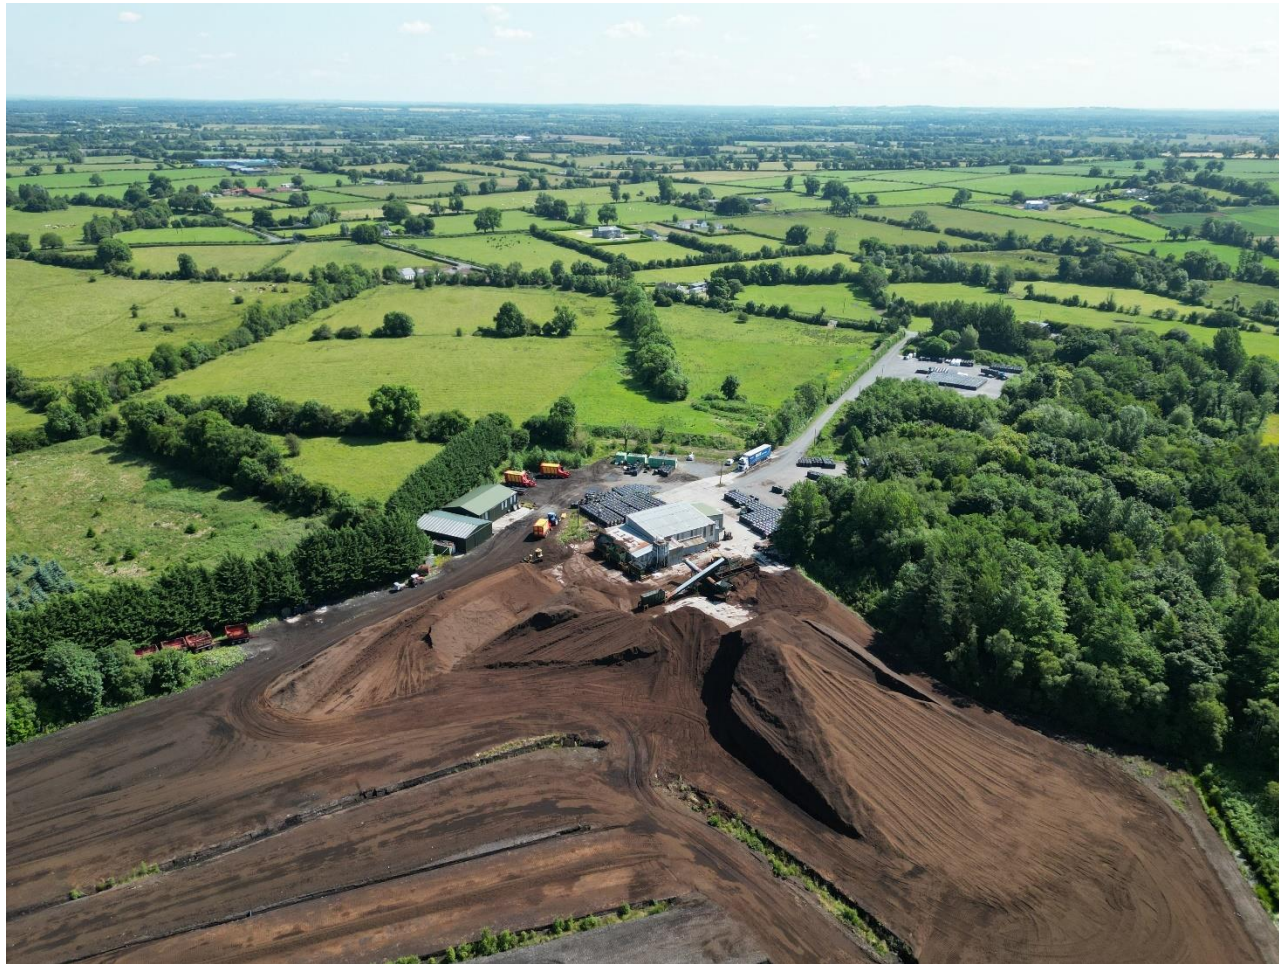
**Photo 5: Photograph of the processing and bagging plant, stockpiles of milled peat and storage areas.**

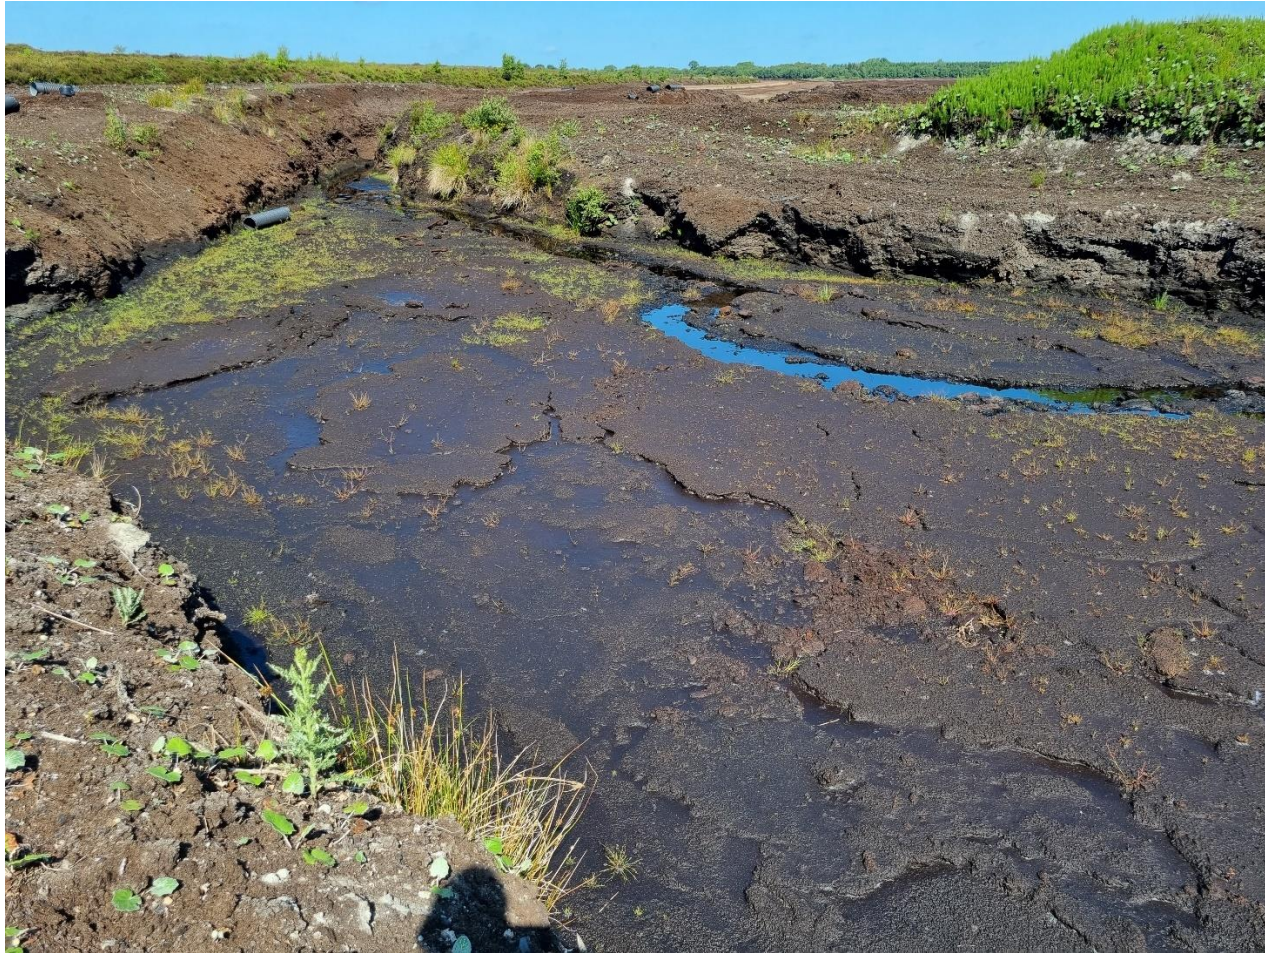
**Photo 6: Significant accumulation of solids noted in drainage network at the peatland.**

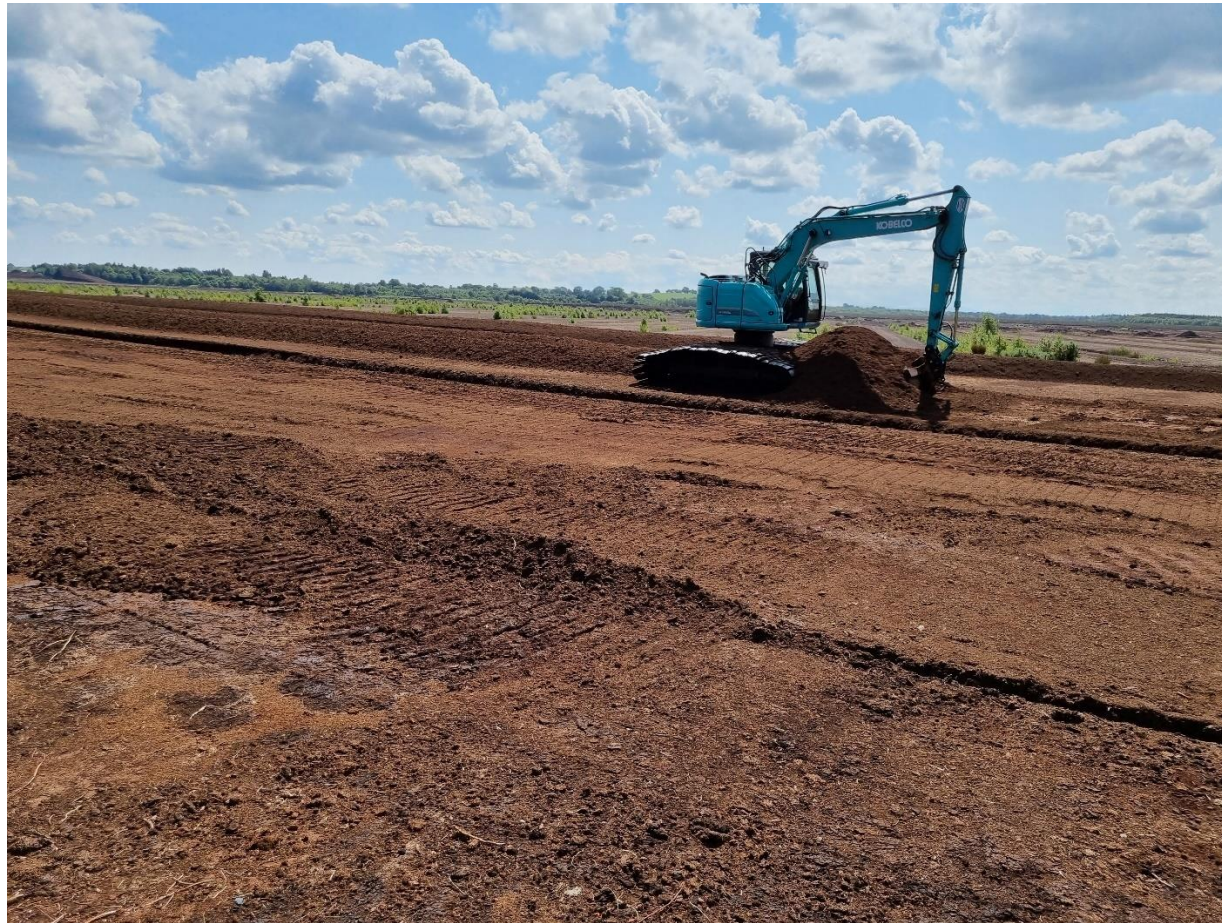
**Photo 9: Photograph showing excavator and rows of 'ridged' milled peat on the peatland.**

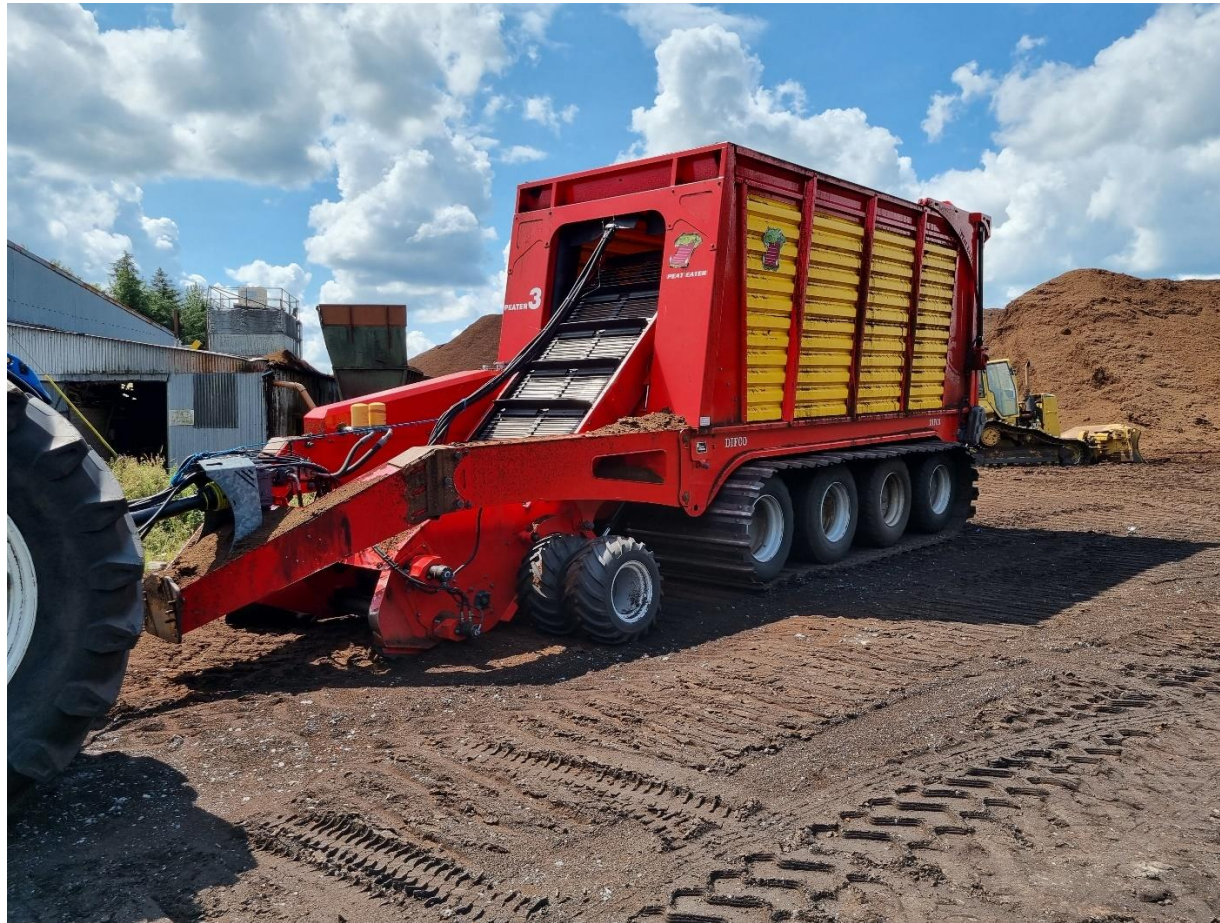
**Photo 10: Photograph showing peat harvesting equipment parked adjacent to the bagging/processing plant at the peatland.**
