SITE VISIT REPORT

Purpose of Site Visit: Peat Extraction in Co. Kildare

Site Address: Ballinderry, Carbury, Co. Kildare

Date of Visit: 10/07/24

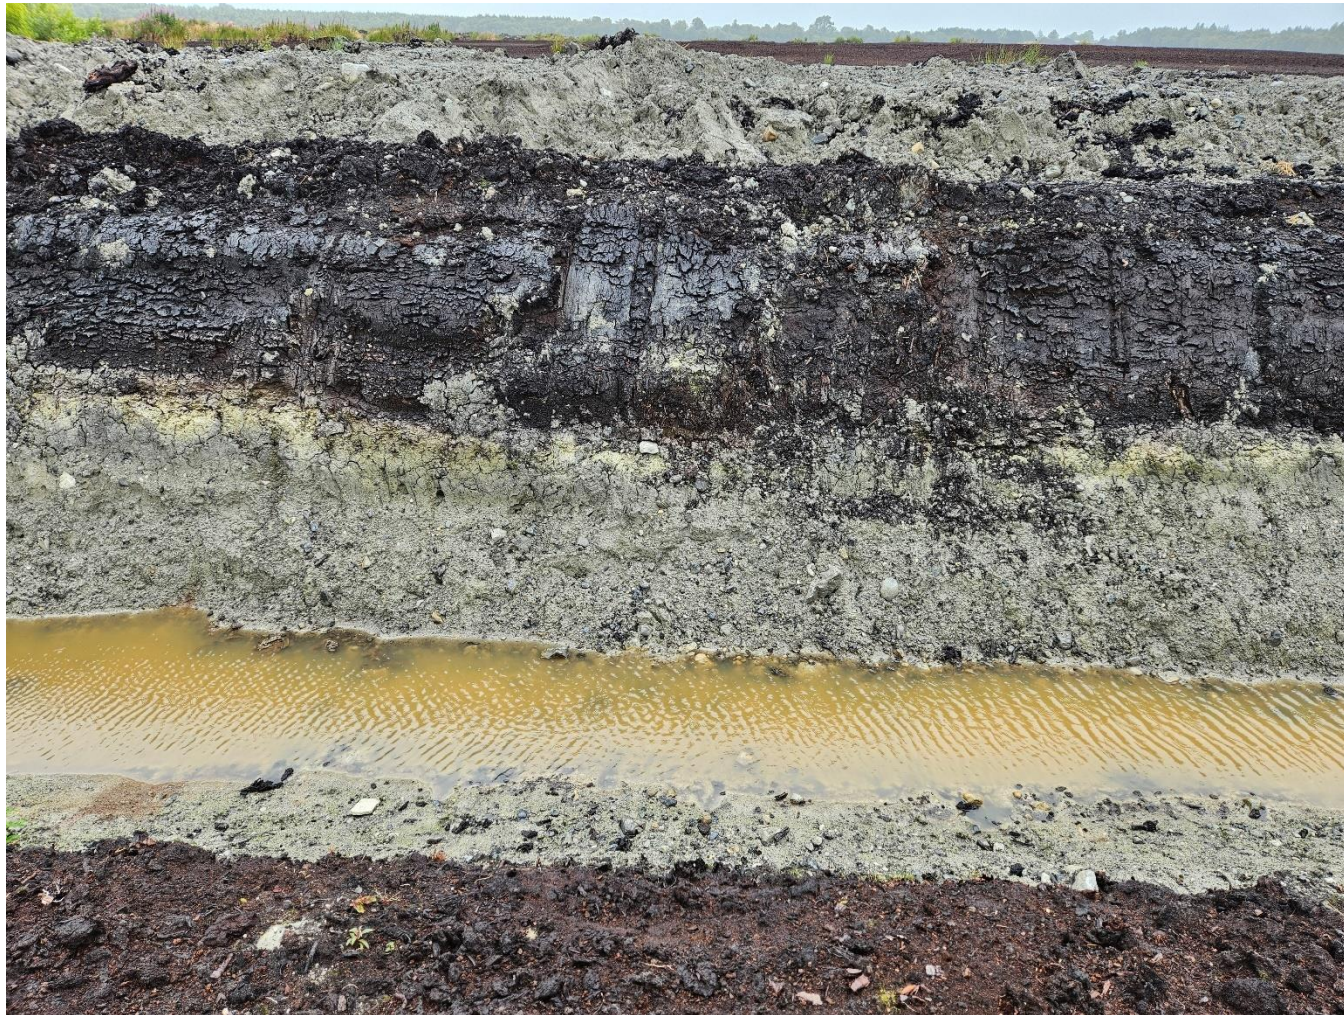
- An excavator was noted to be carrying out drainage works on the Eastern boundary of the peatland.
 - Significant drainage works had been carried out throughout the peatland. An examination of some of the drains on the peatland showed that the layer of peat was reduced to approximately one metre in places and the marl like material was evident in a number of the drains. Some of the drains were also noted to be a milky white/brown colour.

Photo 1: Photo showing the marl like materials underlying the remaining peaty deposits on the peatland.

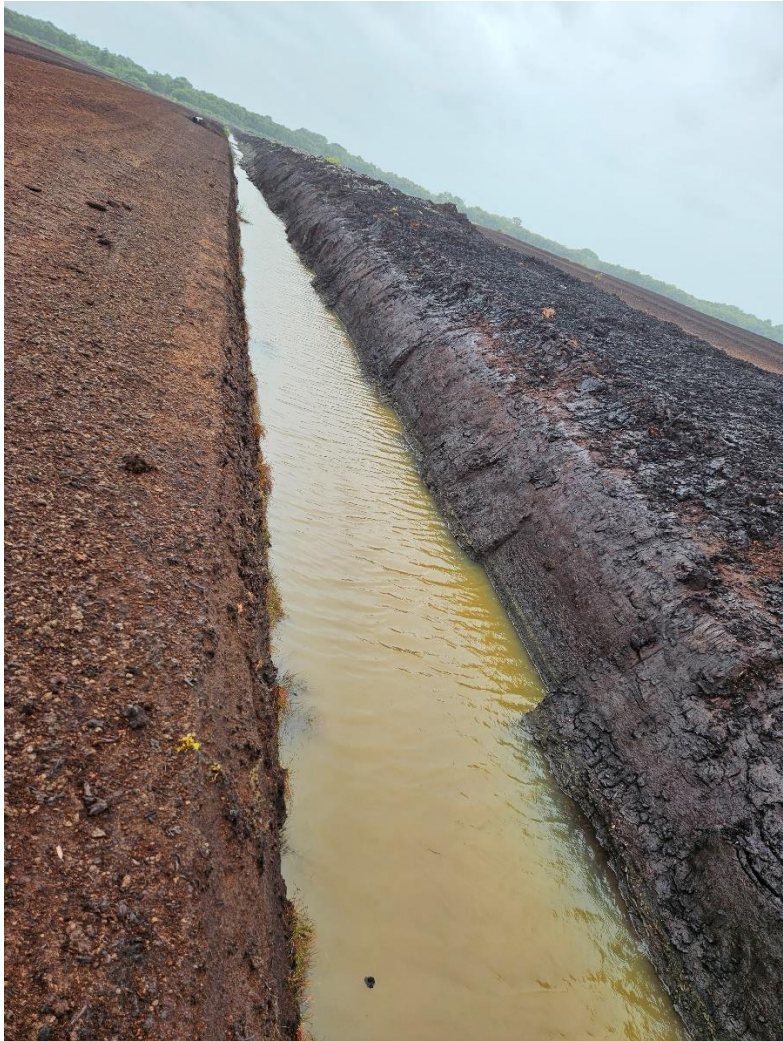
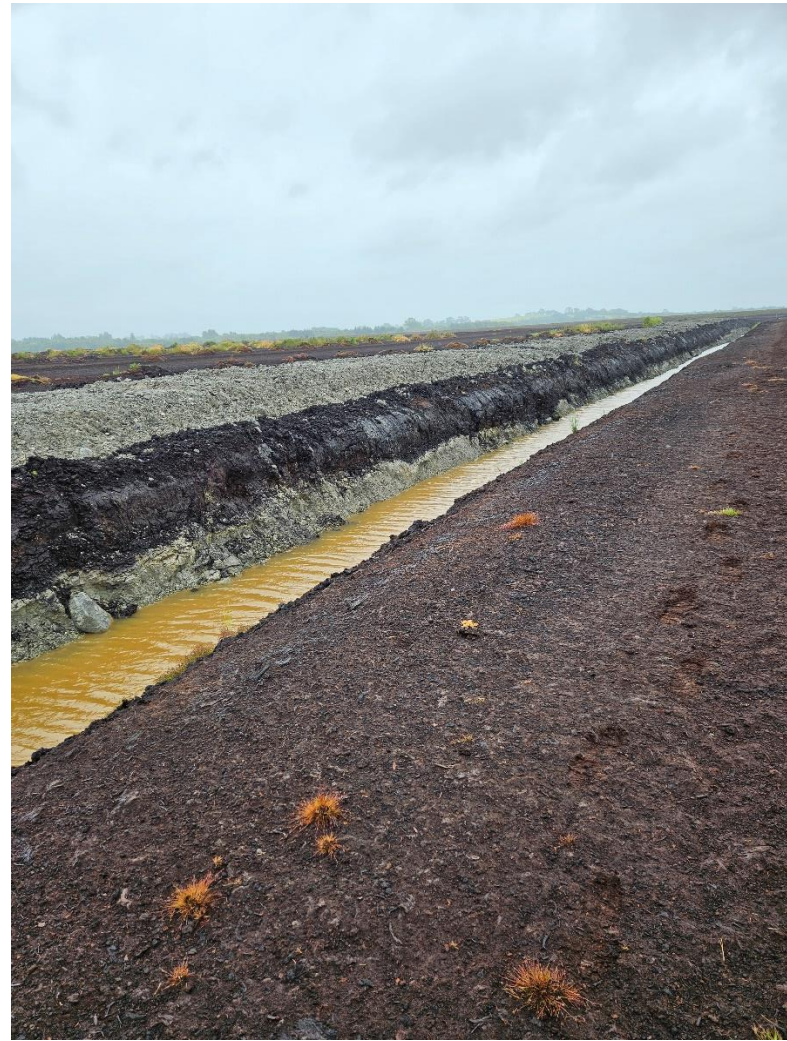
Photos 2 & 3: Milkywhite/brown colour noted in drains on the peatland, also note marl like material close to the surface of the peatland.

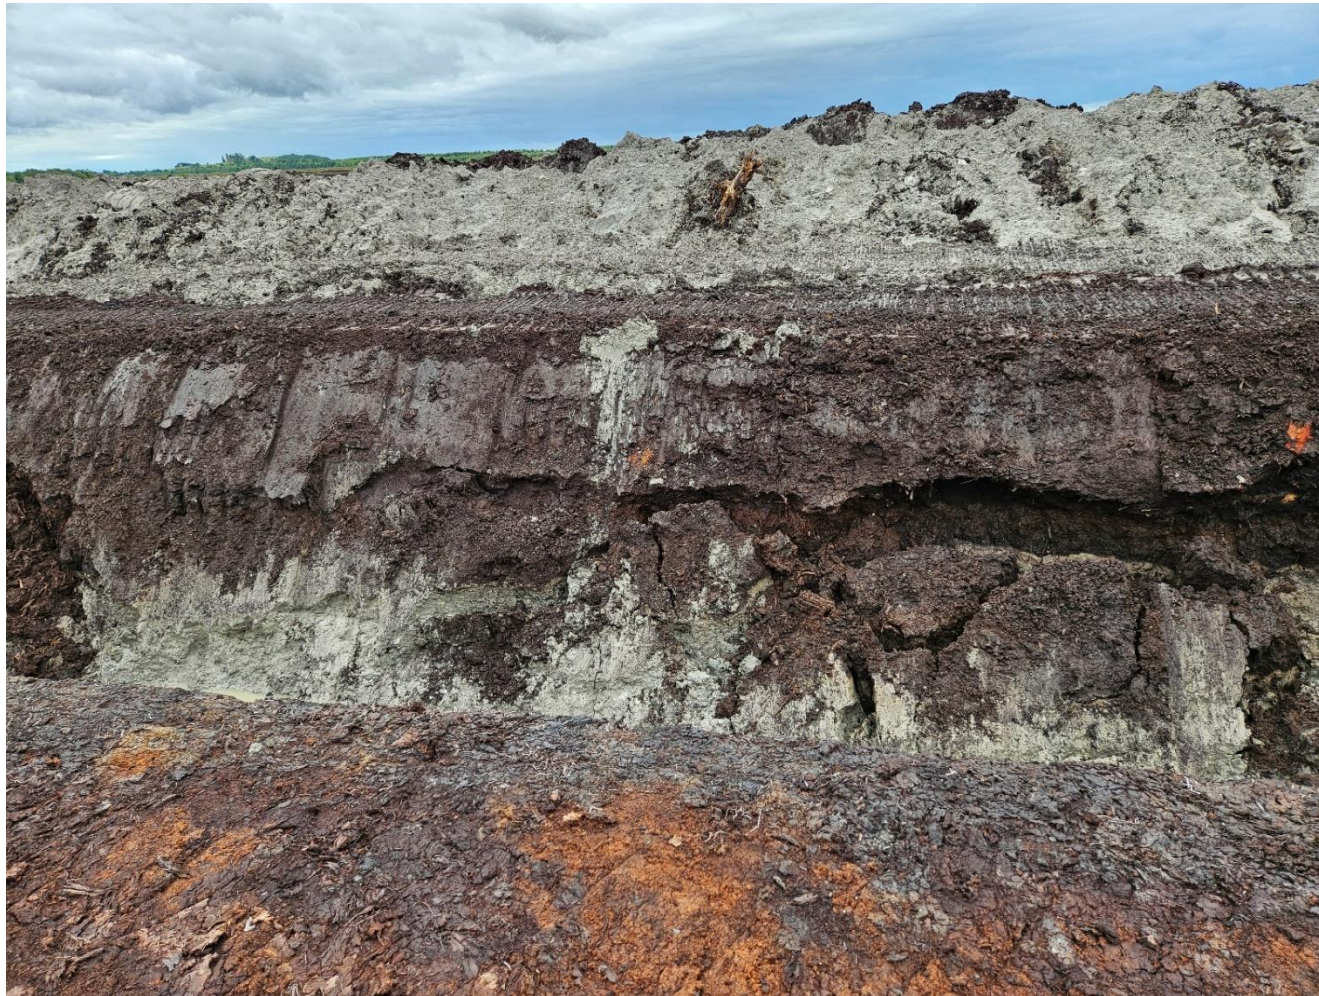
Photo 4: Photo showing slippage in some of the drains on the peatland.
