SITE VISIT REPORT

Purpose of Site Visit: Peat Extraction in Co. Kildare

Site Address: Ballinderry, Carbury, Co. Kildare

Date of Visit: 12/06/24

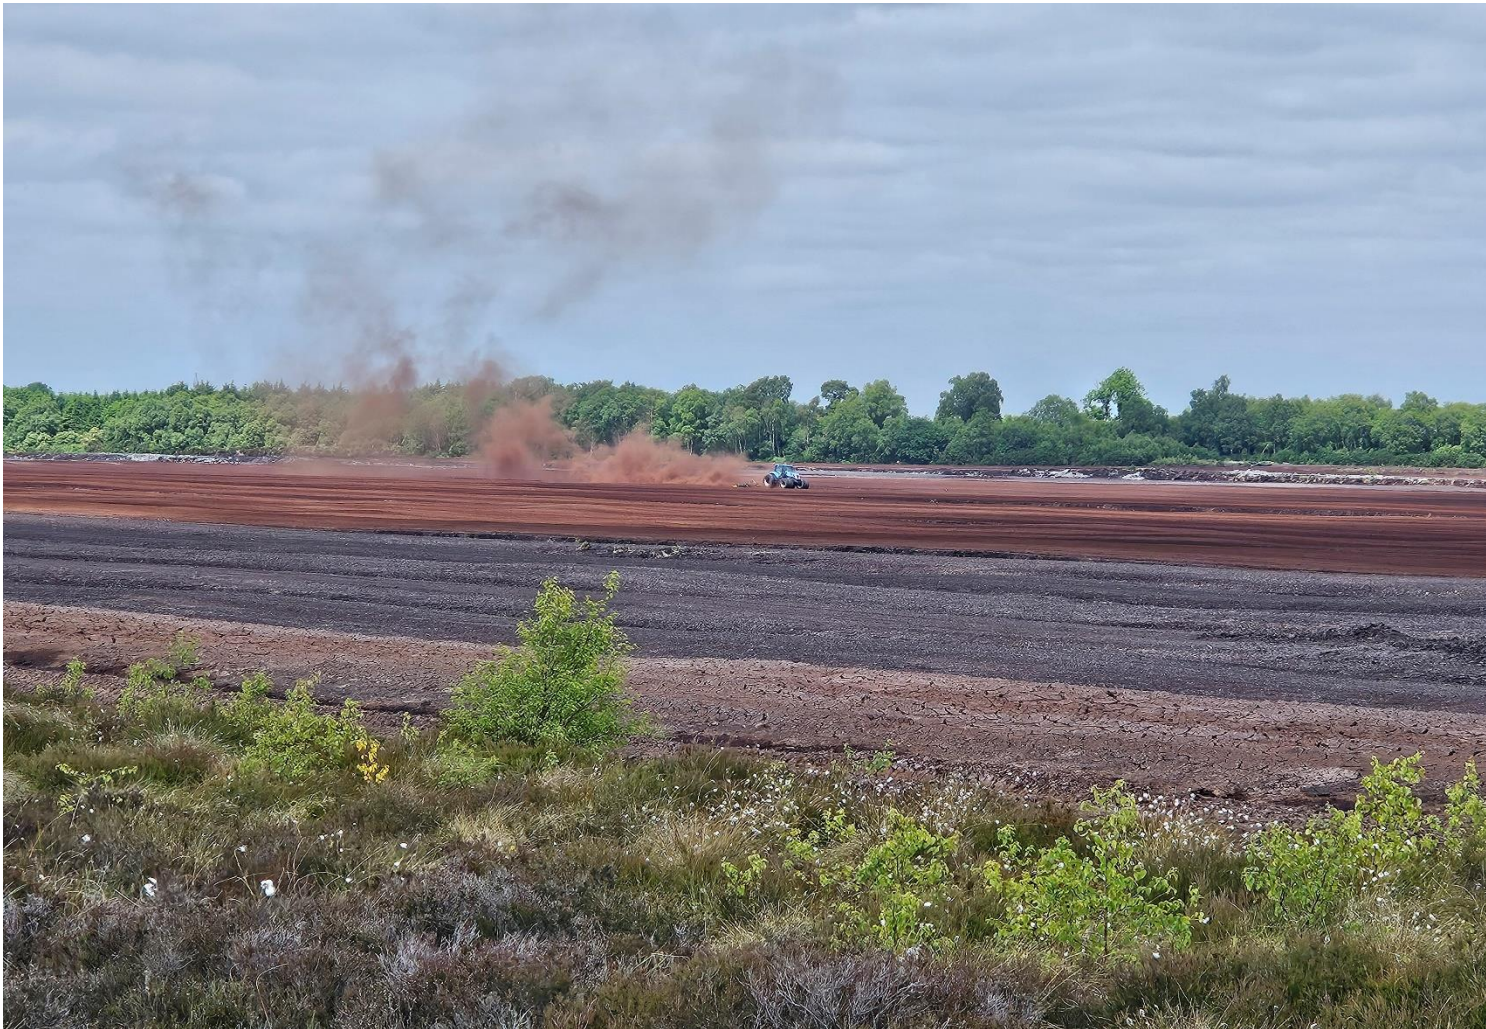
Photo 1: Peat extraction was noted to be taking place during the visit.

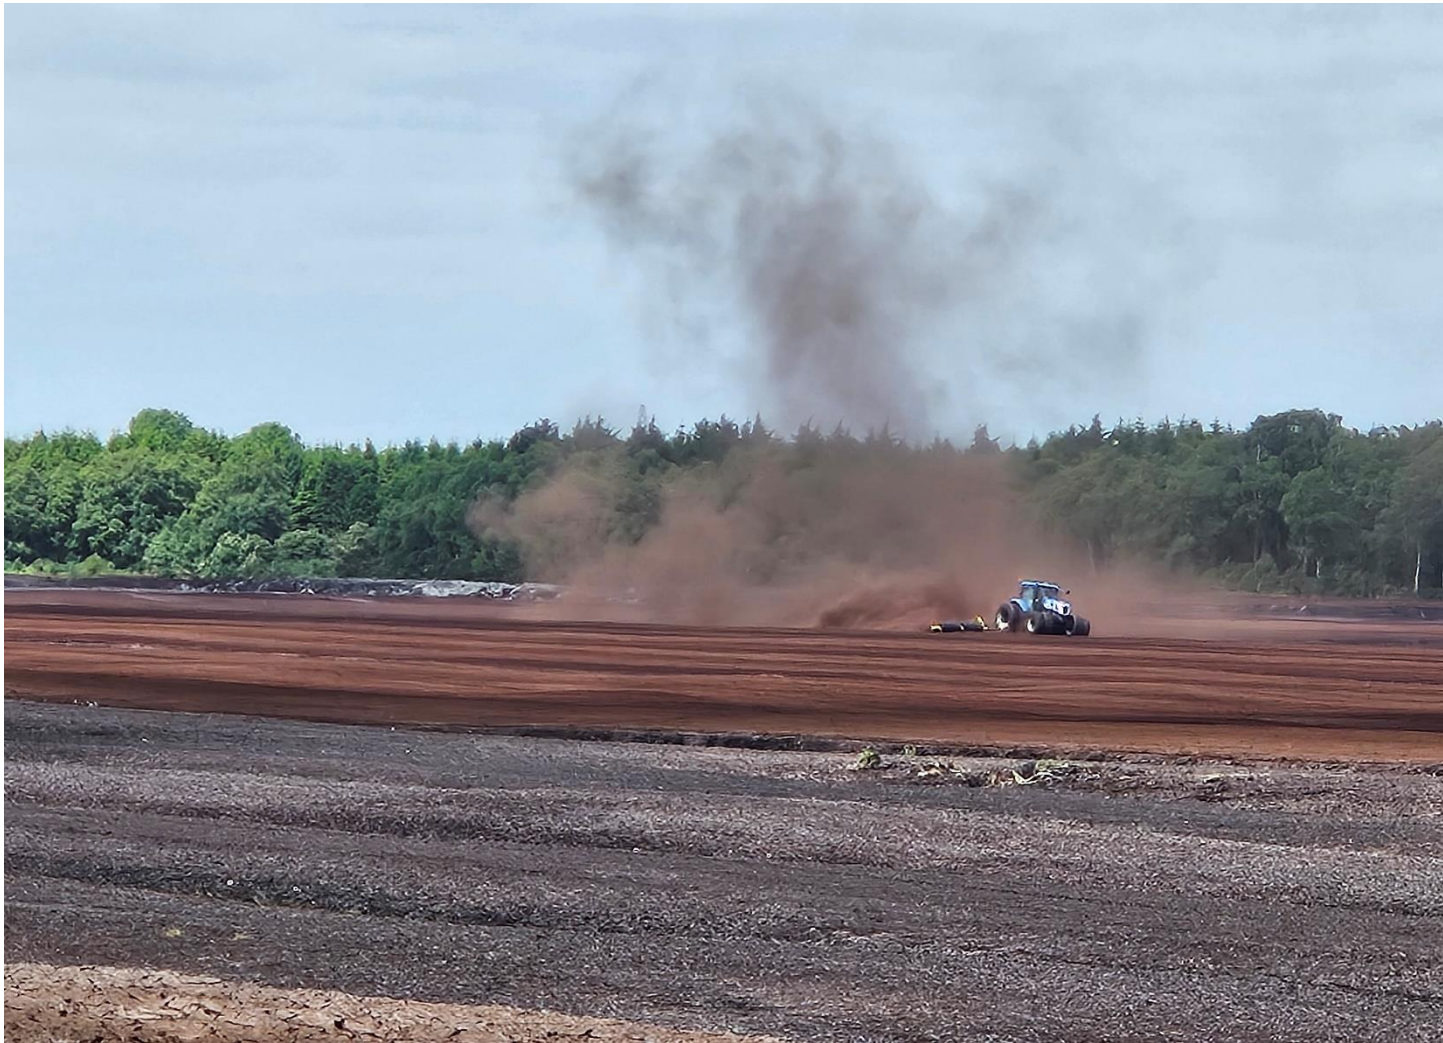
Photo 2: Peat extraction was noted to be taking place during the visit with significant dust arising.

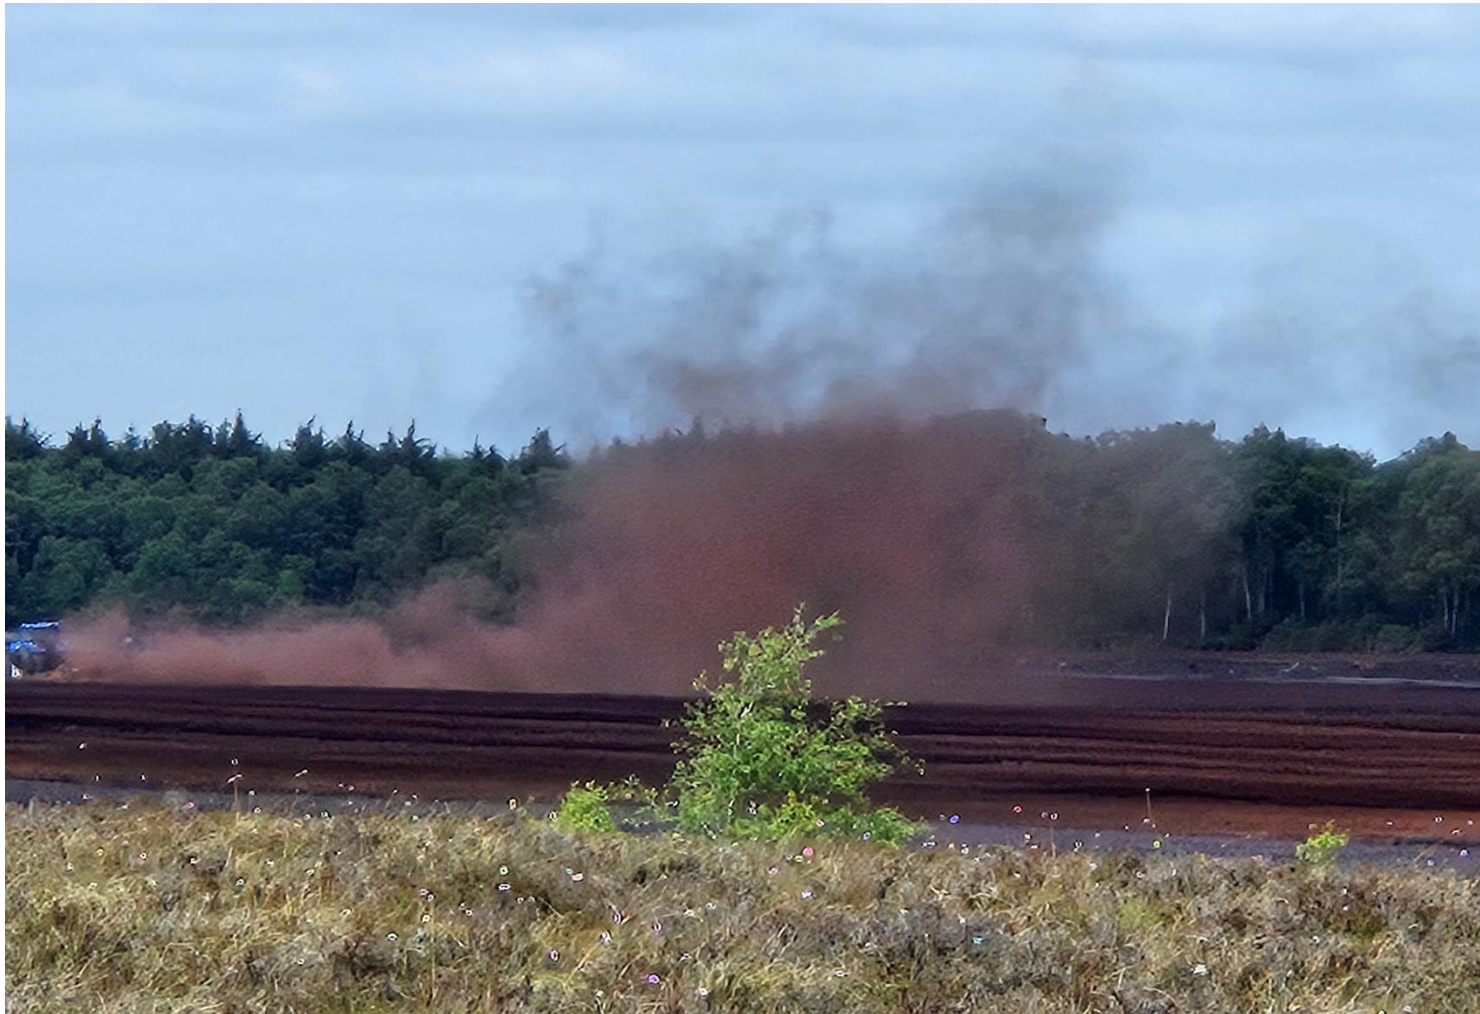
Photo 3: Significant dust emissions were noted to be coming from the peat extraction activities at the peatland.

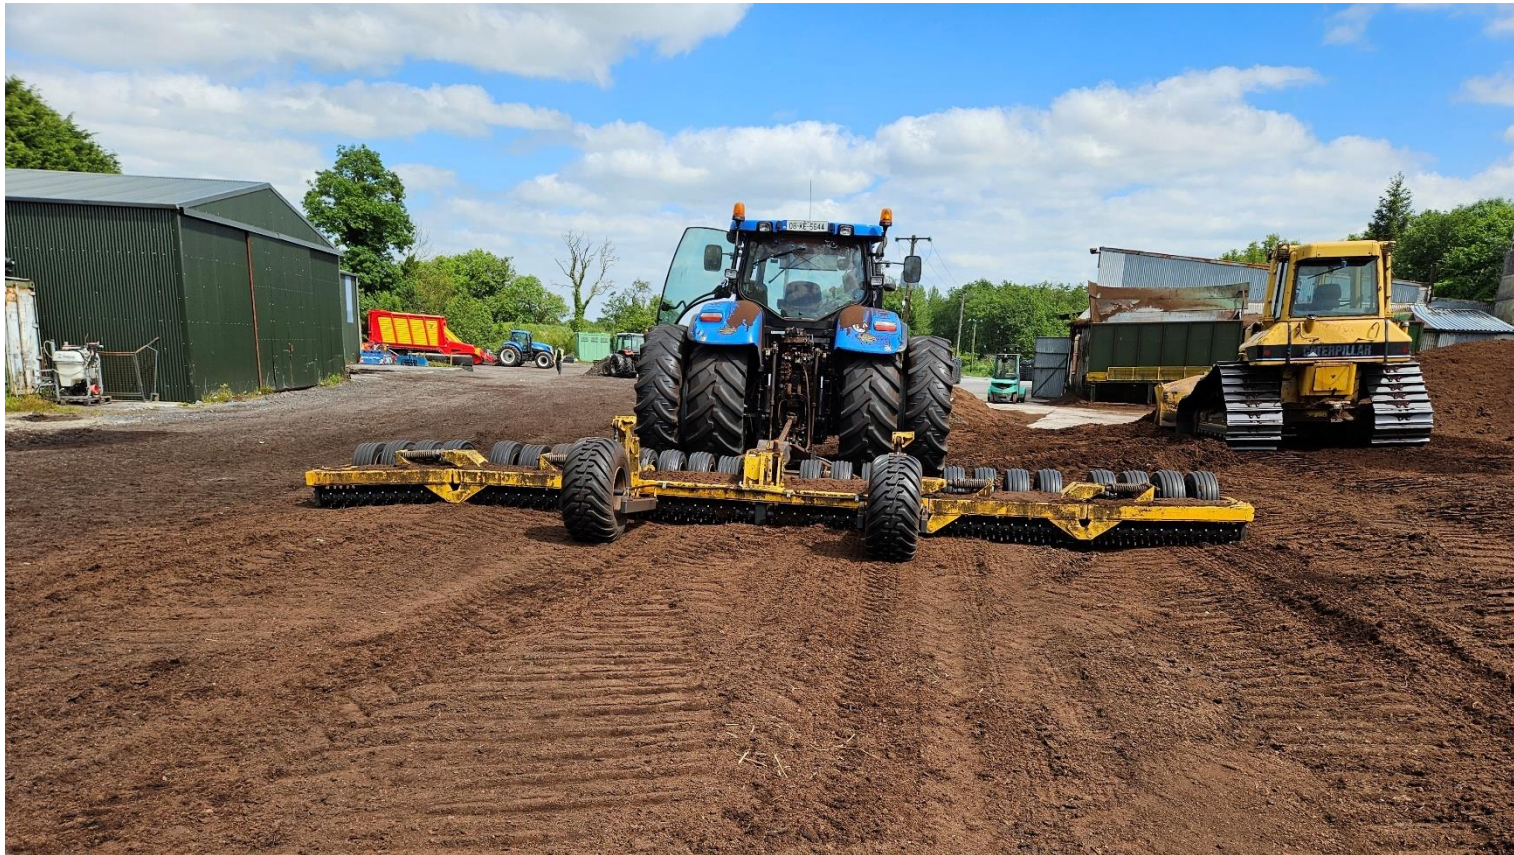
Photo 5: Machine for ‘milling’ peat was noted at the peatland.
