# SITE VISIT REPORT

**Purpose of Site Visit:** Peat Extraction in Co. Kildare

**Site Address:** Ballinderry, Carbury, Co. Kildare

**Date of Visit:** 18/06/24

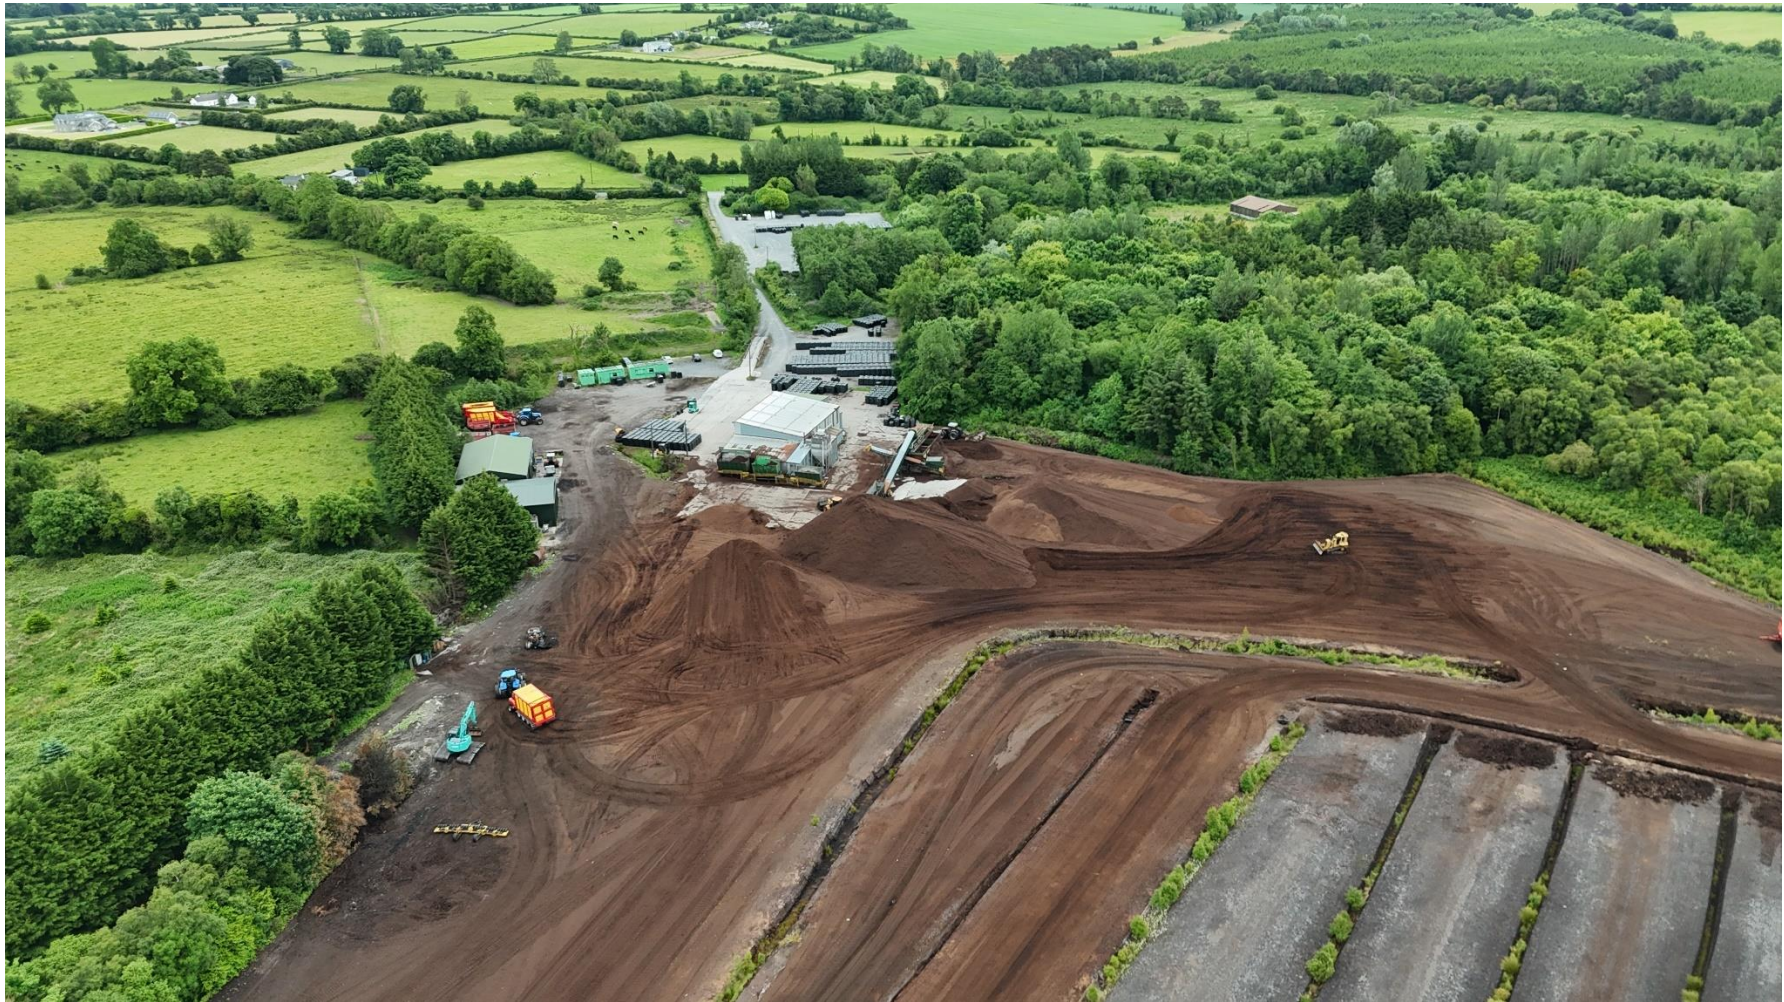
- Machinery/equipment for extracting and harvesting peat was noted to be parked adjacent to the bagging/processing plant at the site.
- Large stockpiles of milled peat were noted adjacent to the bagging/processing plant and an excavator was working on top of the stockpiles.

**Photo 1: Overview of factory area with stockpiles of milled peat noted along with peat extraction machinery.**

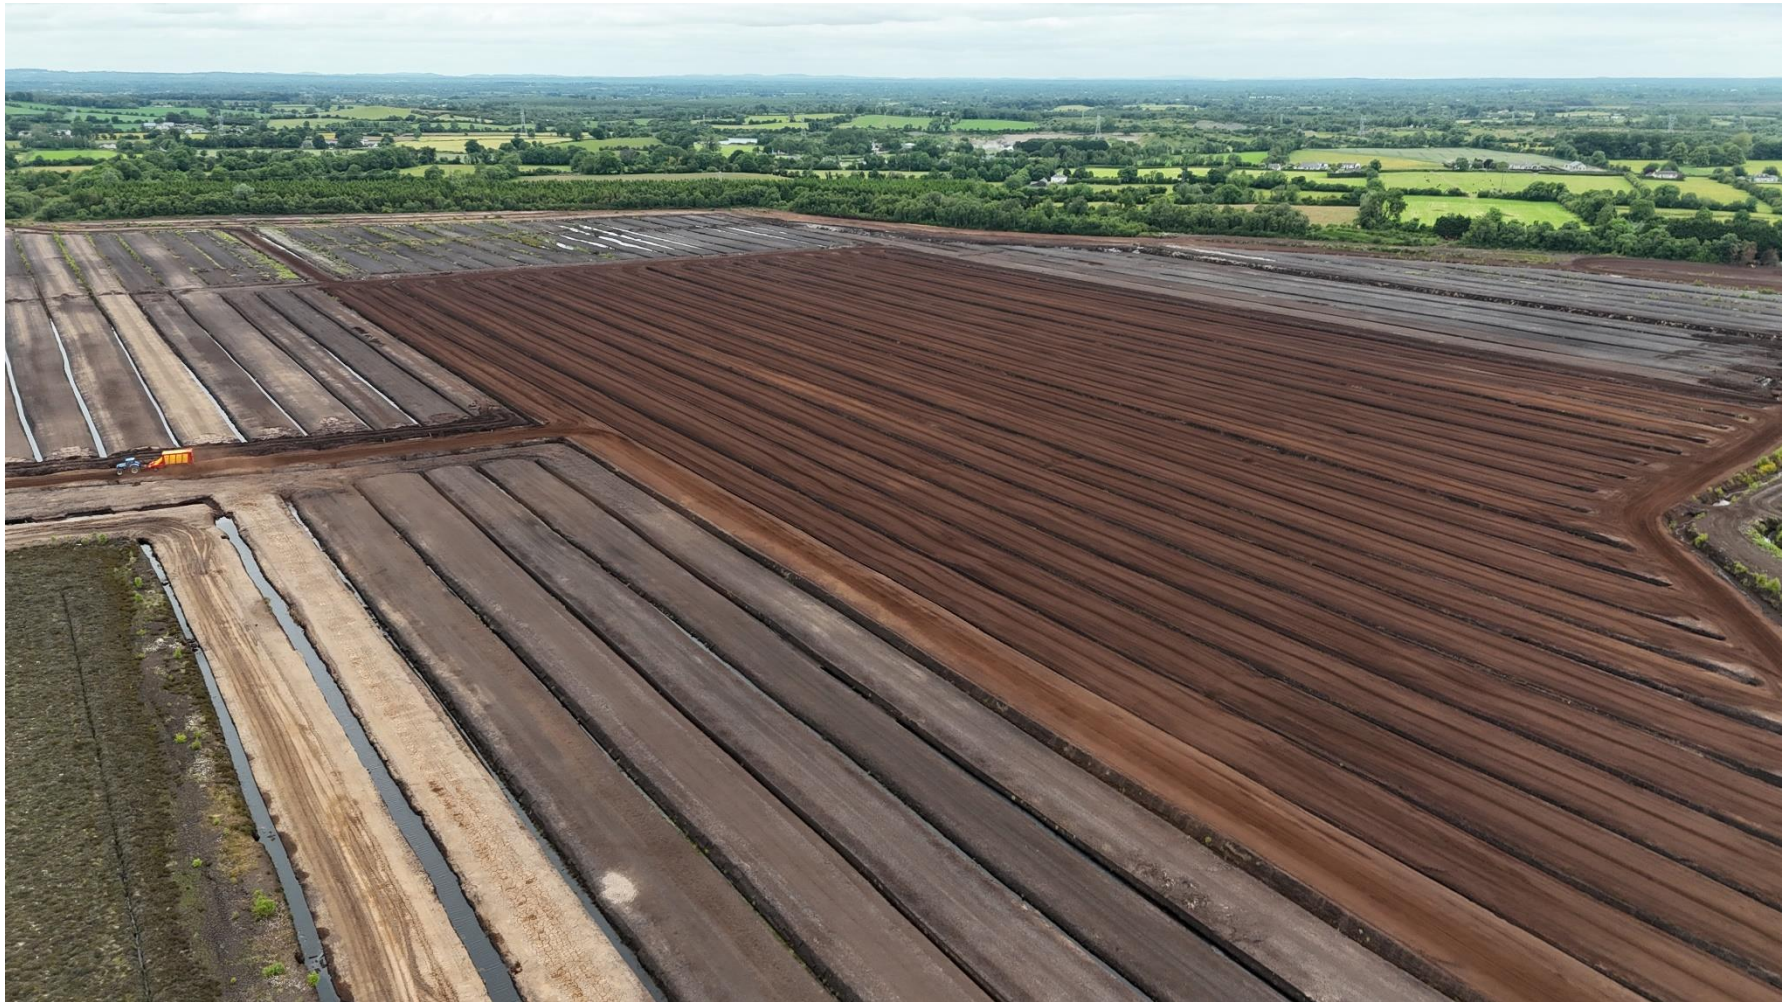
**Photo 2: Photo of central part of the peatland where peat extraction had taken place recently (note dark brown colour). Also, note tractor and trailer (‘Bog Hog’ ) going to the South western part of the peatland to collect milled peat.**

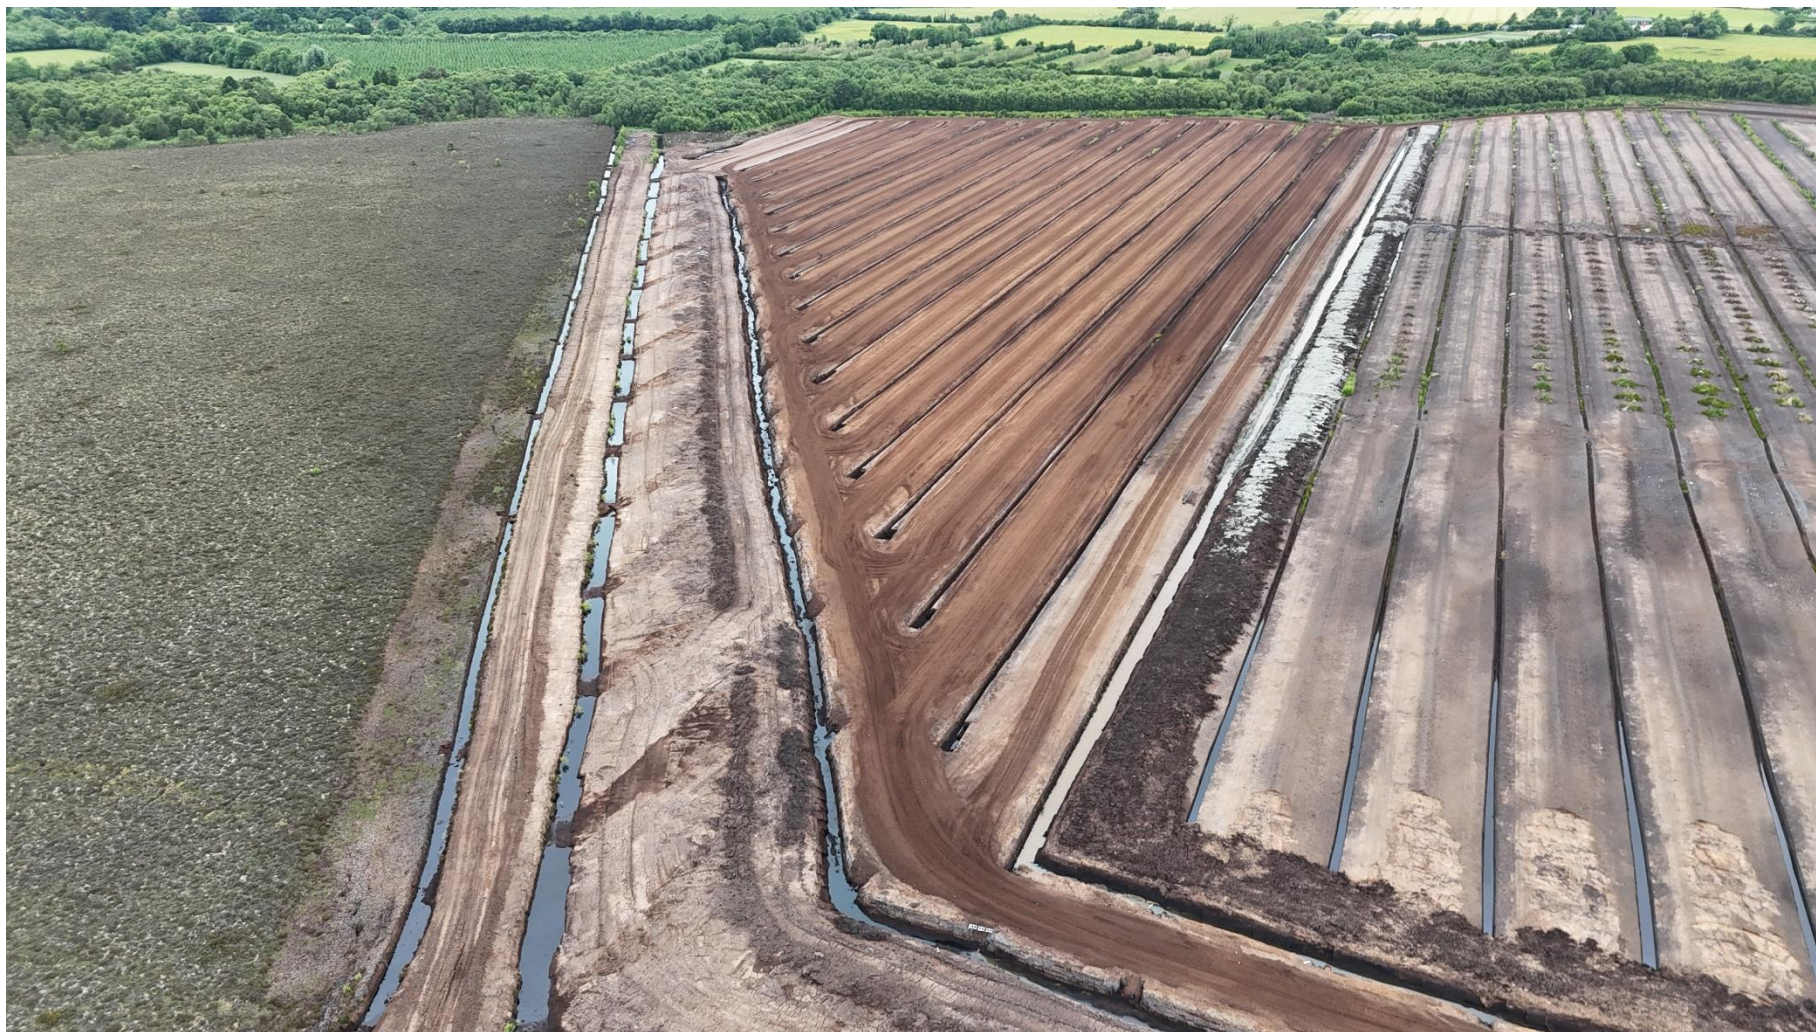
**Photo 3: Overview of South Western part of the peatland prior to the collection of the milled peat. Also, note the untouched virgin bog on left of photo and drainage network.**

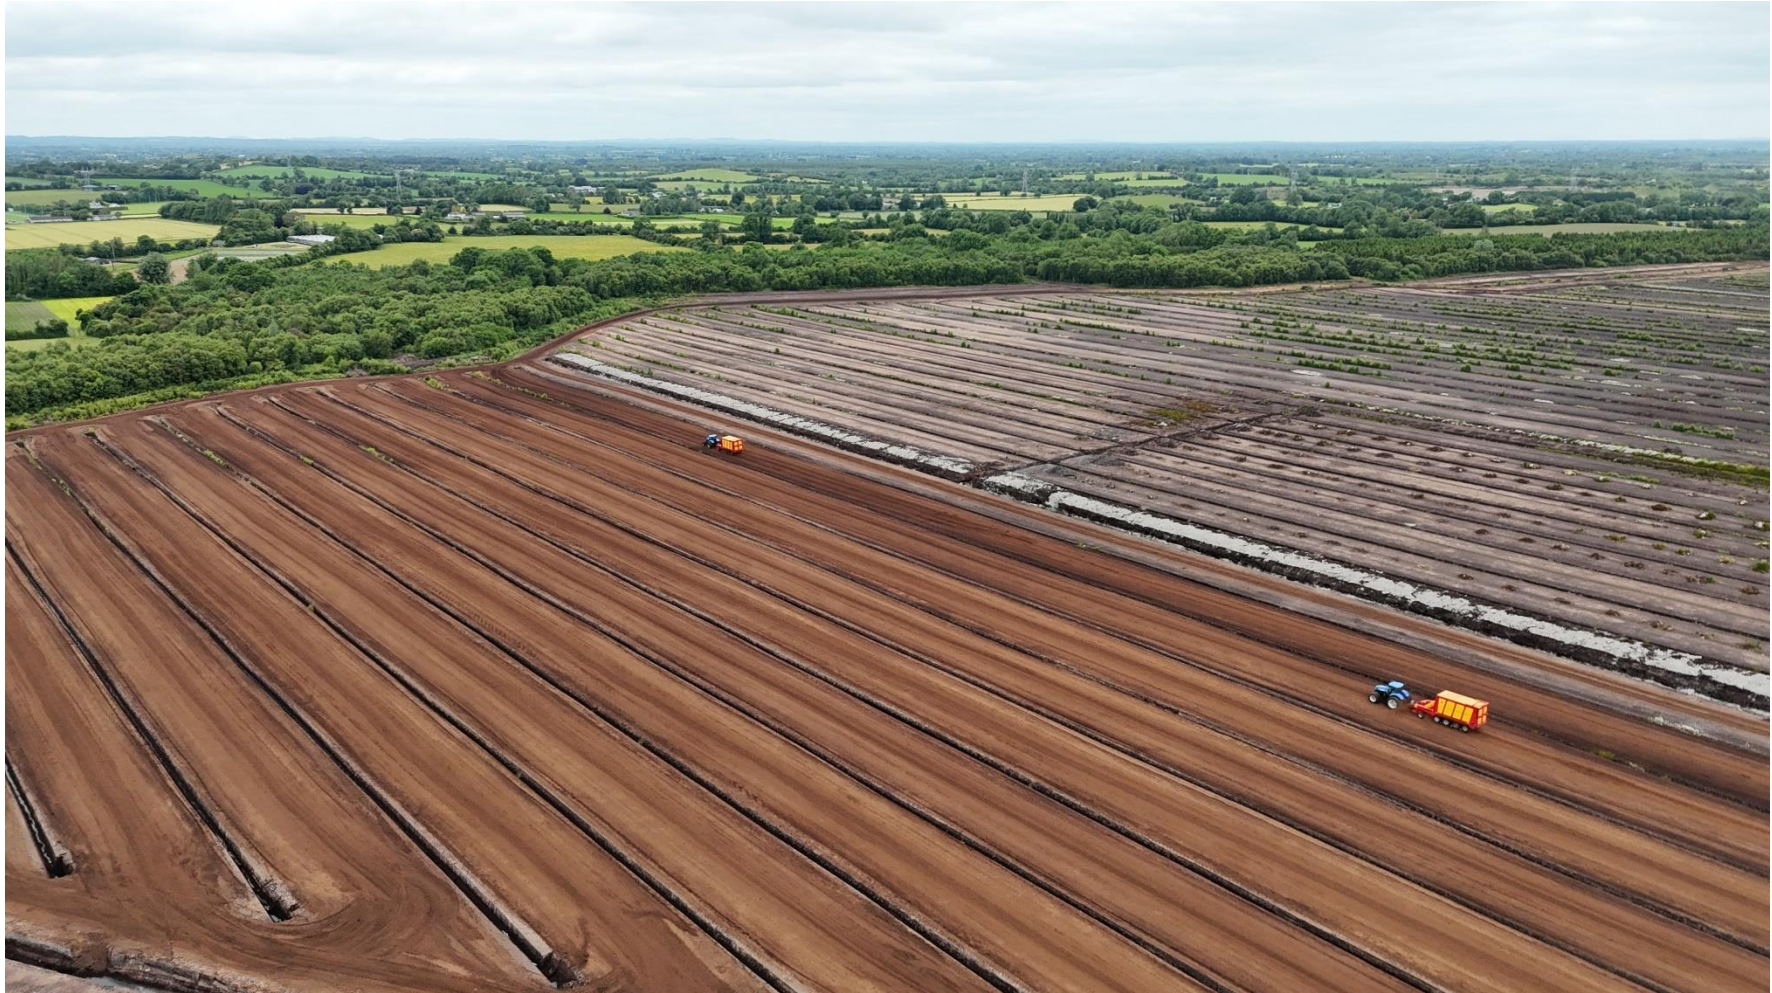
**Photo 4: Two Tractors and trailers ('Bog Hog's') collecting milled peat at the South Western part of the peatland during the visit.**

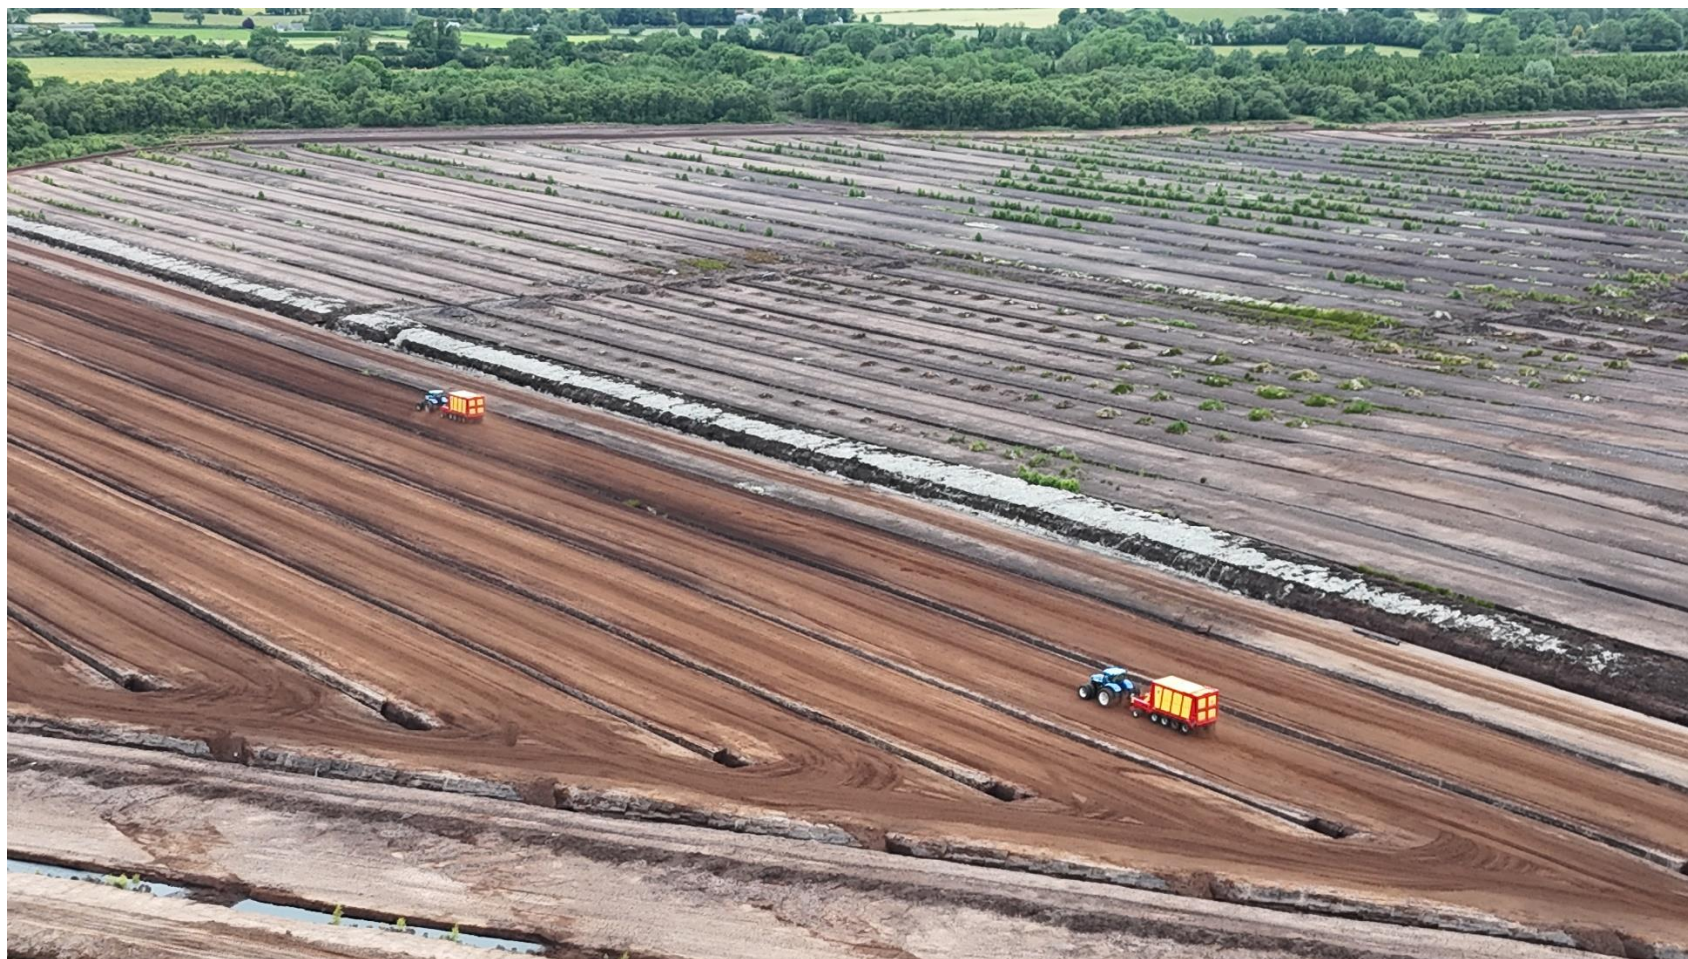
**Photo 5: Two Tractors and trailers ('Bog Hog's') collecting milled peat at the South Western part of the peatland during the visit.**

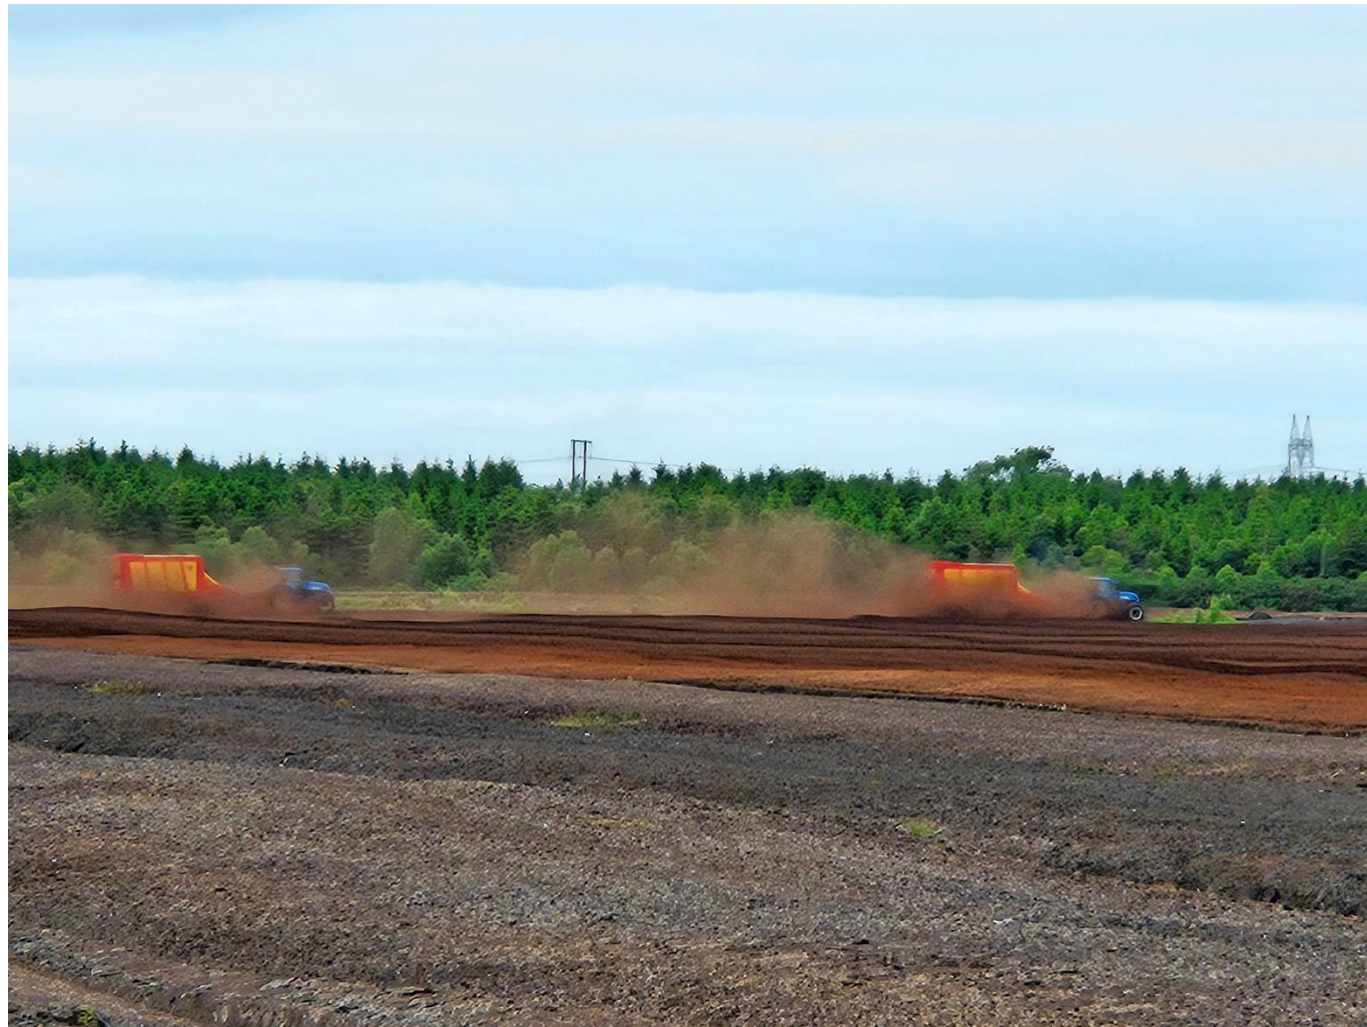
- Significant dust emissions were noted to be arising from the milled peat extraction activities, particularly as the milled peat was being transported from the South Western part of the peatland back up to the bagging/processing plant area.

**Photo 6: Significant dust emissions noted from the transport of the milled peat back to the bagging/processing plant area.**

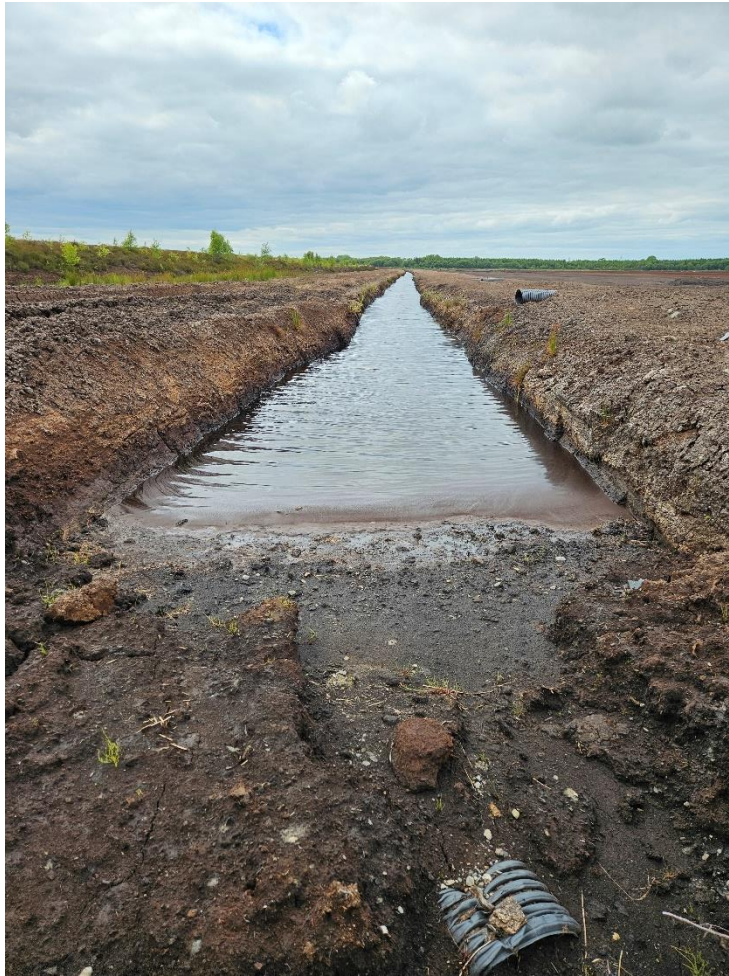
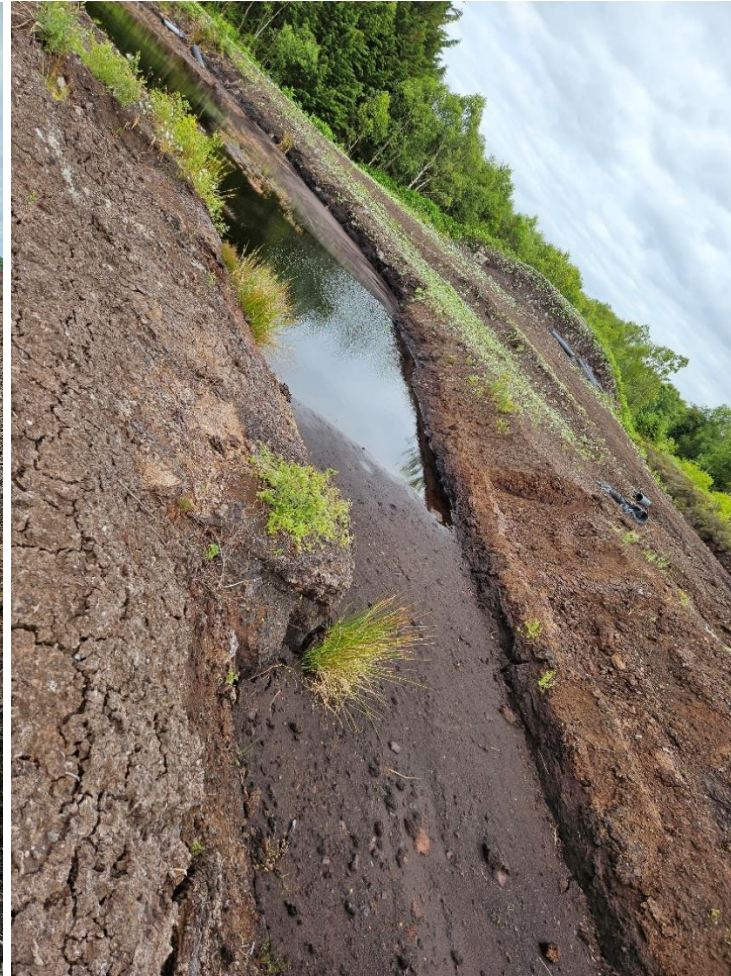
- Significant sediment build up was noted in the drainage network at the South eastern corner of the peatland.

**Photos 7 & 8: Drainage network with significant sediment build up noted at the South Eastern corner of the peatland.**
