SITE VISIT REPORT

Purpose of Site Visit: Peat Extraction in Co. Kildare

Site Address: Ballinderry, Carbury, Co. Kildare

Date of Visit: 05/06/24

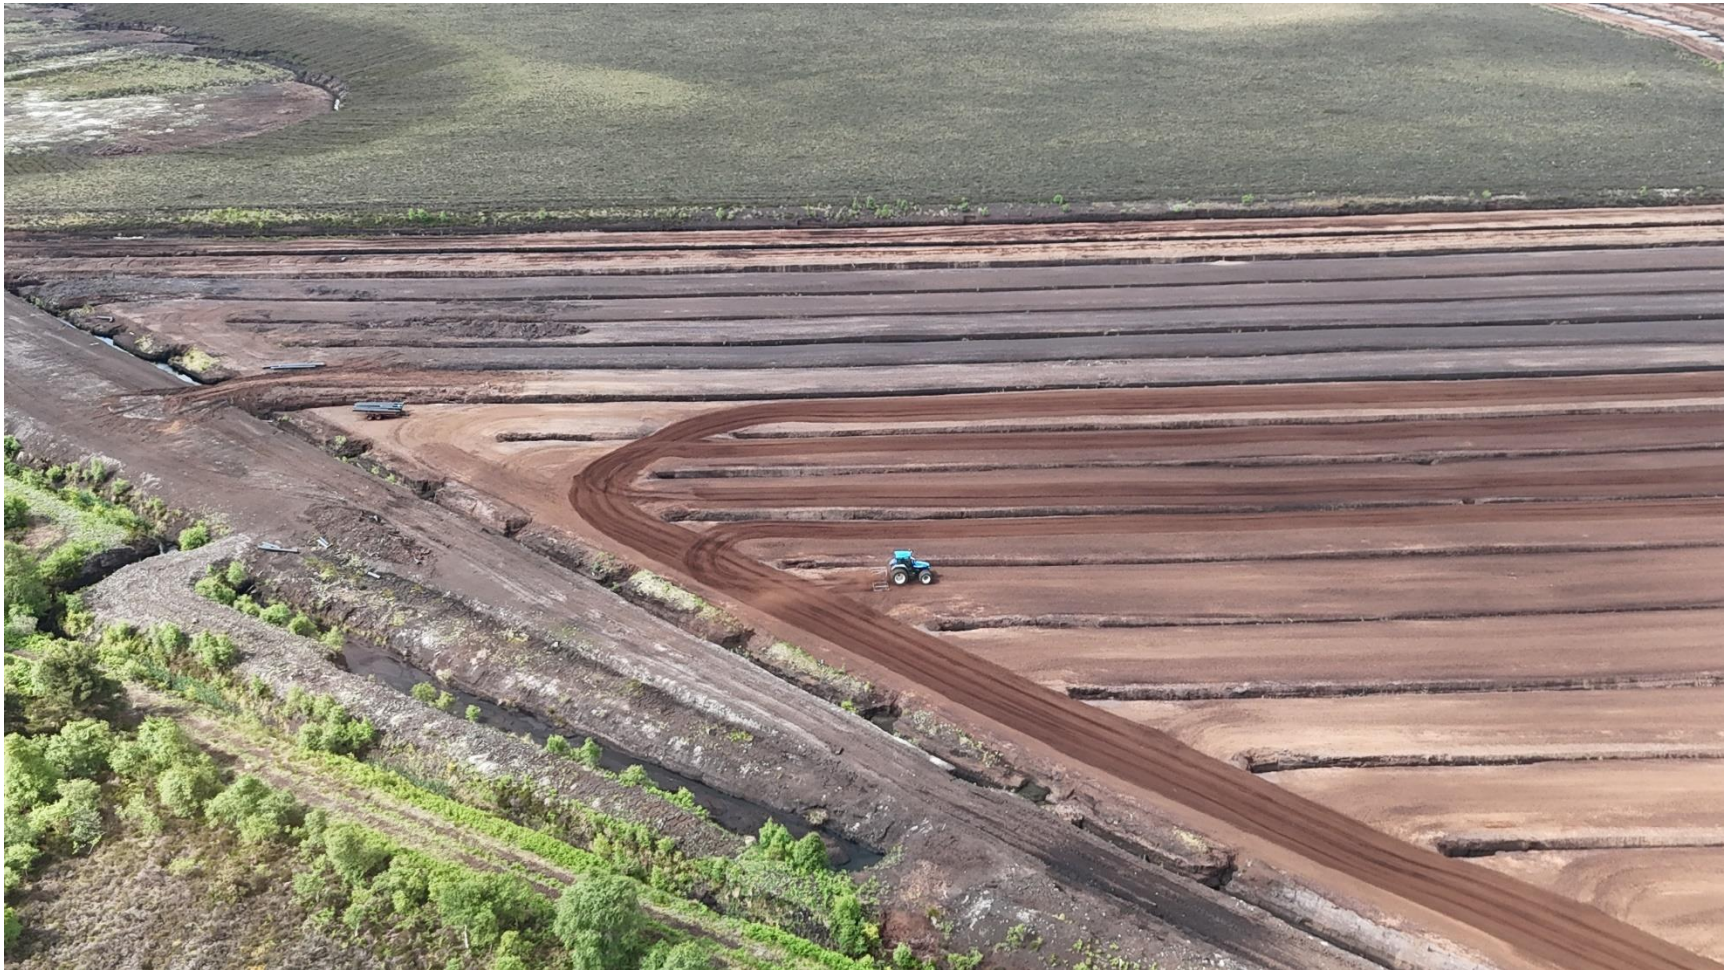
Photo 3: Milled peat extraction was noted to be taking place during the visit.

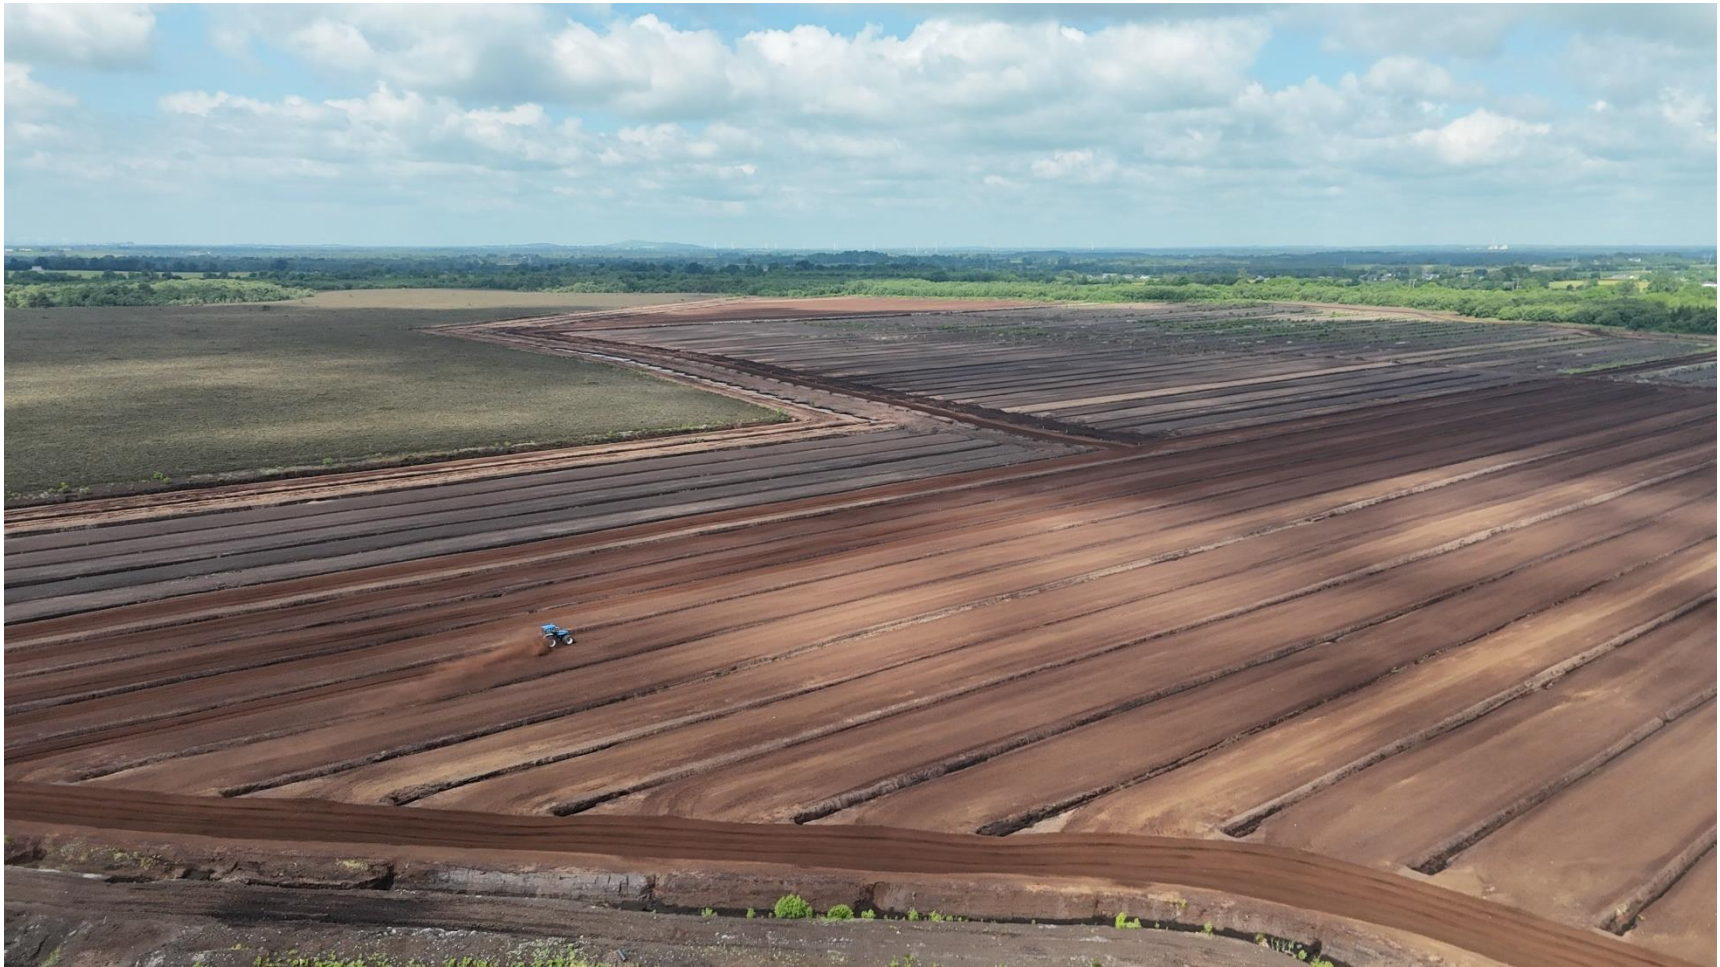
Photo 4: Milled peat extraction was noted to be taking place during the visit.

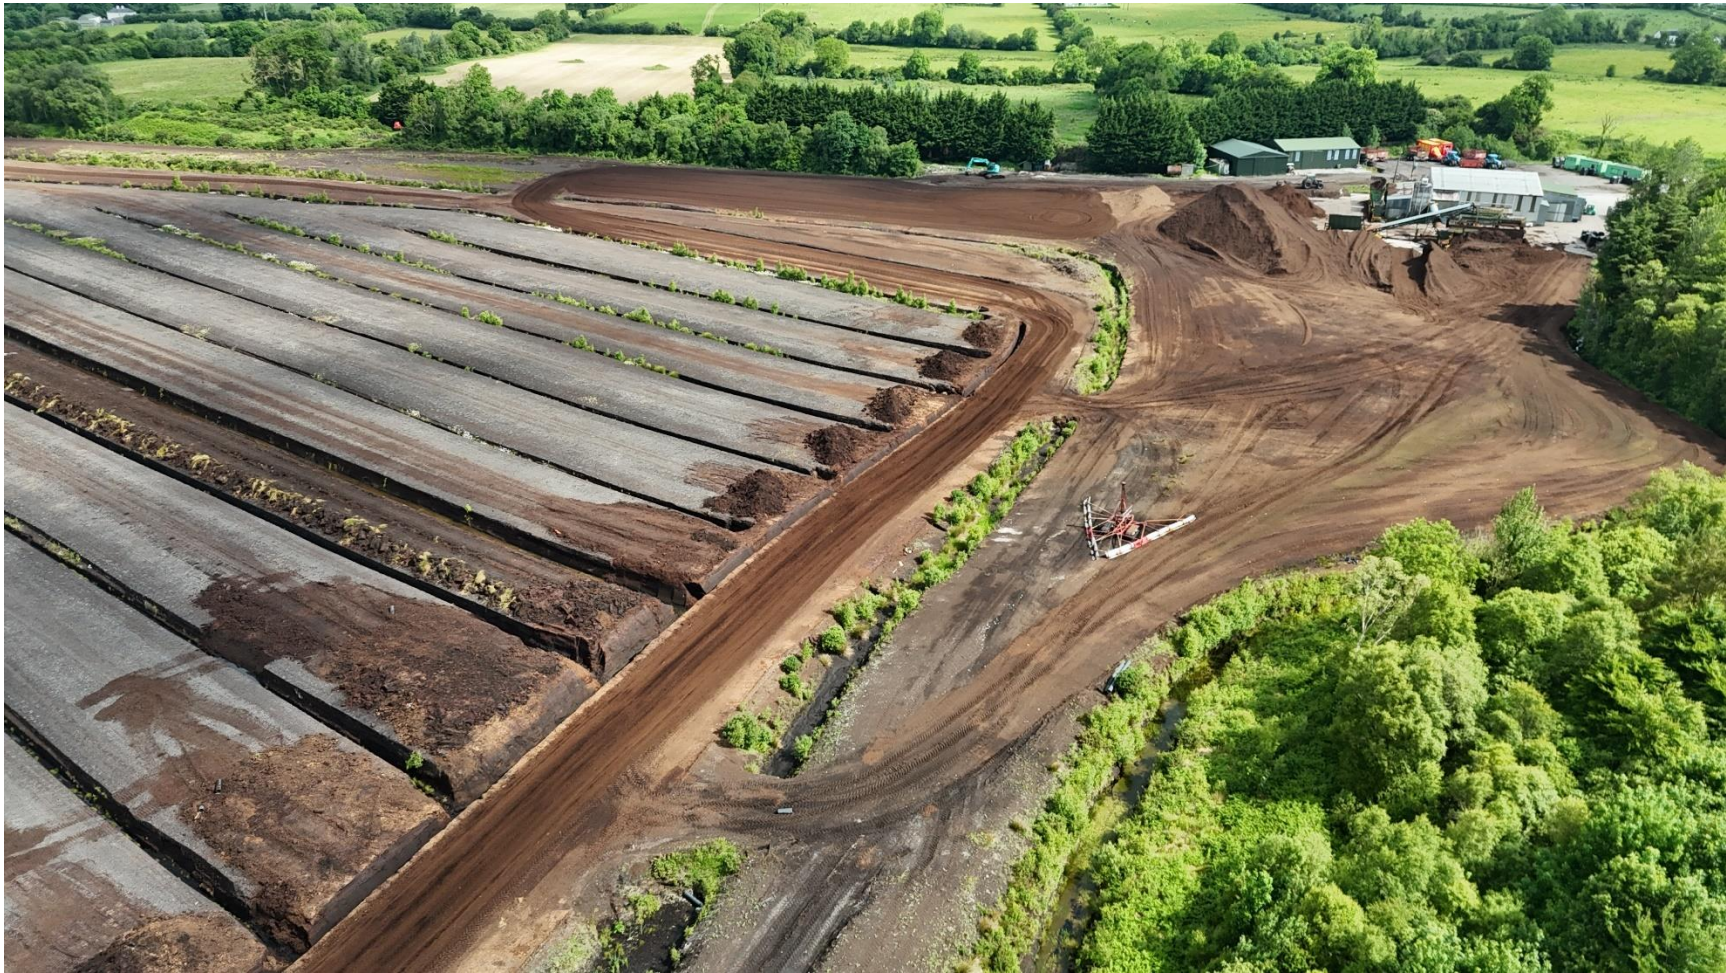
- EPA Inspectors walked the peatlands and noted the areas of the peatland where milled peat extraction had recently taken place.
 - Drainage works were noted to have been undertaken on the peatland and the water levels in the drains in some parts of the peatland were raised.

Photo 5: Drainage works noted on the peatland.

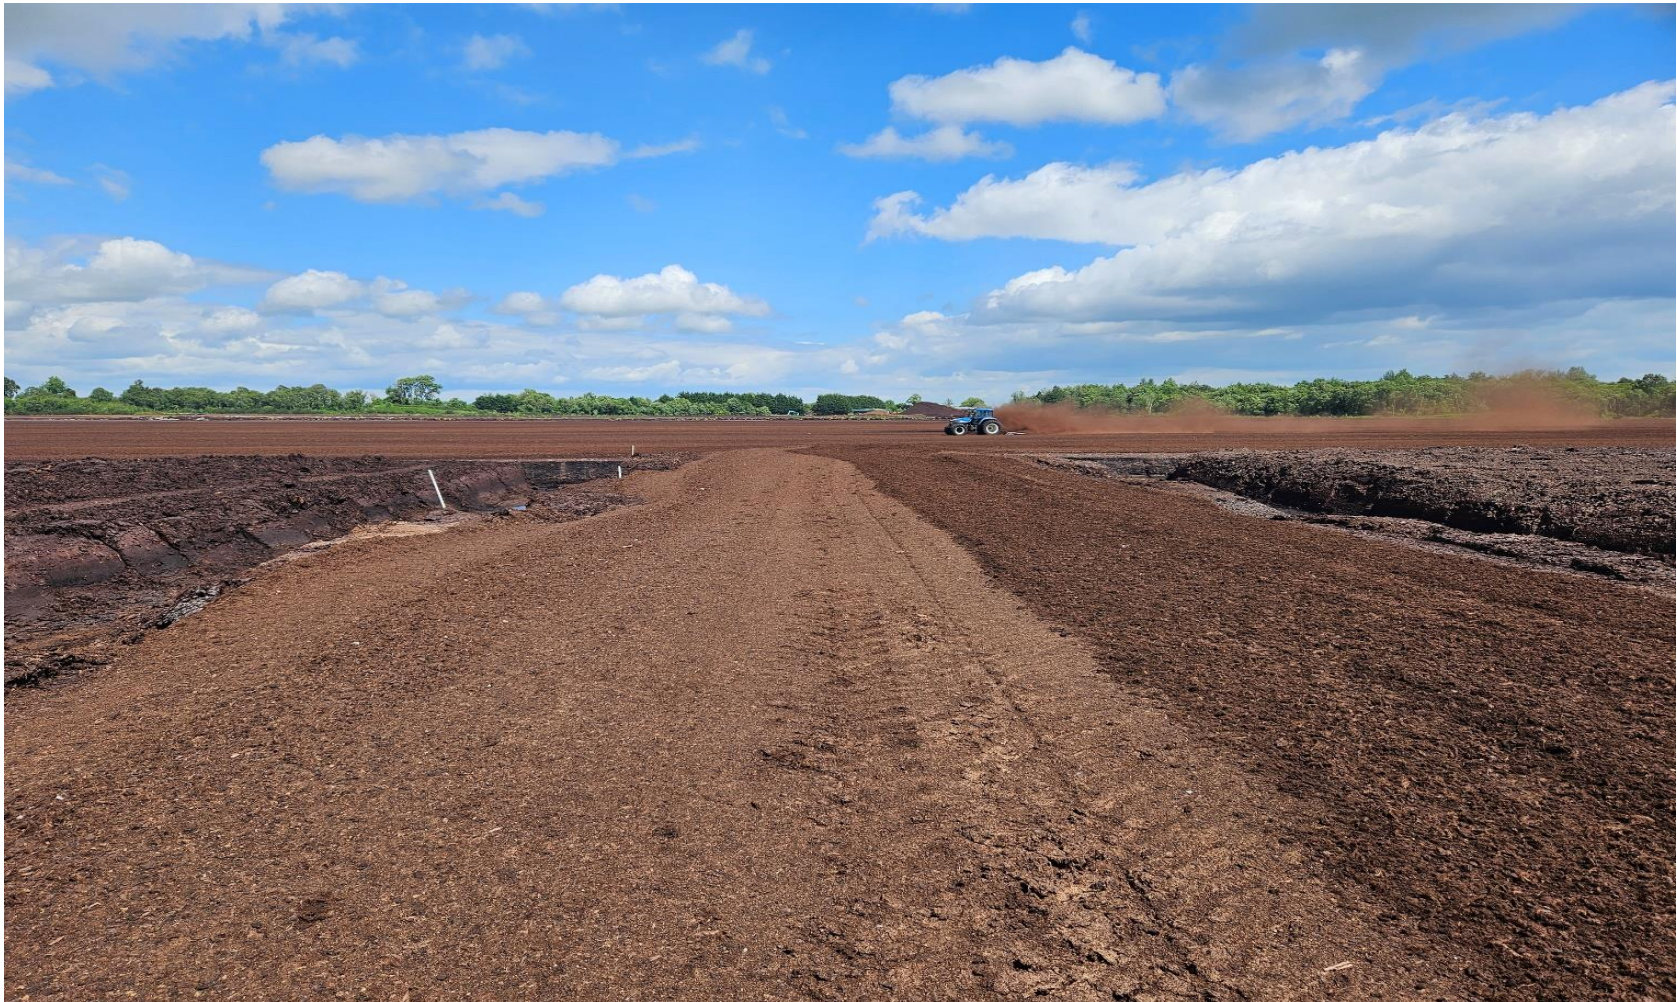
Photo 6– Milled peat extraction activities were ongoing during the visit.
