SITE VISIT REPORT

Purpose of Site Visit: Peat Extraction in Co Longford

Site Address: Derrymore, Ardagh Co Longford

Date of Visit: 20/05/2024

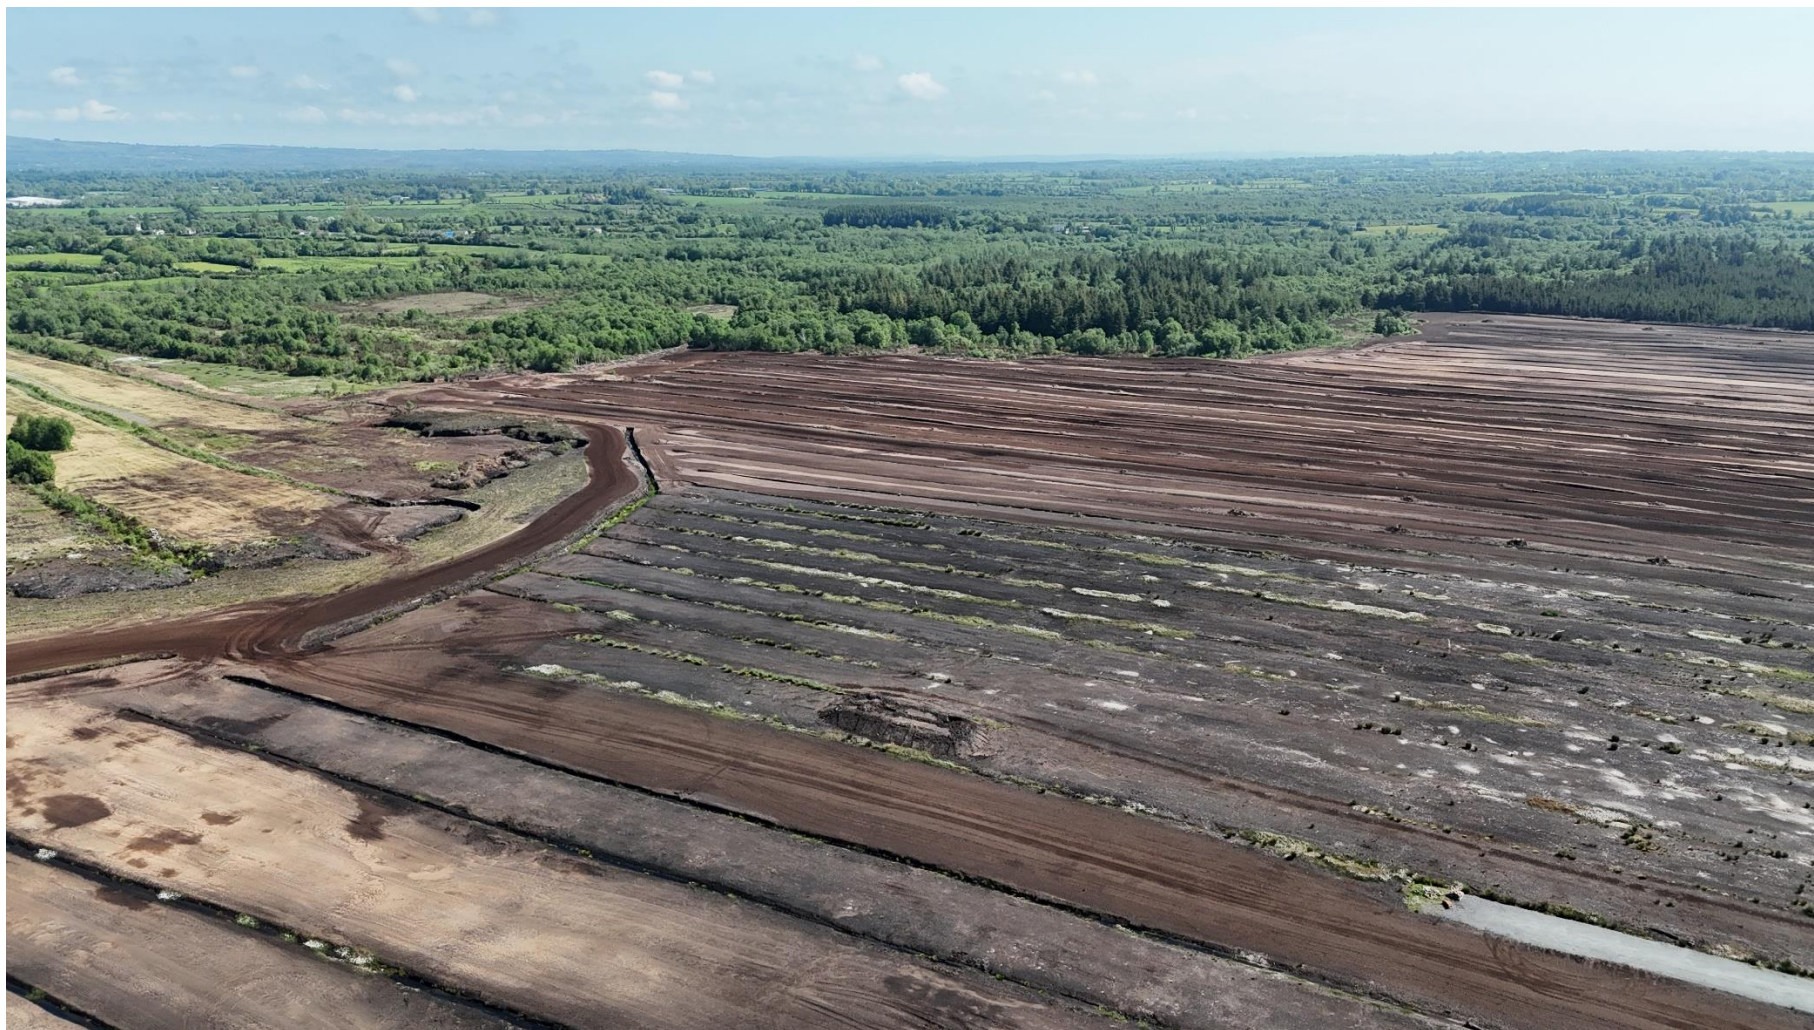
Photo 2: General overview of the North/North eastern section of the peatland.

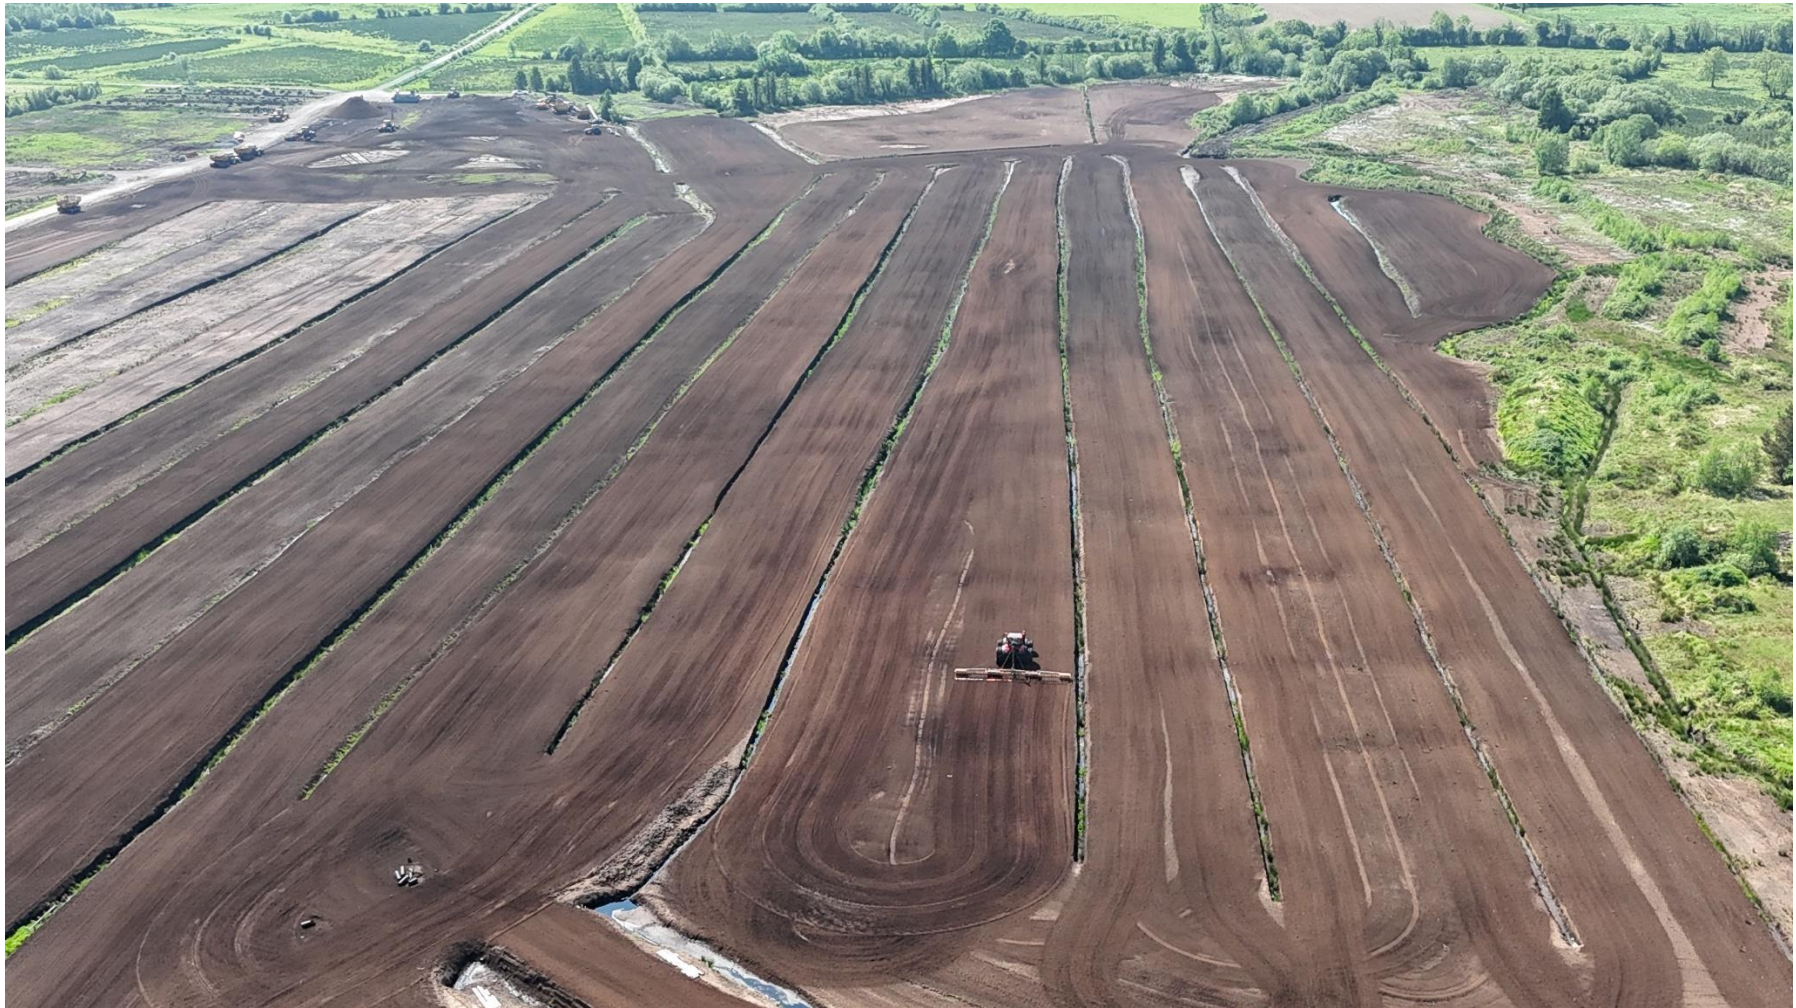
Photo 4: Milled peat harrowing was noted to be taking place during the visit.

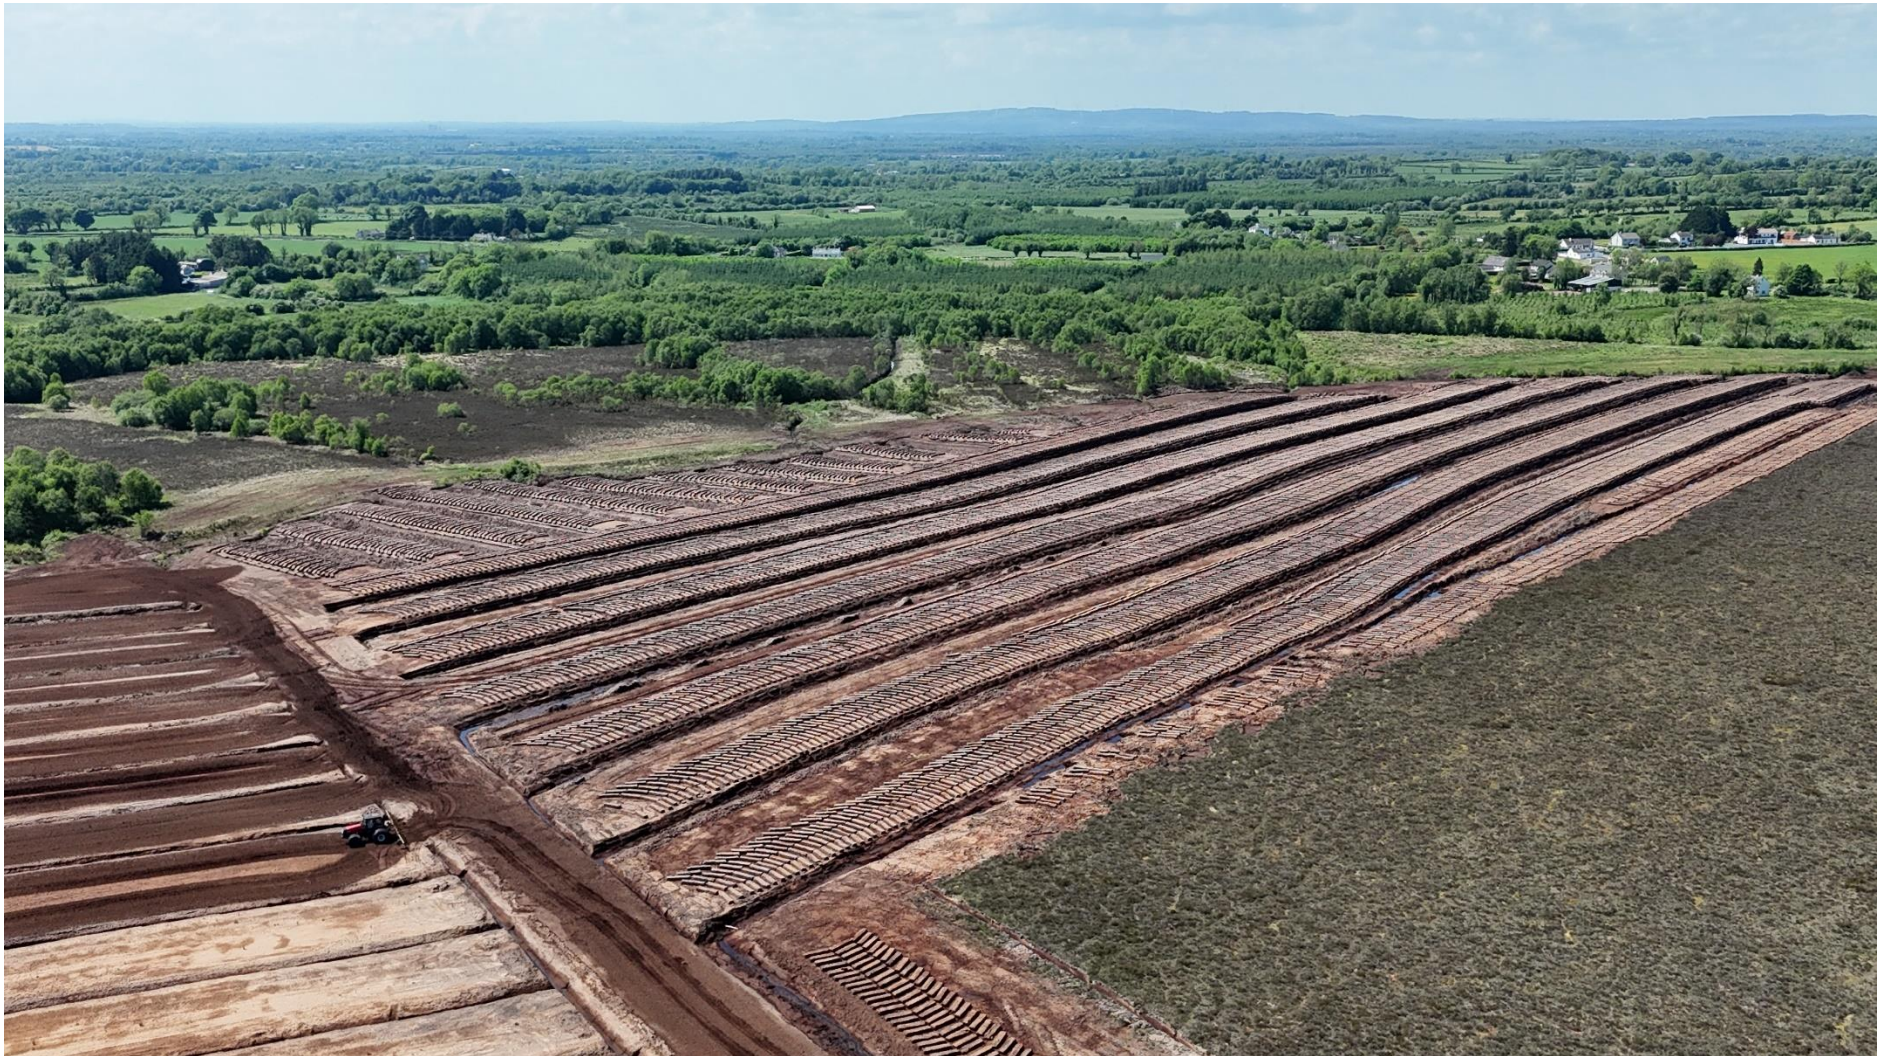
- Large sod peat had recently been extracted and left out on the North western section of the peatland. ██████████ said that he had extracted the large sod peat in the last month or so.

Photo 5: View of section of the peatland where large sod peat had recently been excavated, note milled peat extraction taking place also.

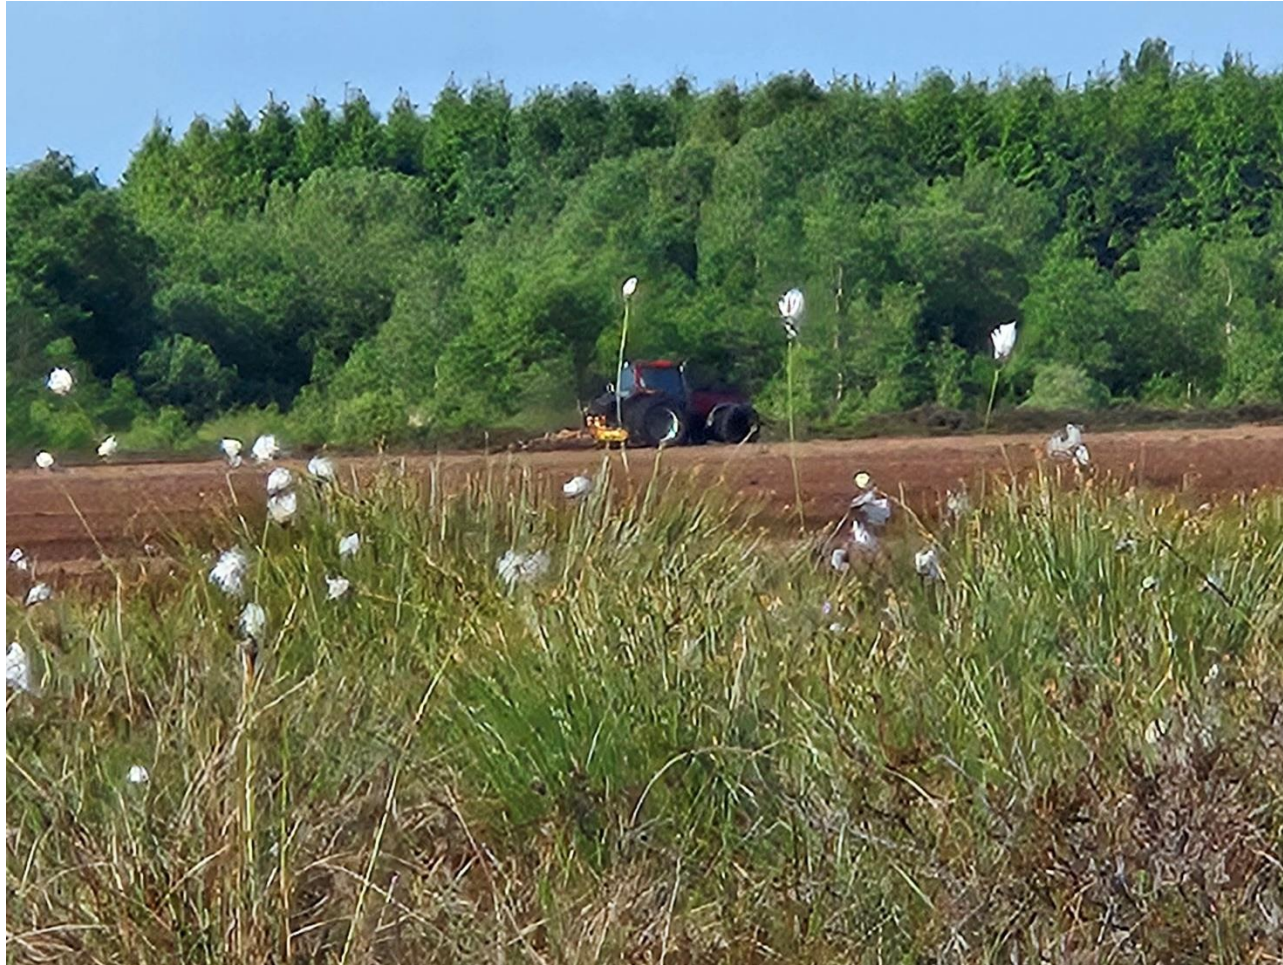
Photo 6: Milled peat harrowing was noted to be taking place during the visit.

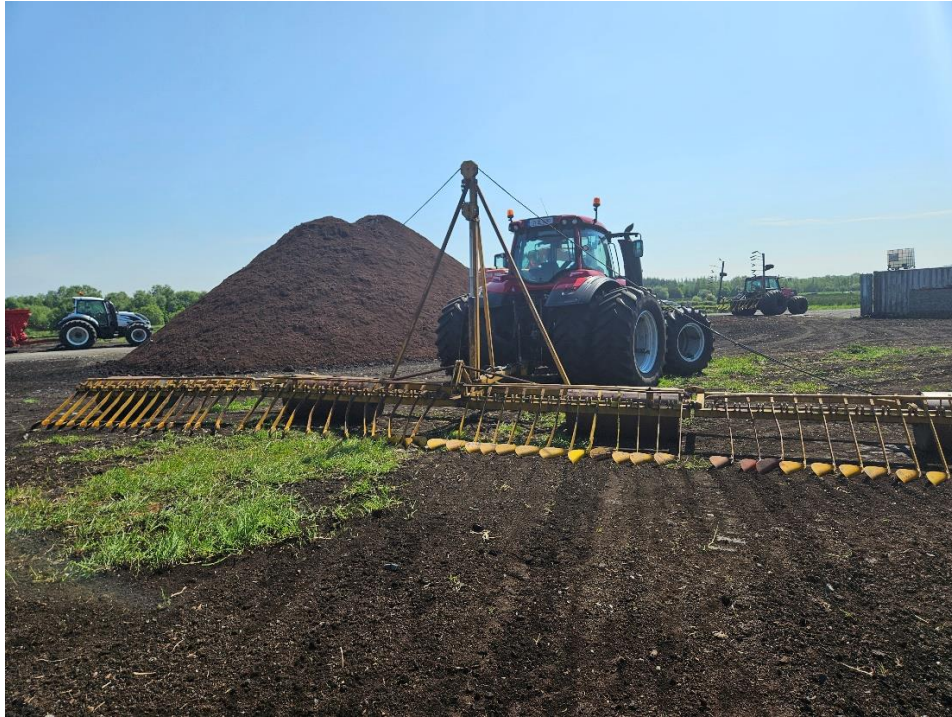
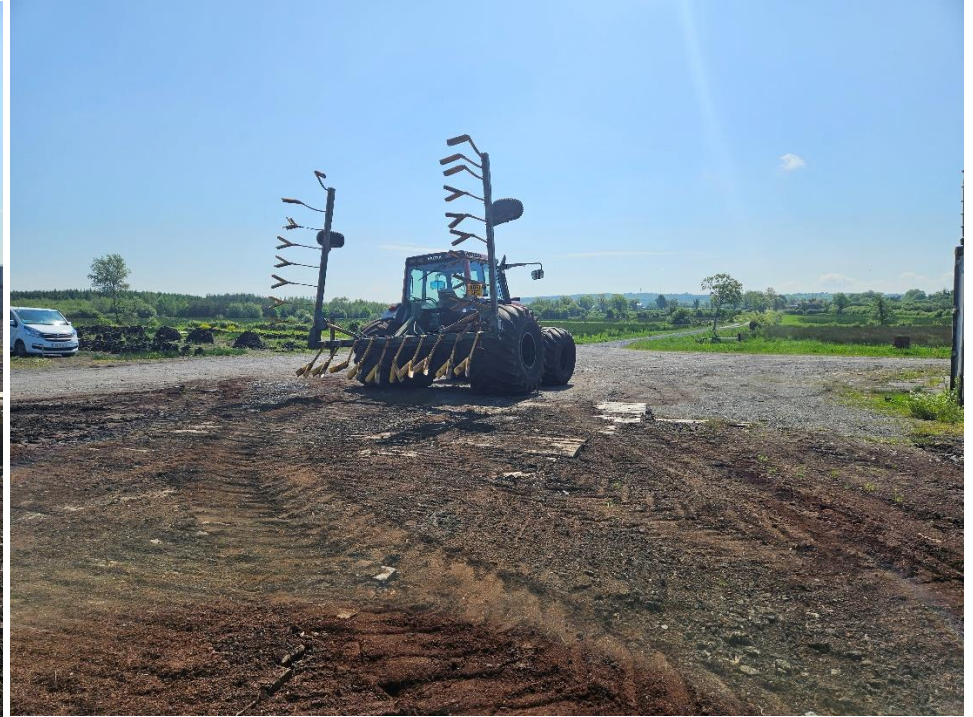
- One excavator was noted to be parked on a milled peat stockpile at the loading area.
 - A significant number of machines and equipment for peat extraction/harvesting was noted to be parked adjacent to the loading area/entrance at the Southern part of the peatland.

Photos 7 & 8: Milled peat extraction machinery and equipment noted at the loading area.

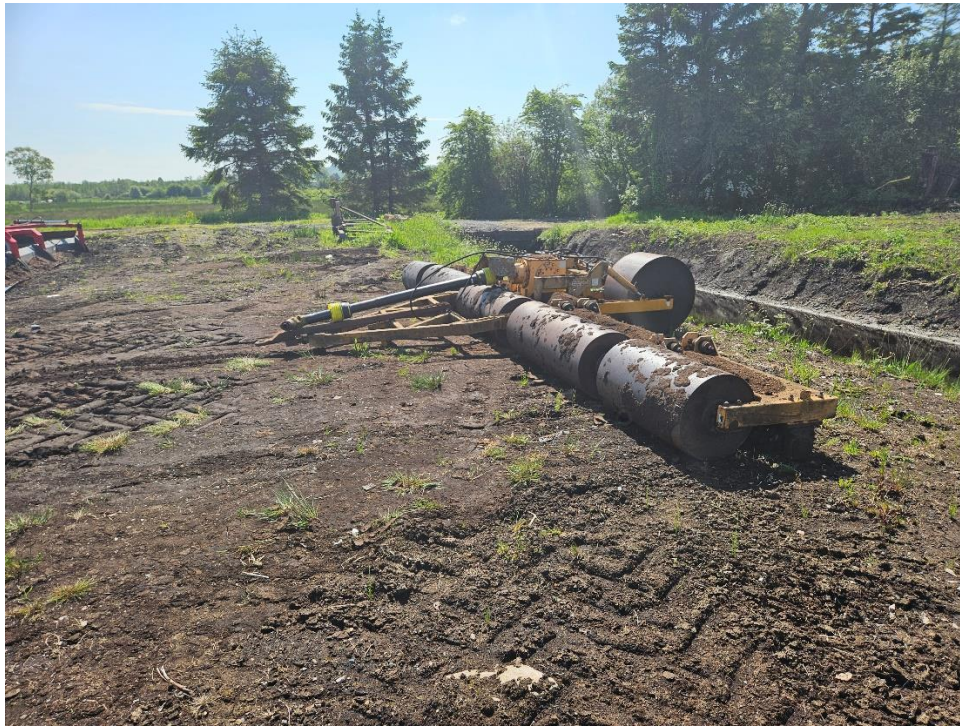
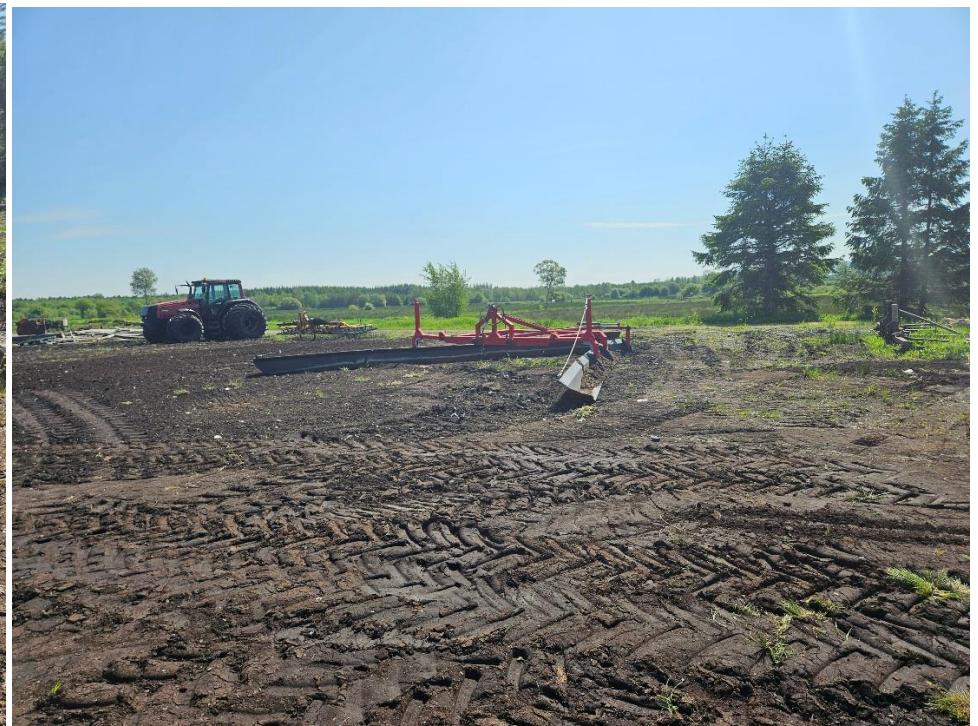
Photos 9 & 10: Milled peat extraction machinery and equipment noted at the loading area.

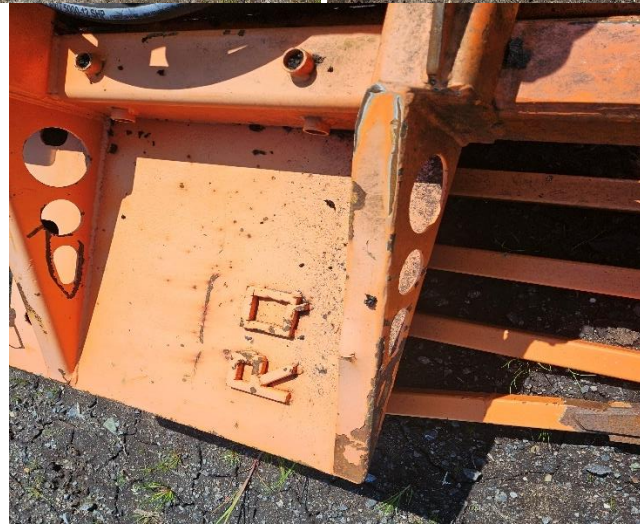
Photos 11, 12 & 13: Large sod peat extraction attachments were noted at the loading area.

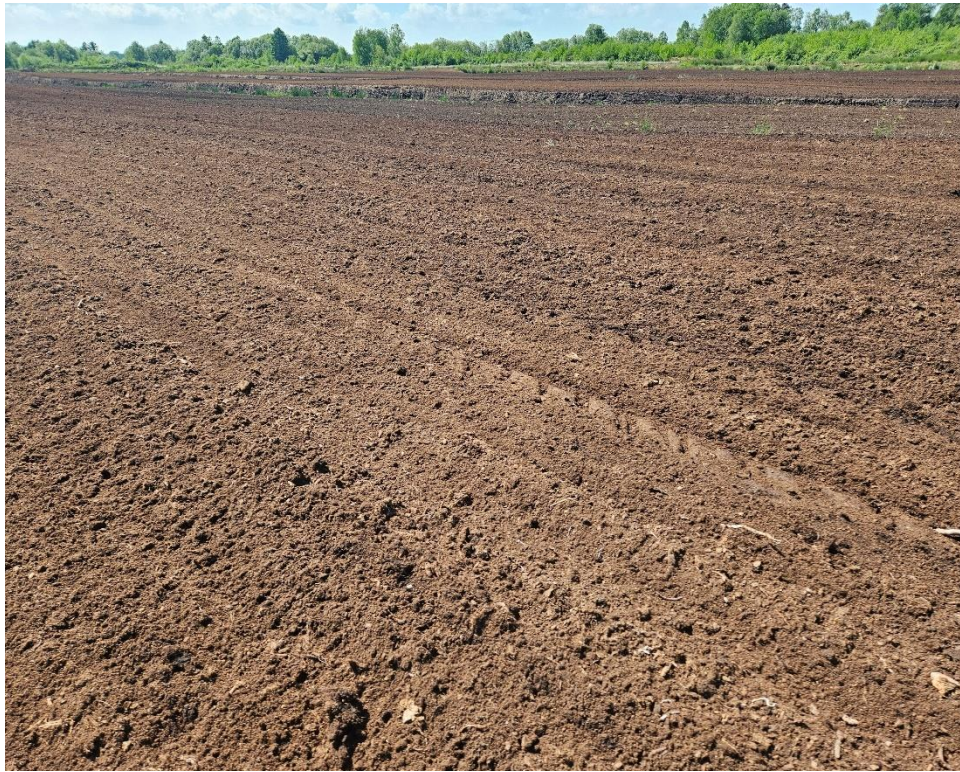
Photos 14 & 15: Recently milled peat noted on the peatland.
