# SITE VISIT REPORT

**Purpose of Site Visit:** Peat Extraction in Co. Tipperary

**Site Address:** Monaincha, Thesheehys and Corville townlands,  
Roscrea, Co Tipperary

**Date of Visit:** 26/01/2024

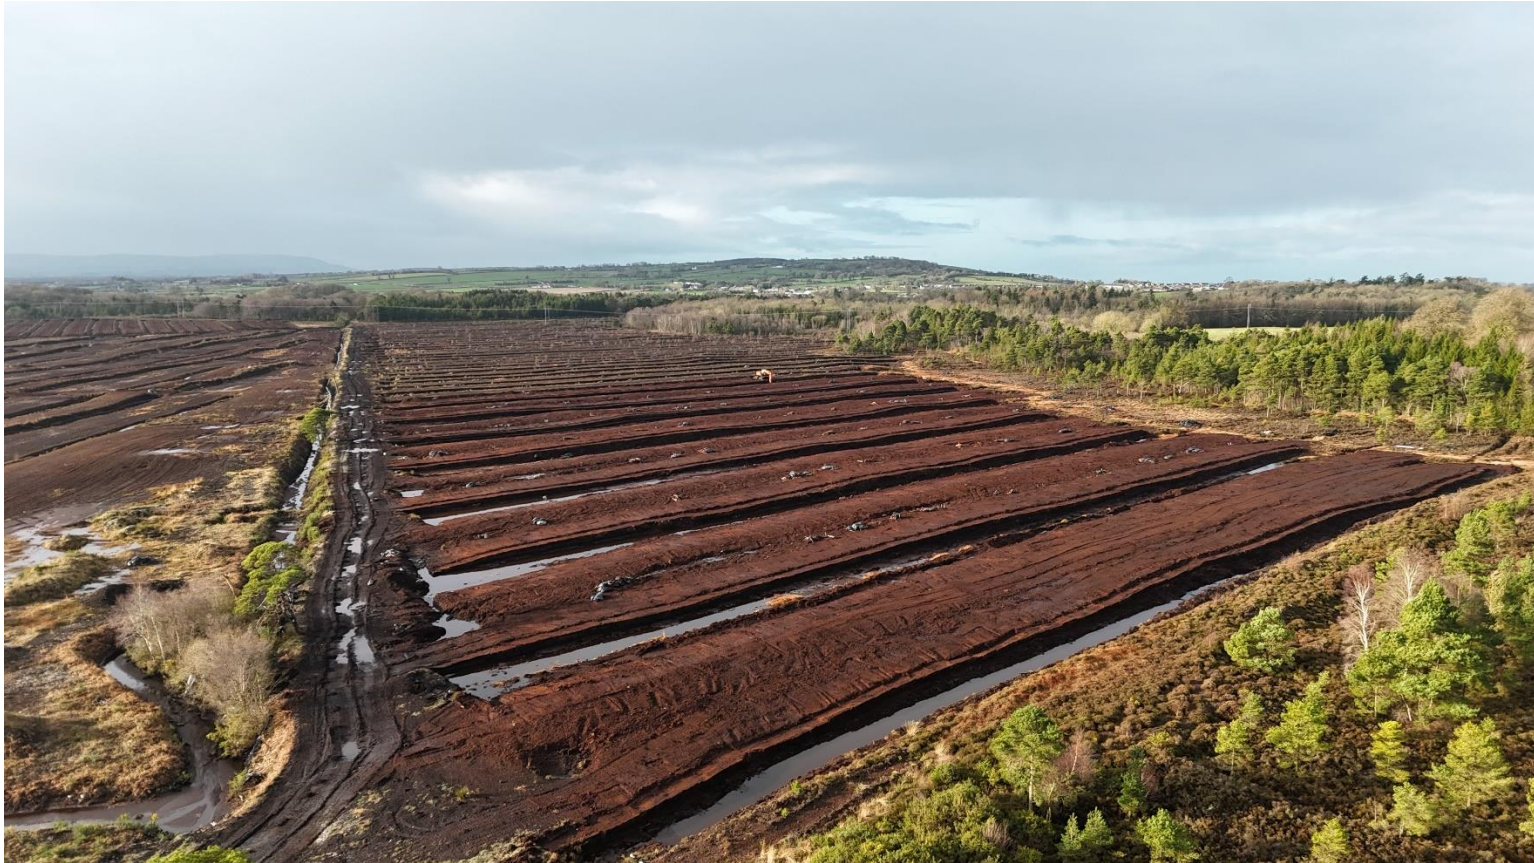
**Photo 1: Photograph showing excavator carrying out ‘clearing’, drainage and preparatory works on the western part of the peatland.**

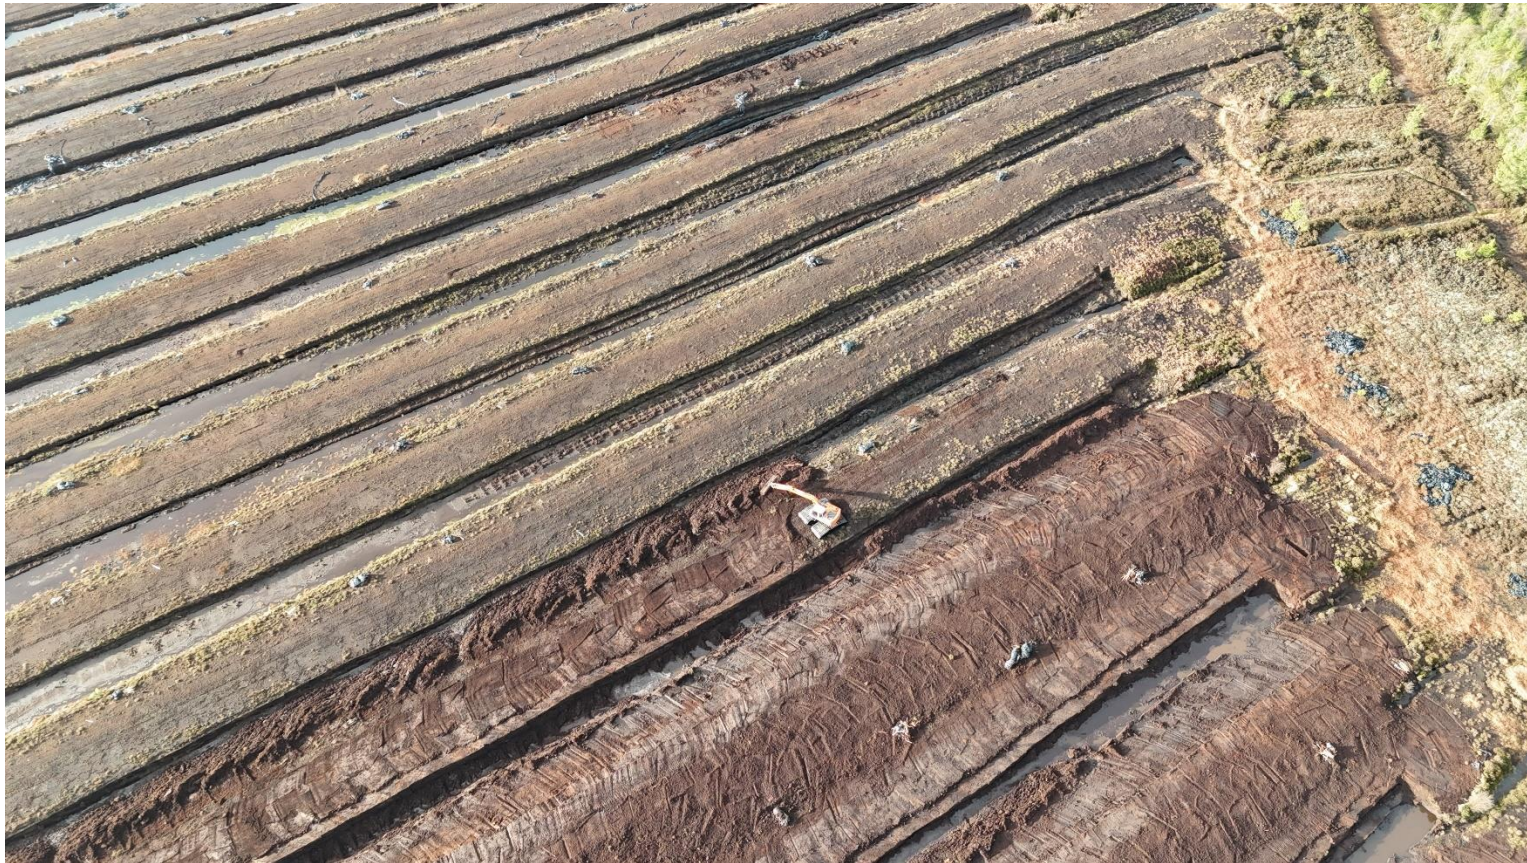
**Photo 2: Aerial photograph showing excavator carrying out ‘clearing’, drainage and preparatory works on the western part of the peatland.**

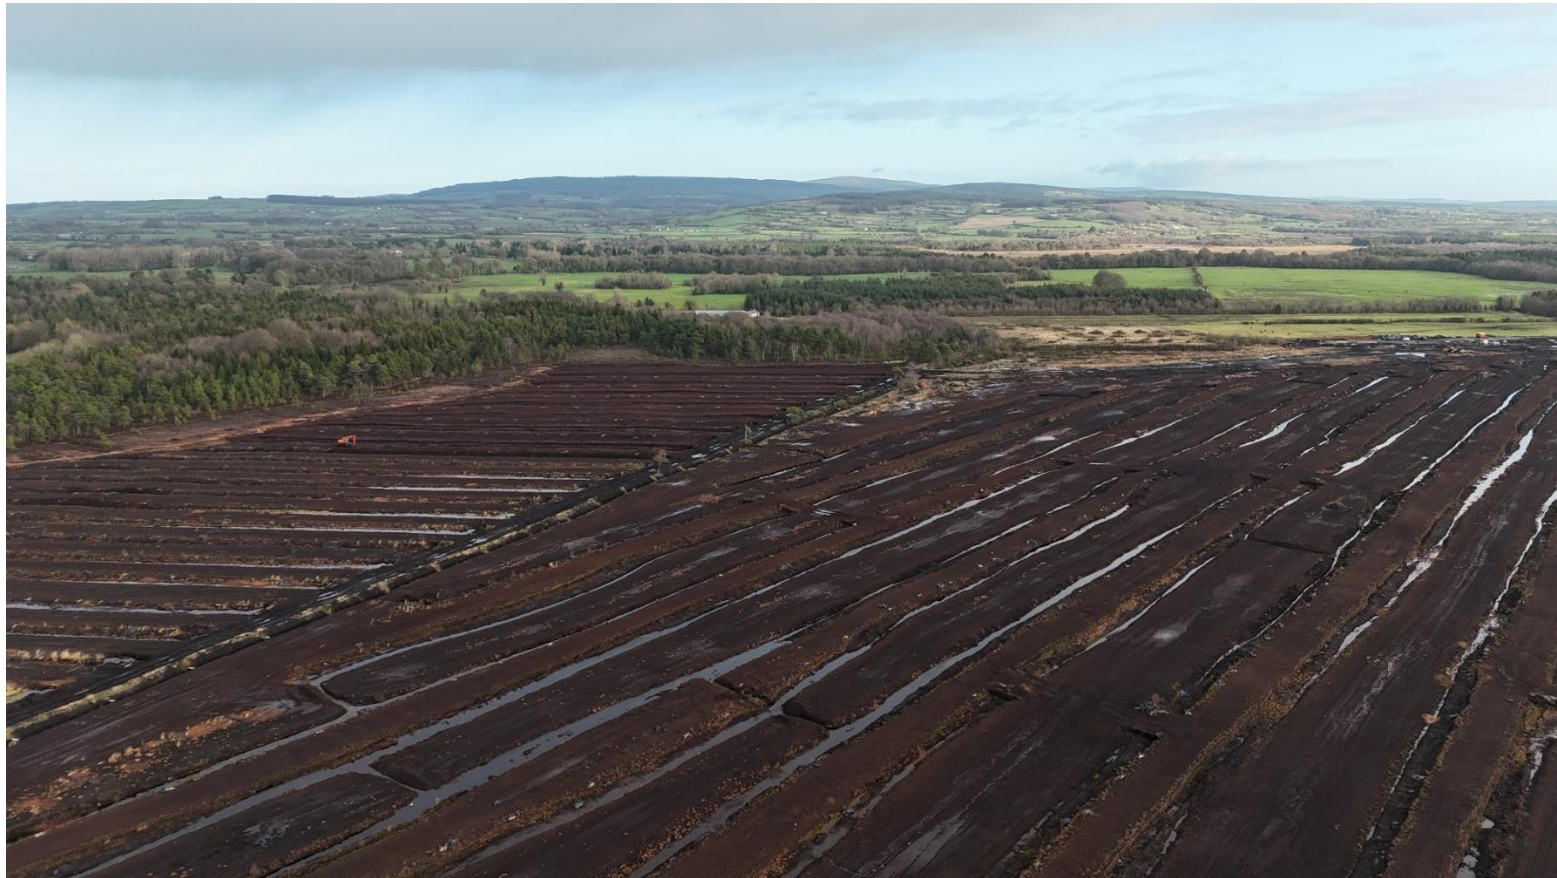
**Photo 3: Photograph (in a northerly direction) of a section of the peatland where milled peat extraction had previously taken place. Note the excavator carrying out ‘clearing’, drainage and preparatory works on the western part of the peatland.**

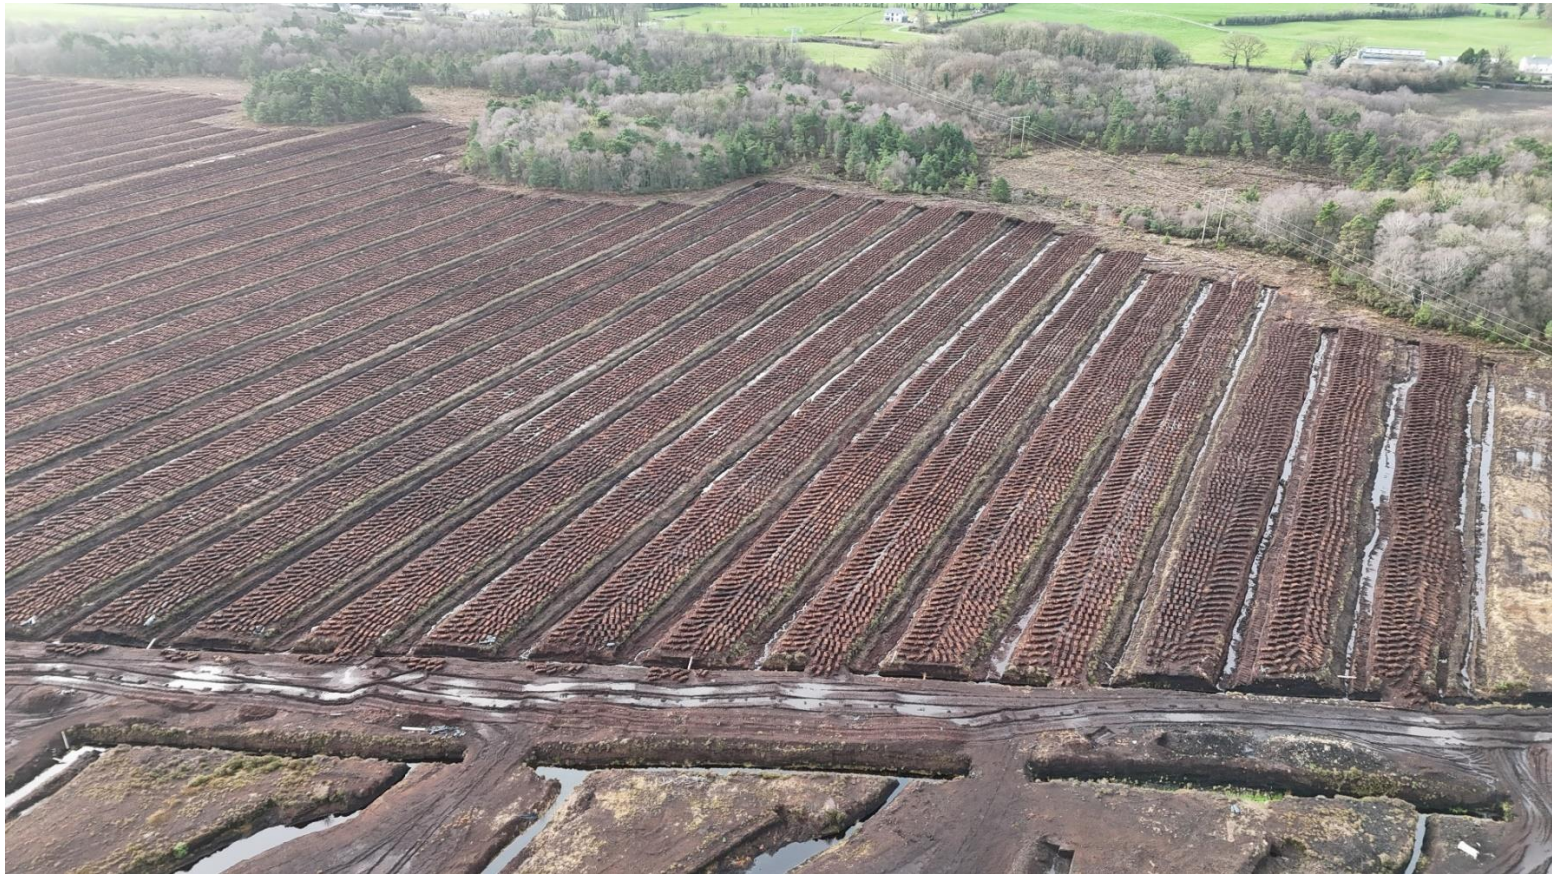
**Photo 4: Photograph of a section of the the southern part of peatland where large sod peat had recently been extracted and left to dry on the peatland.**

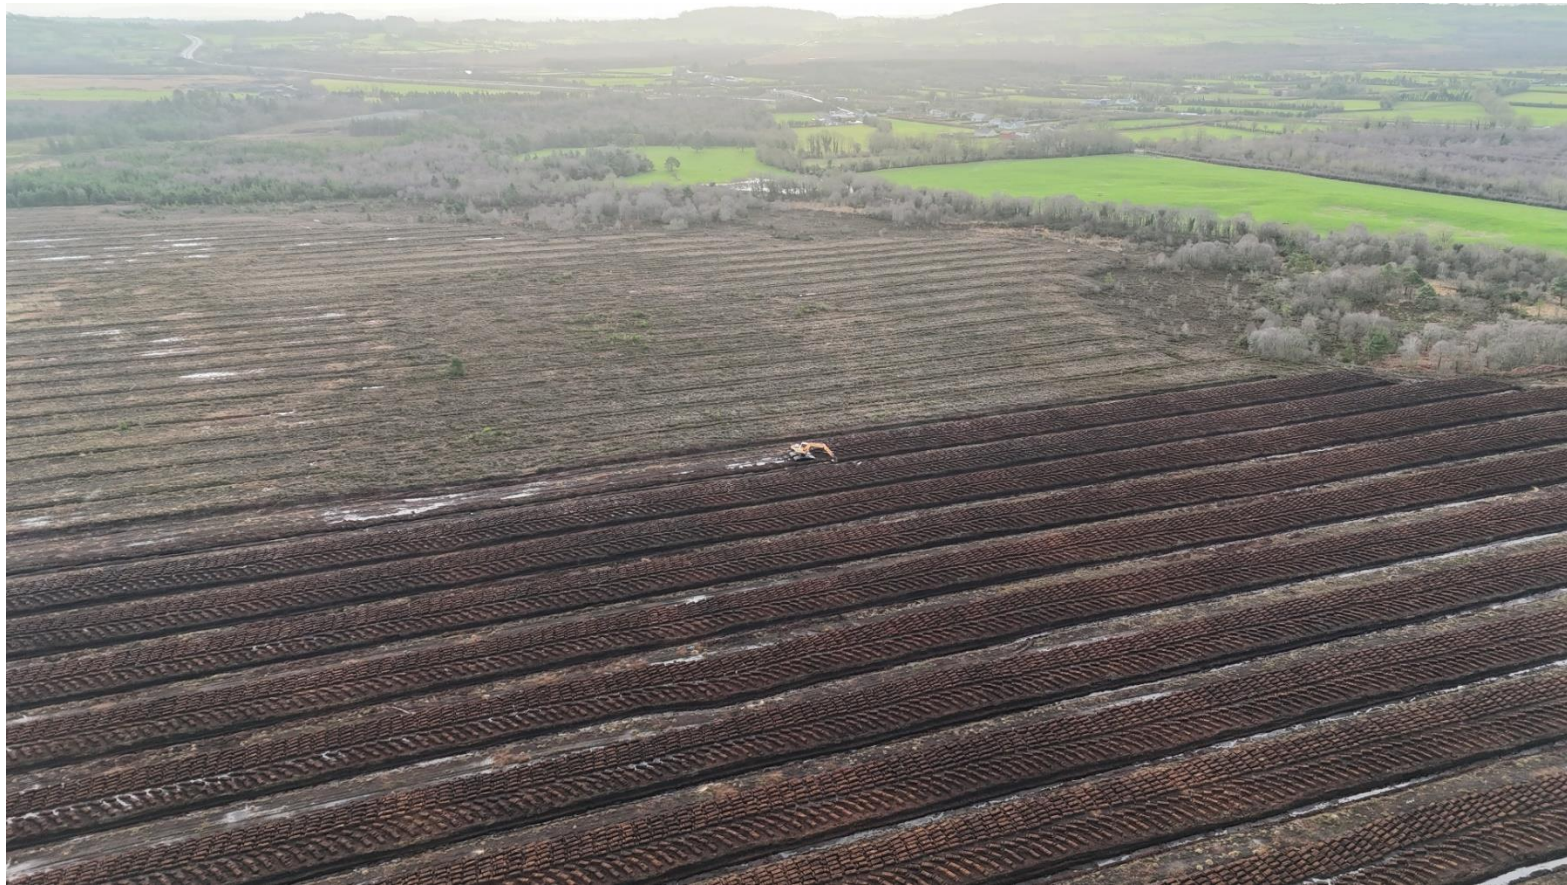
**Photo 5: Photograph of the southern section of the peatland where the extraction of large sod peat was ongoing during the visit (note excavator working in the centre of the photo).**

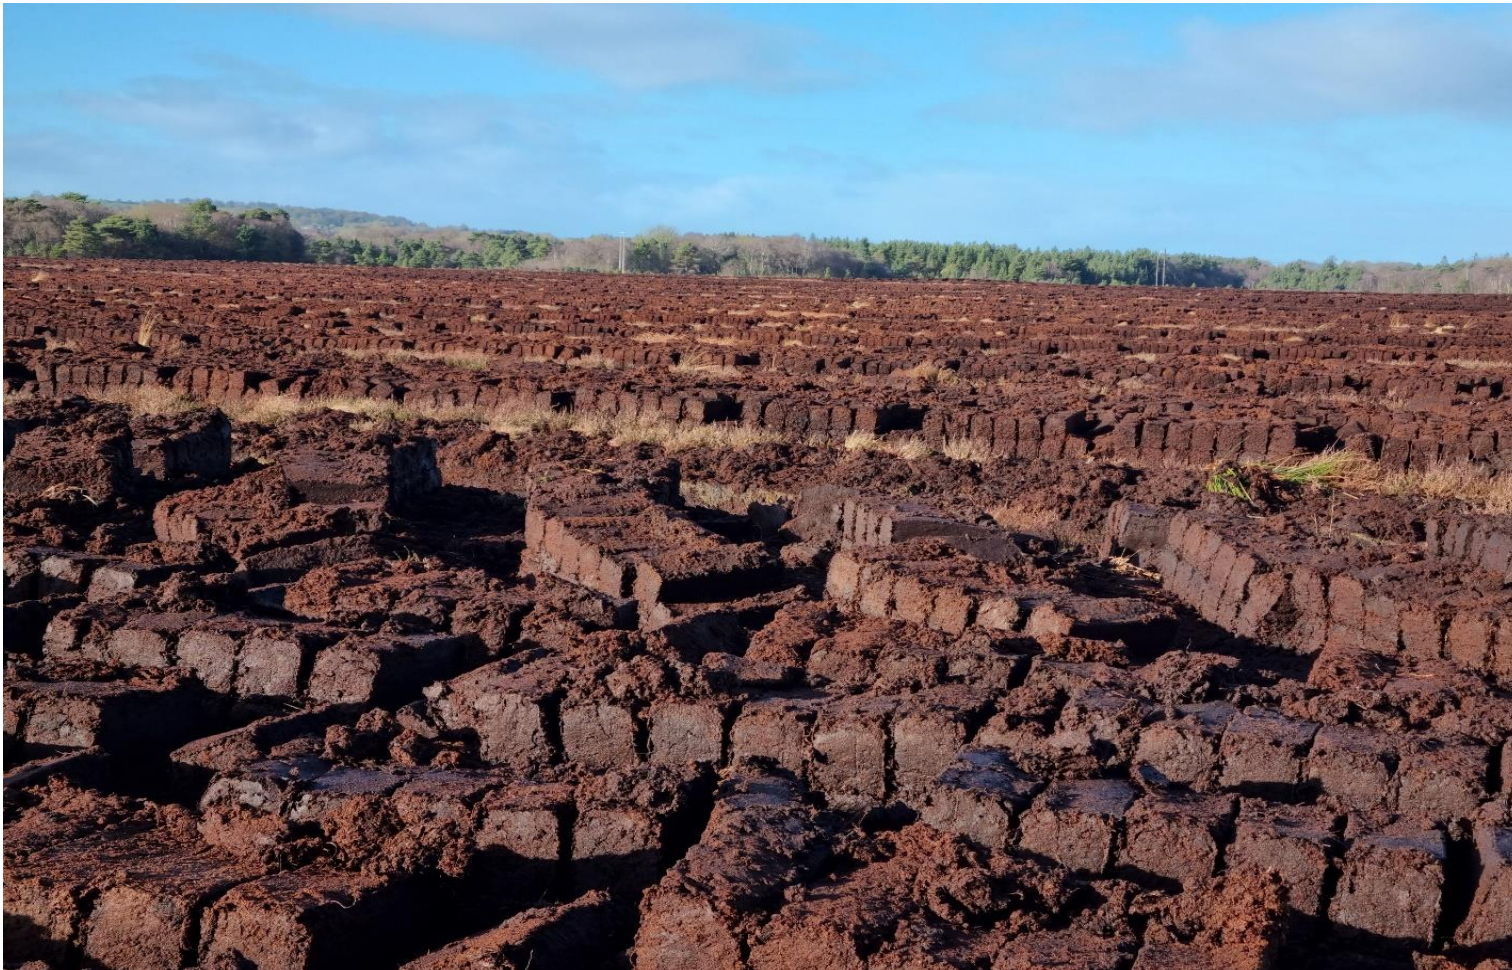
**Photo 6: Recently excavated large sod peat left out to dry on the southern part of the peatland.**

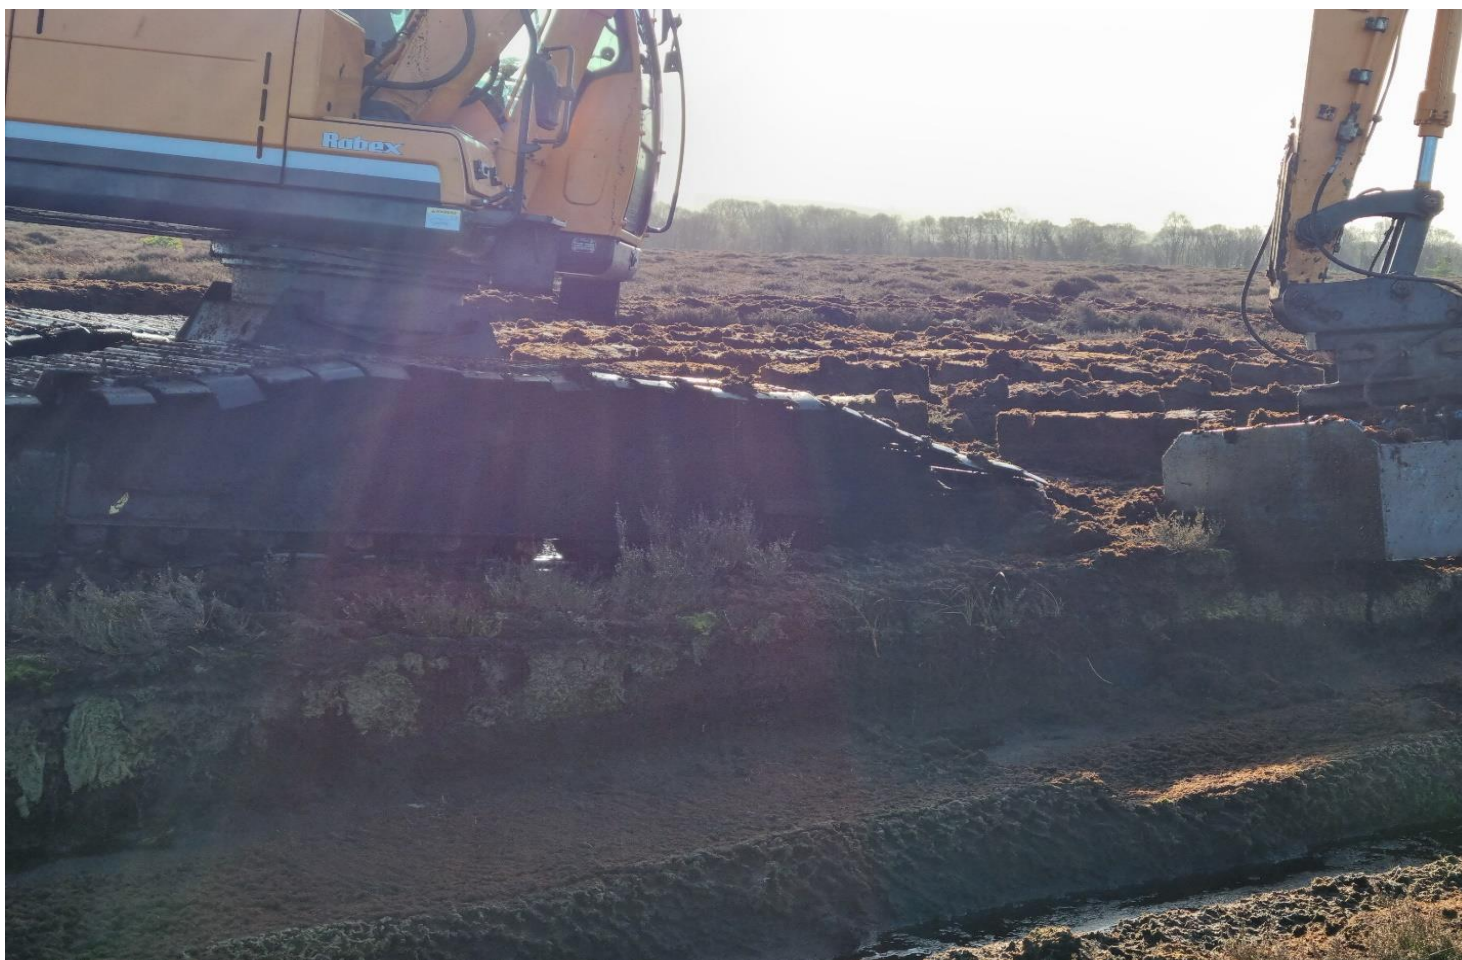
**Photo 7: An excavator extracting large sod peat during the visit.**
