SITE VISIT REPORT

Purpose of Site Visit: Peat Extraction in Co. Kildare

Site Address: Ballinderry, Carbury, Co. Kildare

Date of Visit: 22/05/25

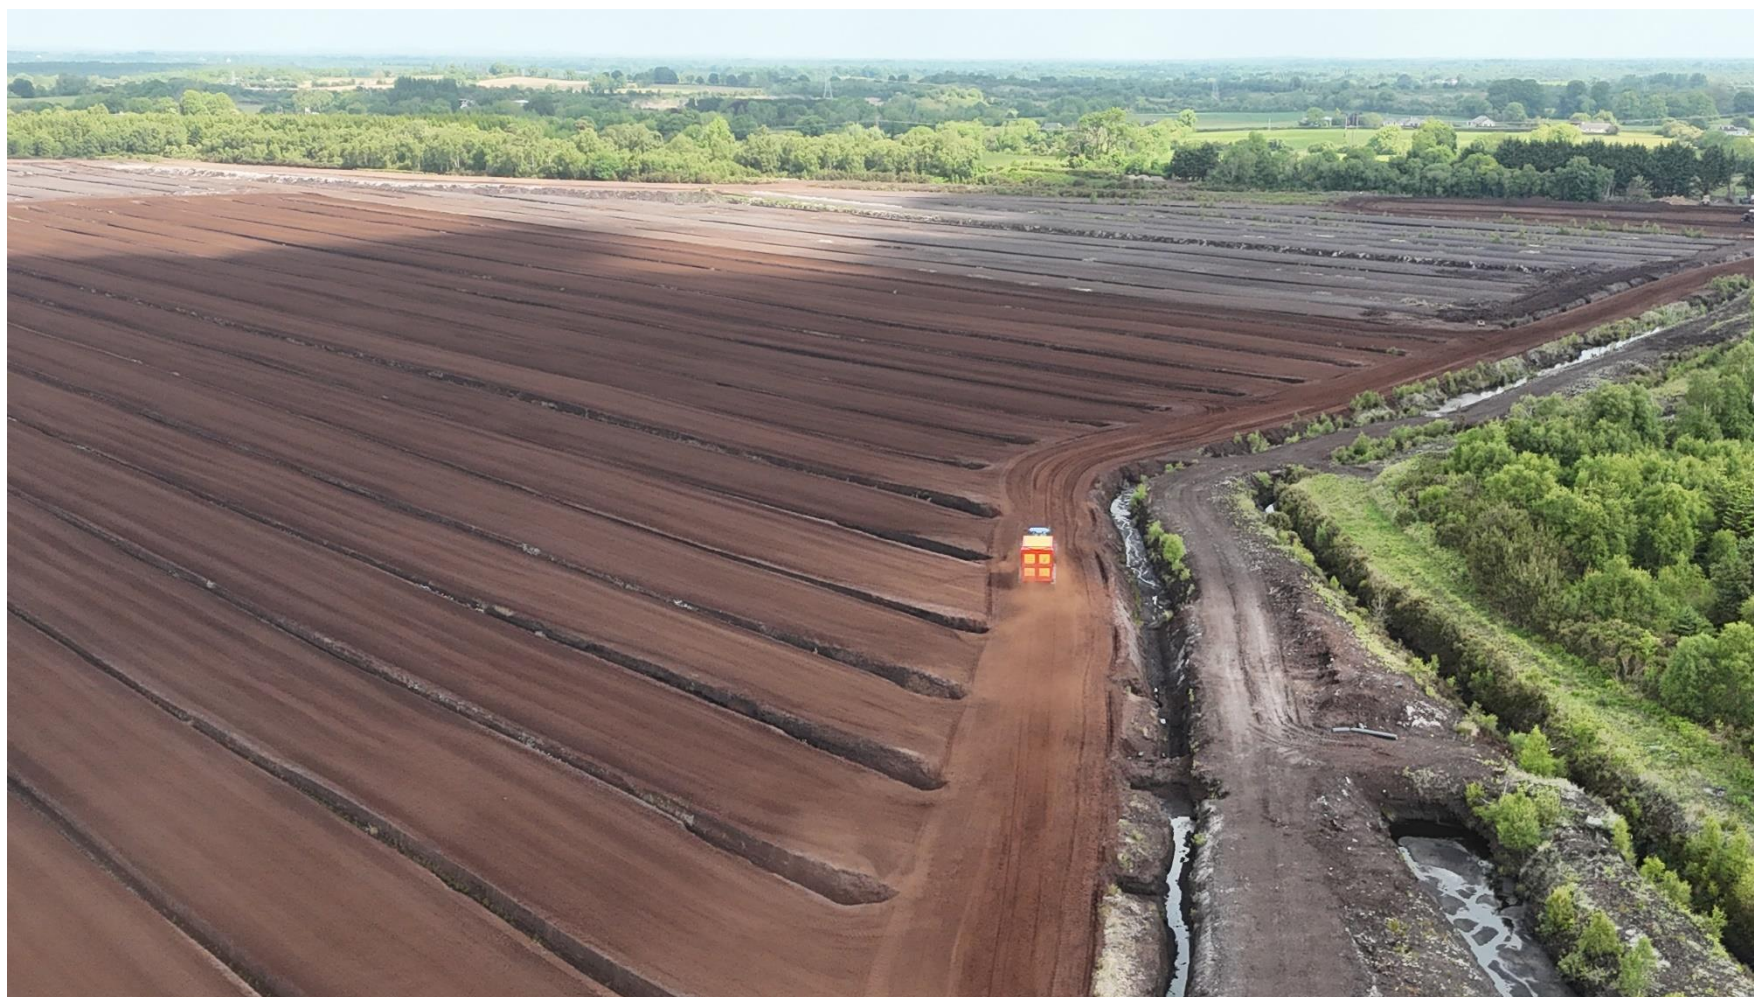
Photo 1: Photo showing the collection of milled peat from the peatland, note significant dust emissions arising.

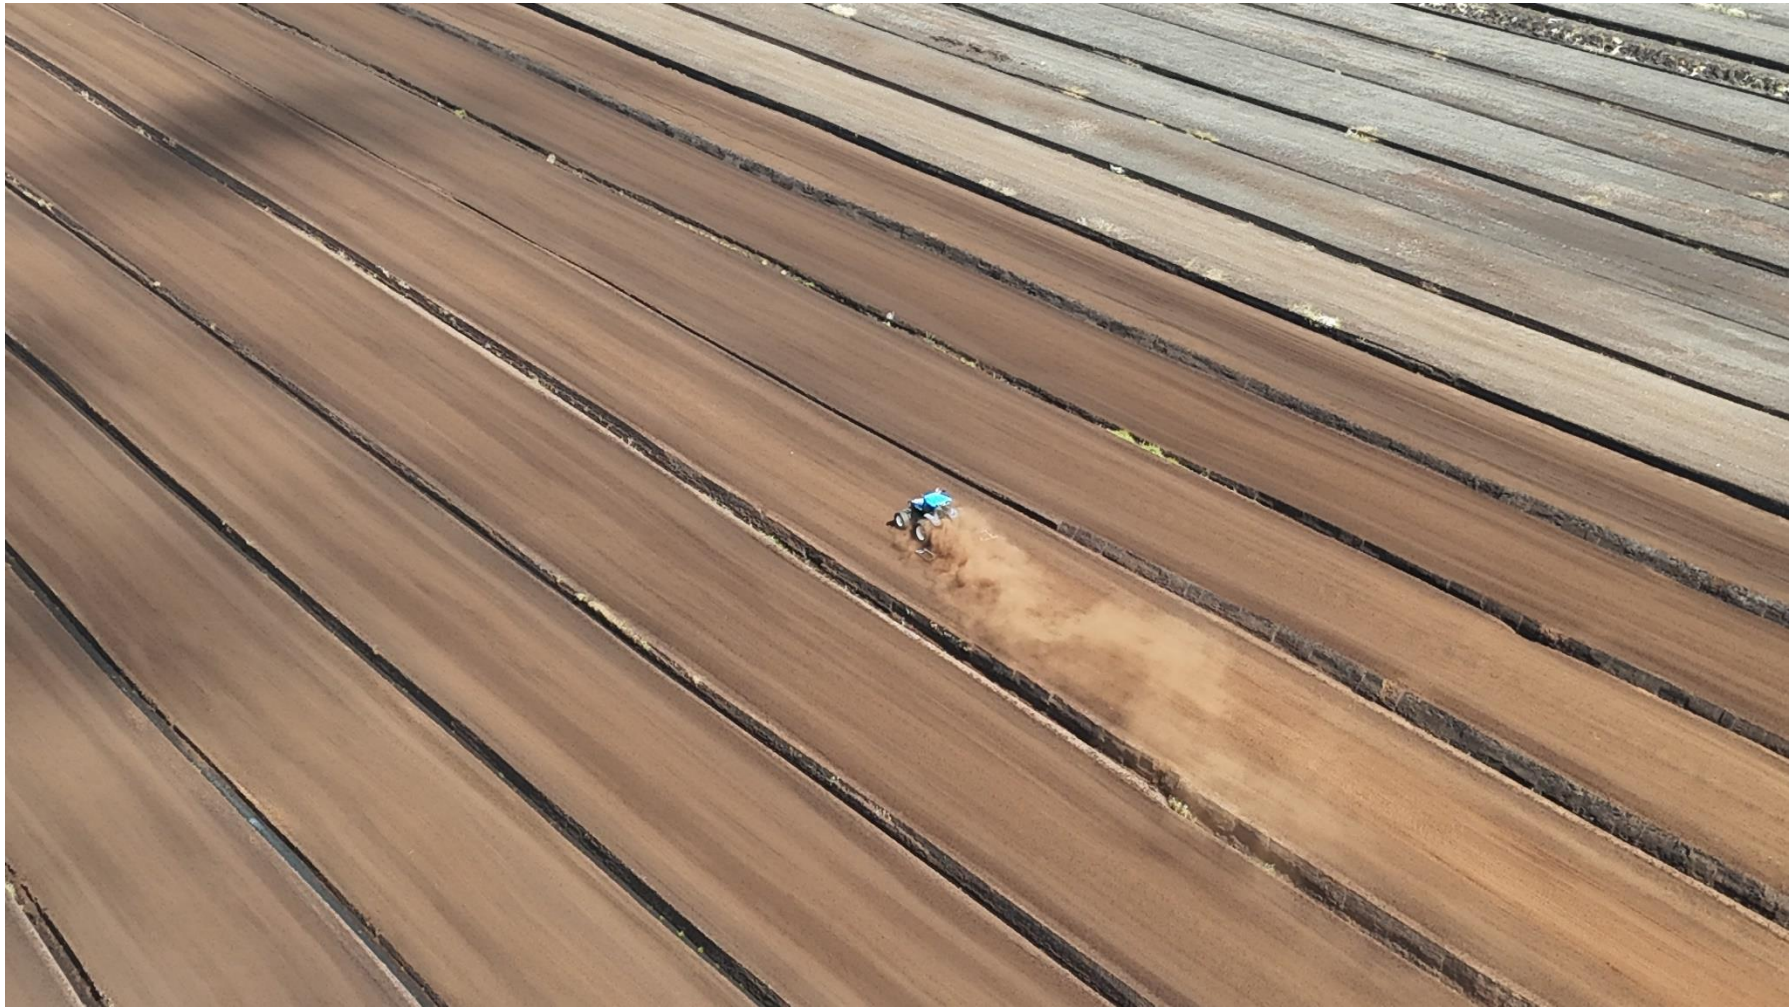
Photo 2: Significant dust emissions noted to be arising from the harrowing of milled peat.

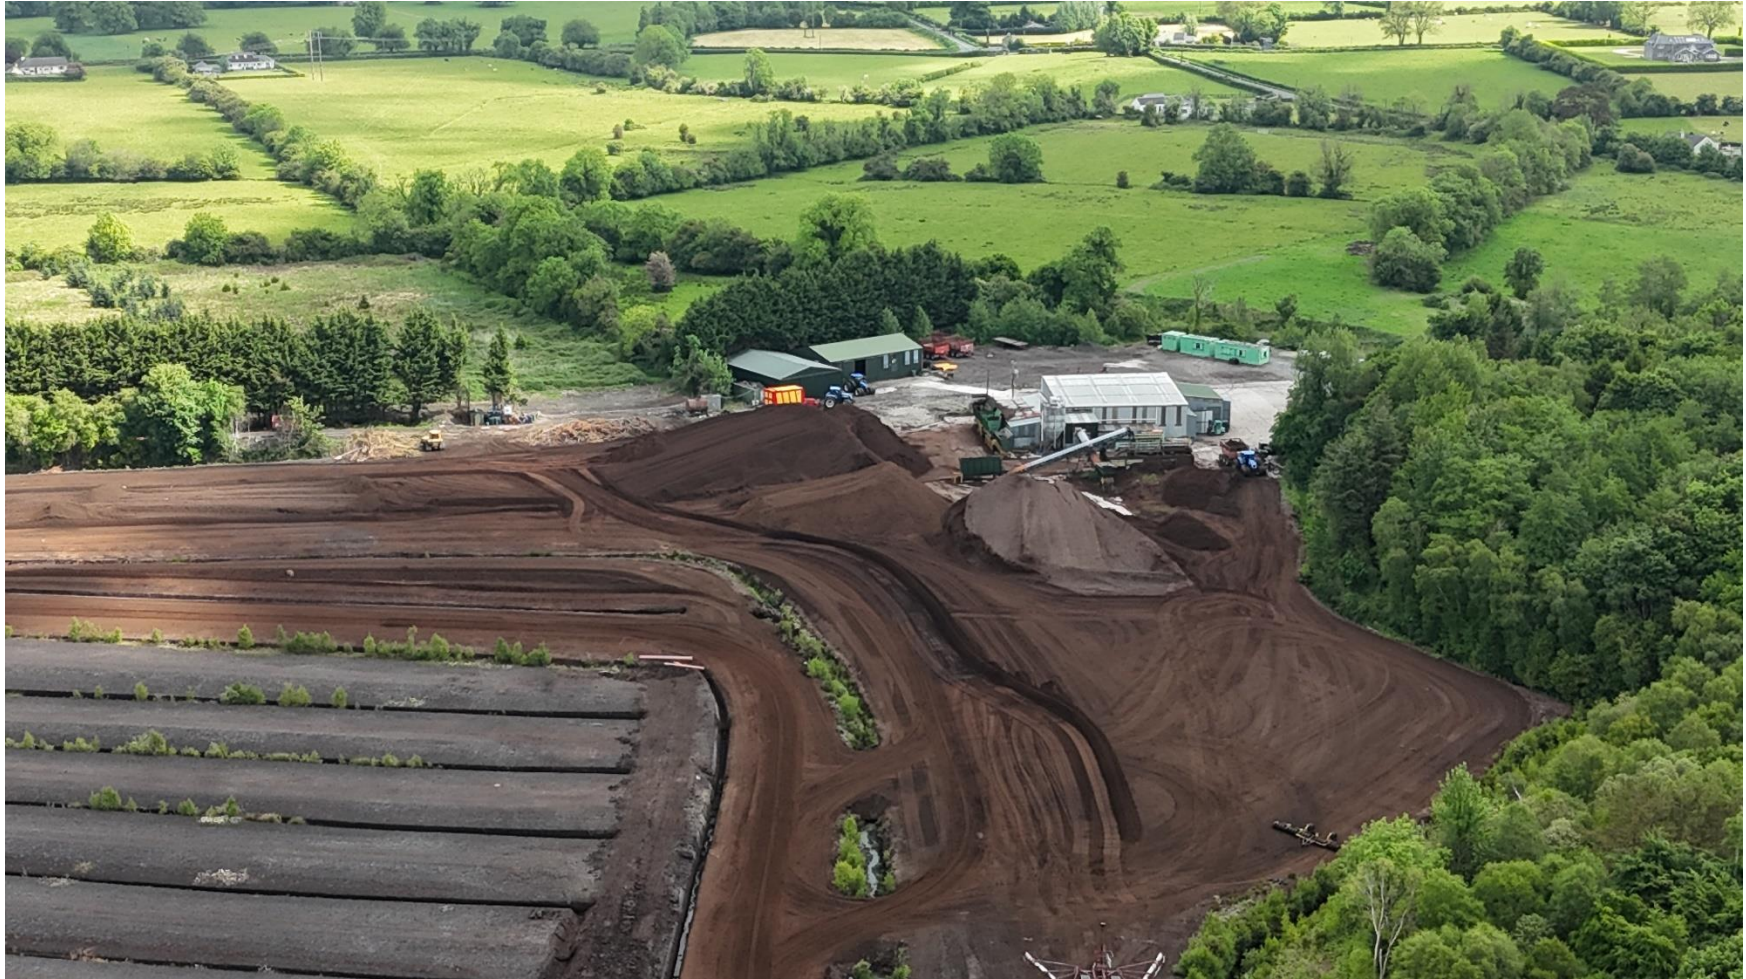
Photo 3: Aerial view of the bagging/processing plant and the stockpiles of milled peat.

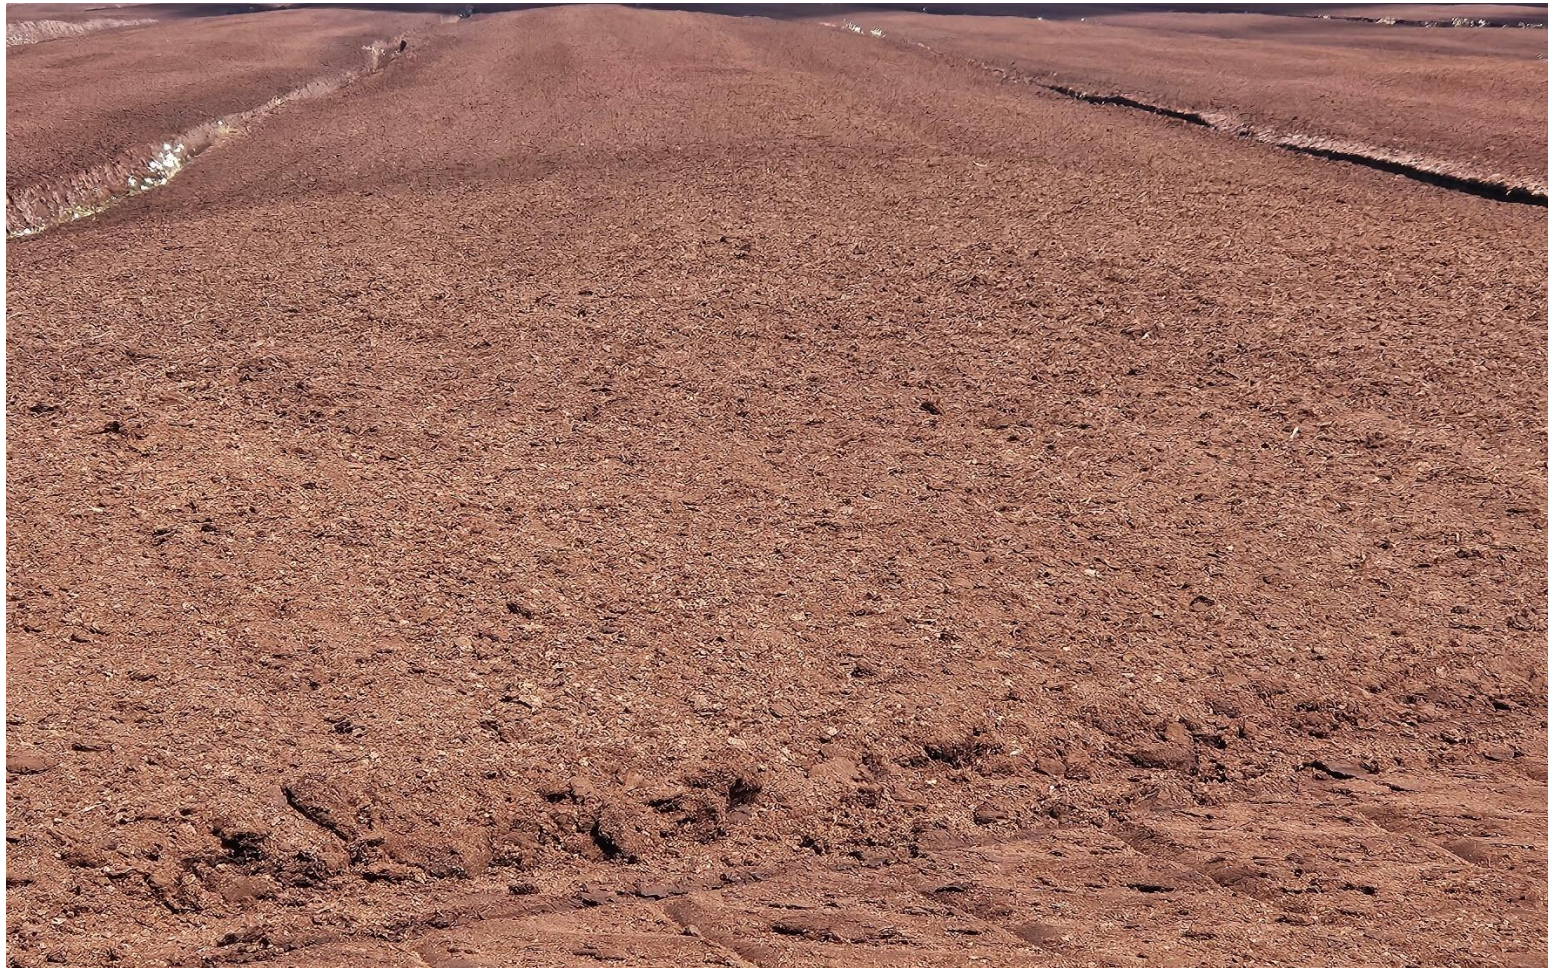
Photo 4: Milling/harrowing of peat had recently taken place on the peatland.

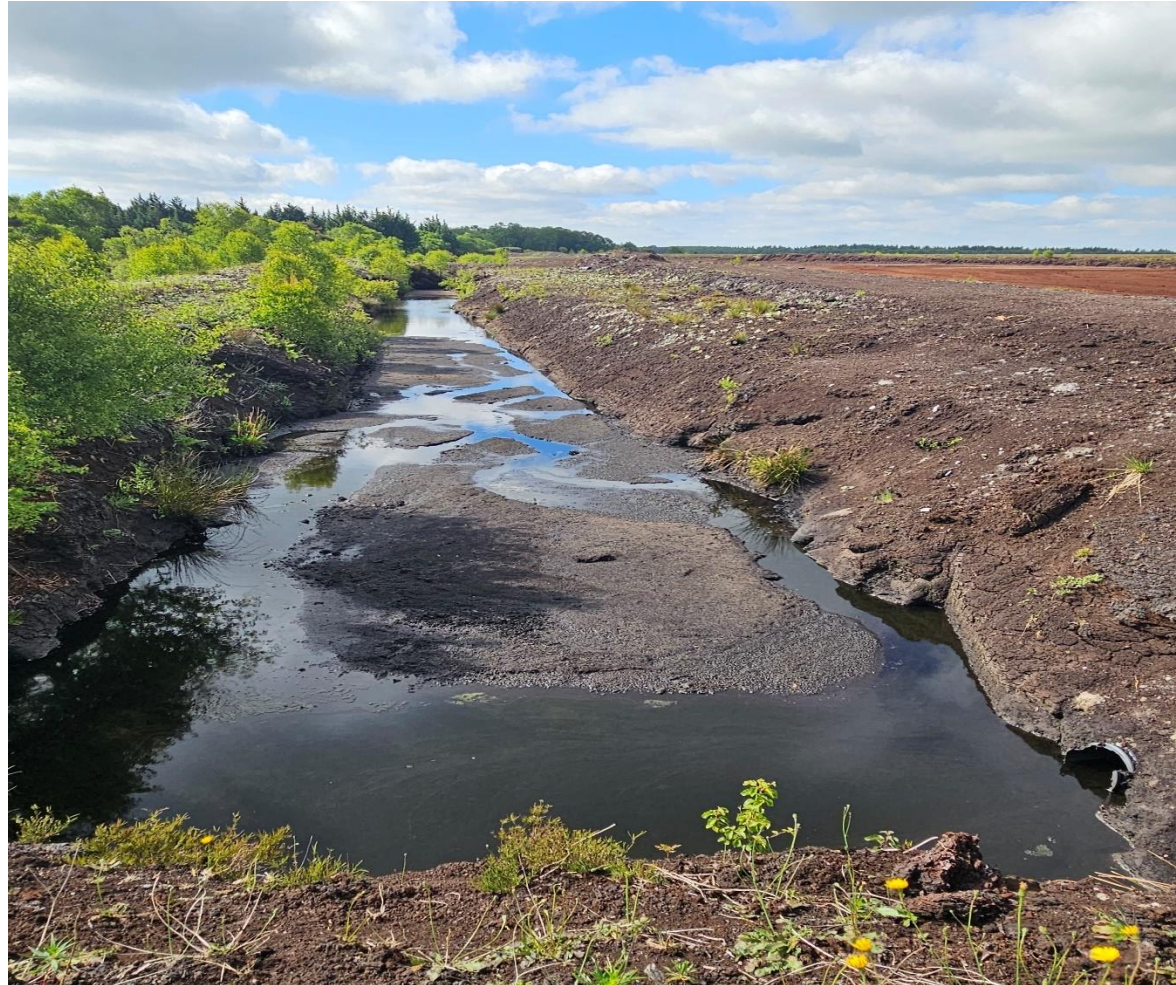
Photo 5: Heavy sedimentation noted in one of the sediment ponds at the Eastern boundary.

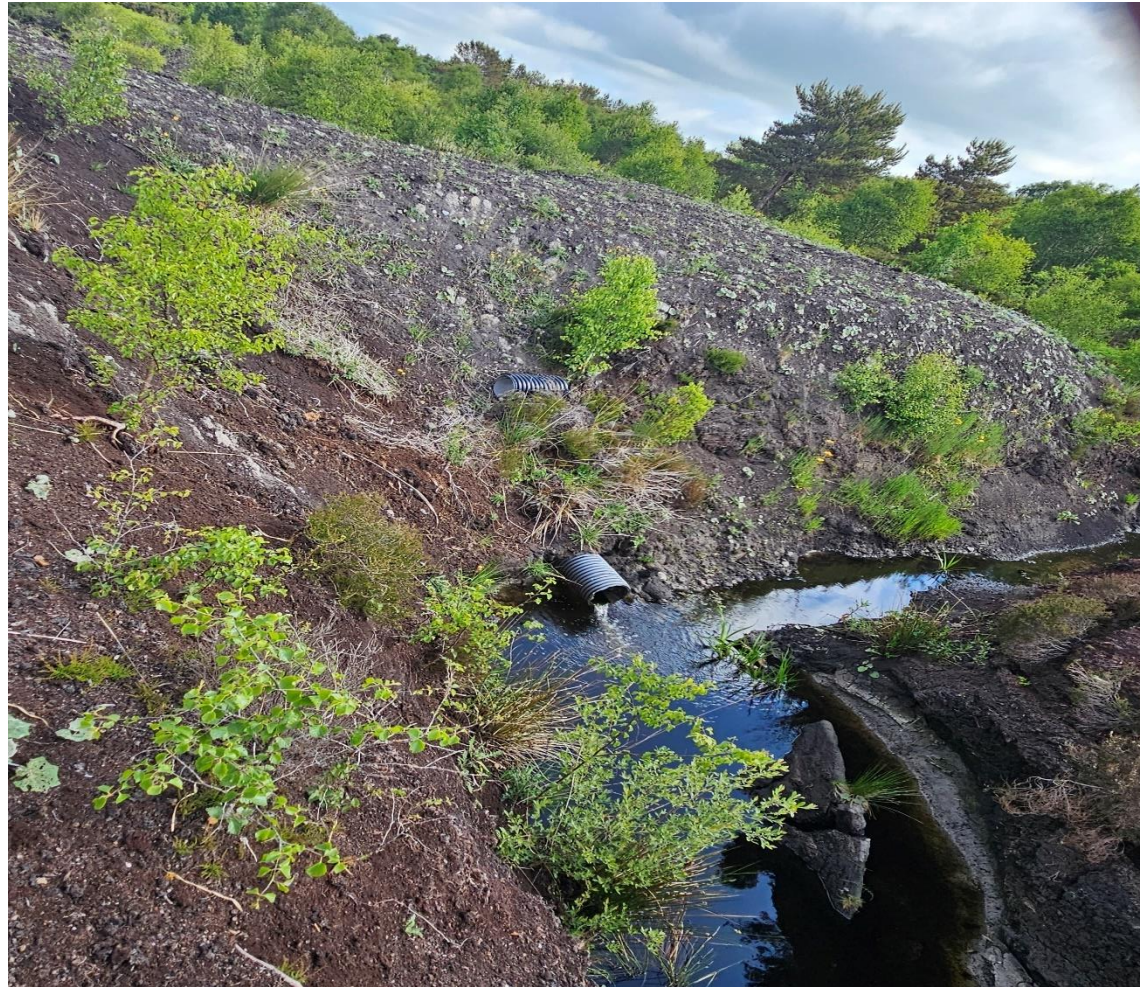
Photo 6: Discharge noted from one of the sediment ponds on the Eastern boundary.
