# SITE VISIT REPORT

**Purpose of Site Visit:** Peat Extraction in Co Longford

**Site Address:** Derrymore, Co Longford

**Date of Visit:** 22/05/2025

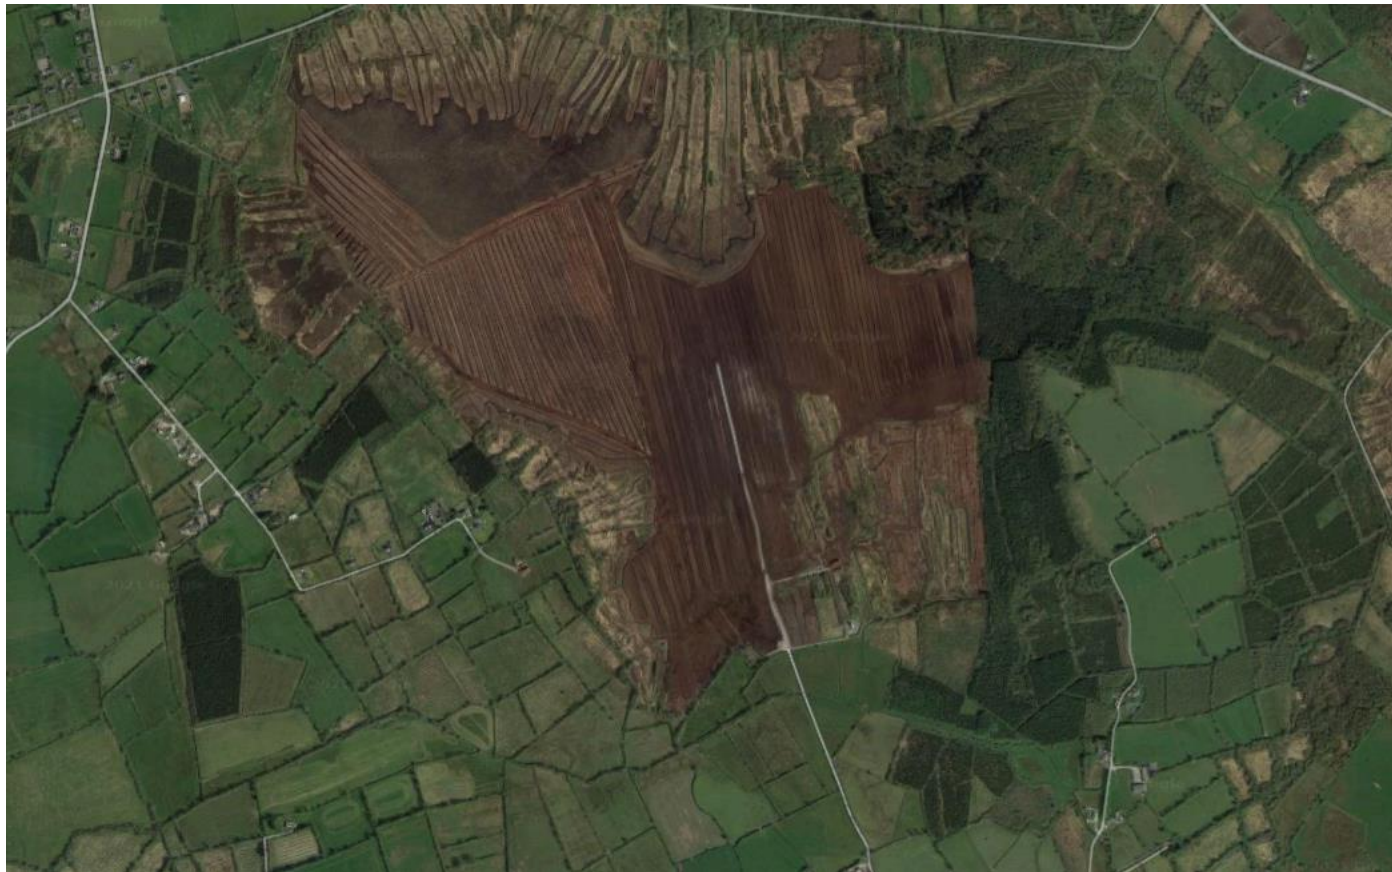
**Figure 2 – Overview of the peatland.**

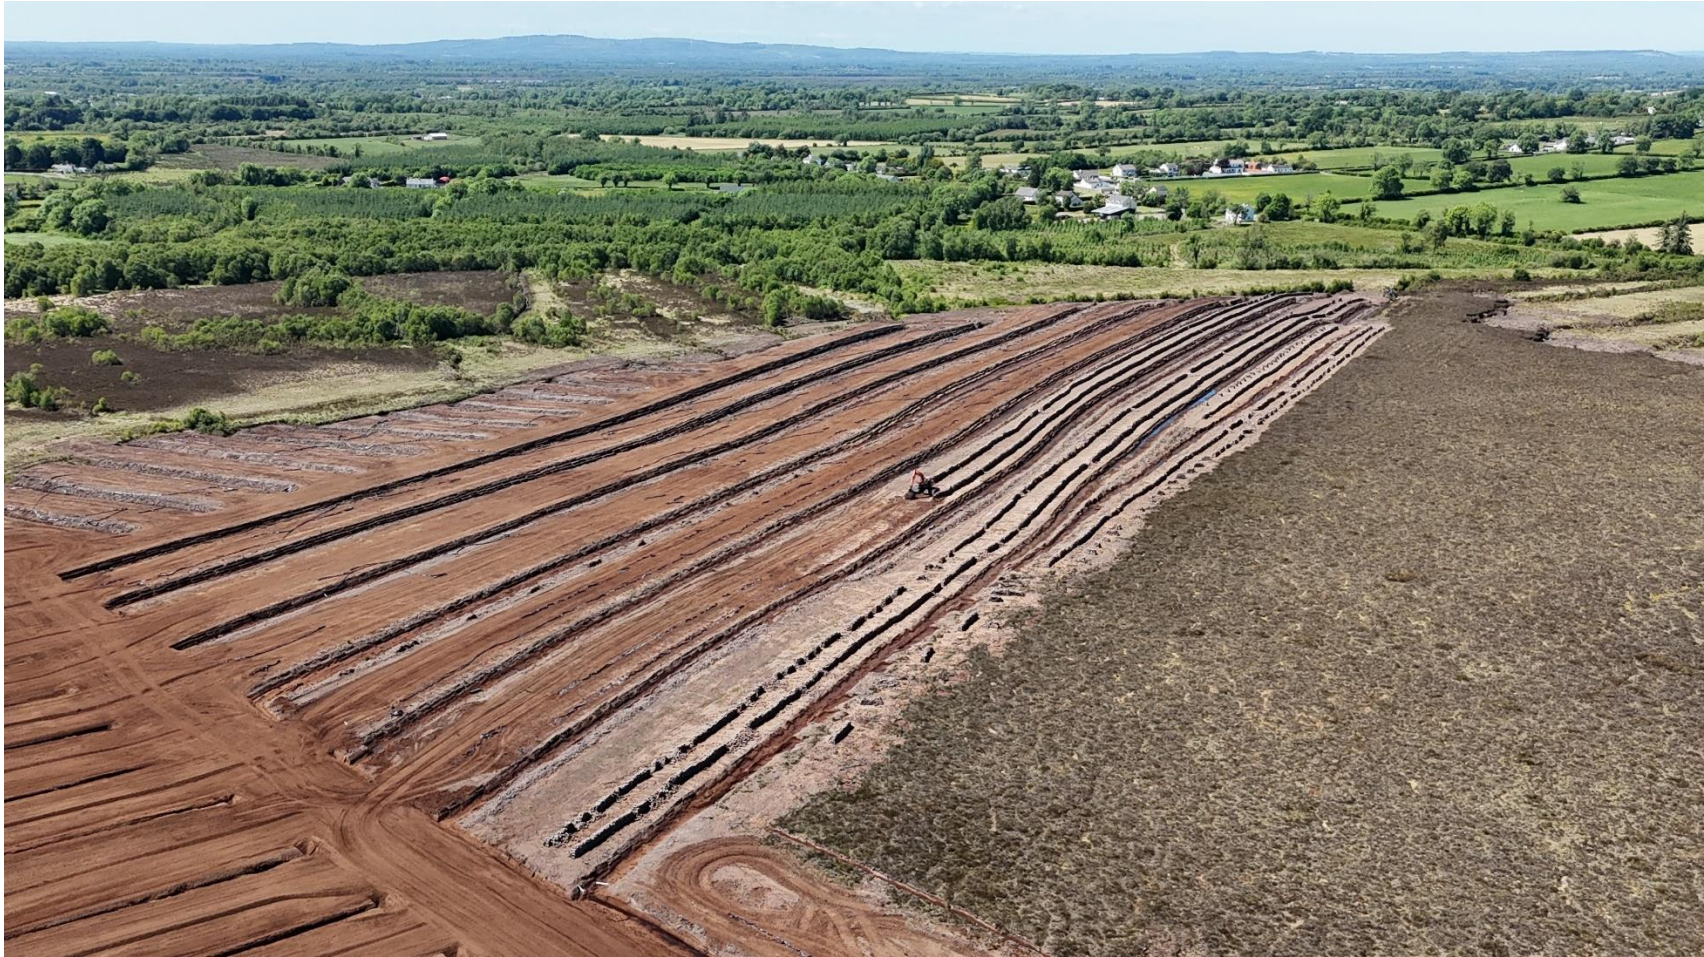
**Photo 1: Excavator parked at the ‘Large sod peat’ area of the north/north western section of the peatland. Note some large sod peat had been removed since the previous Agency visit.**

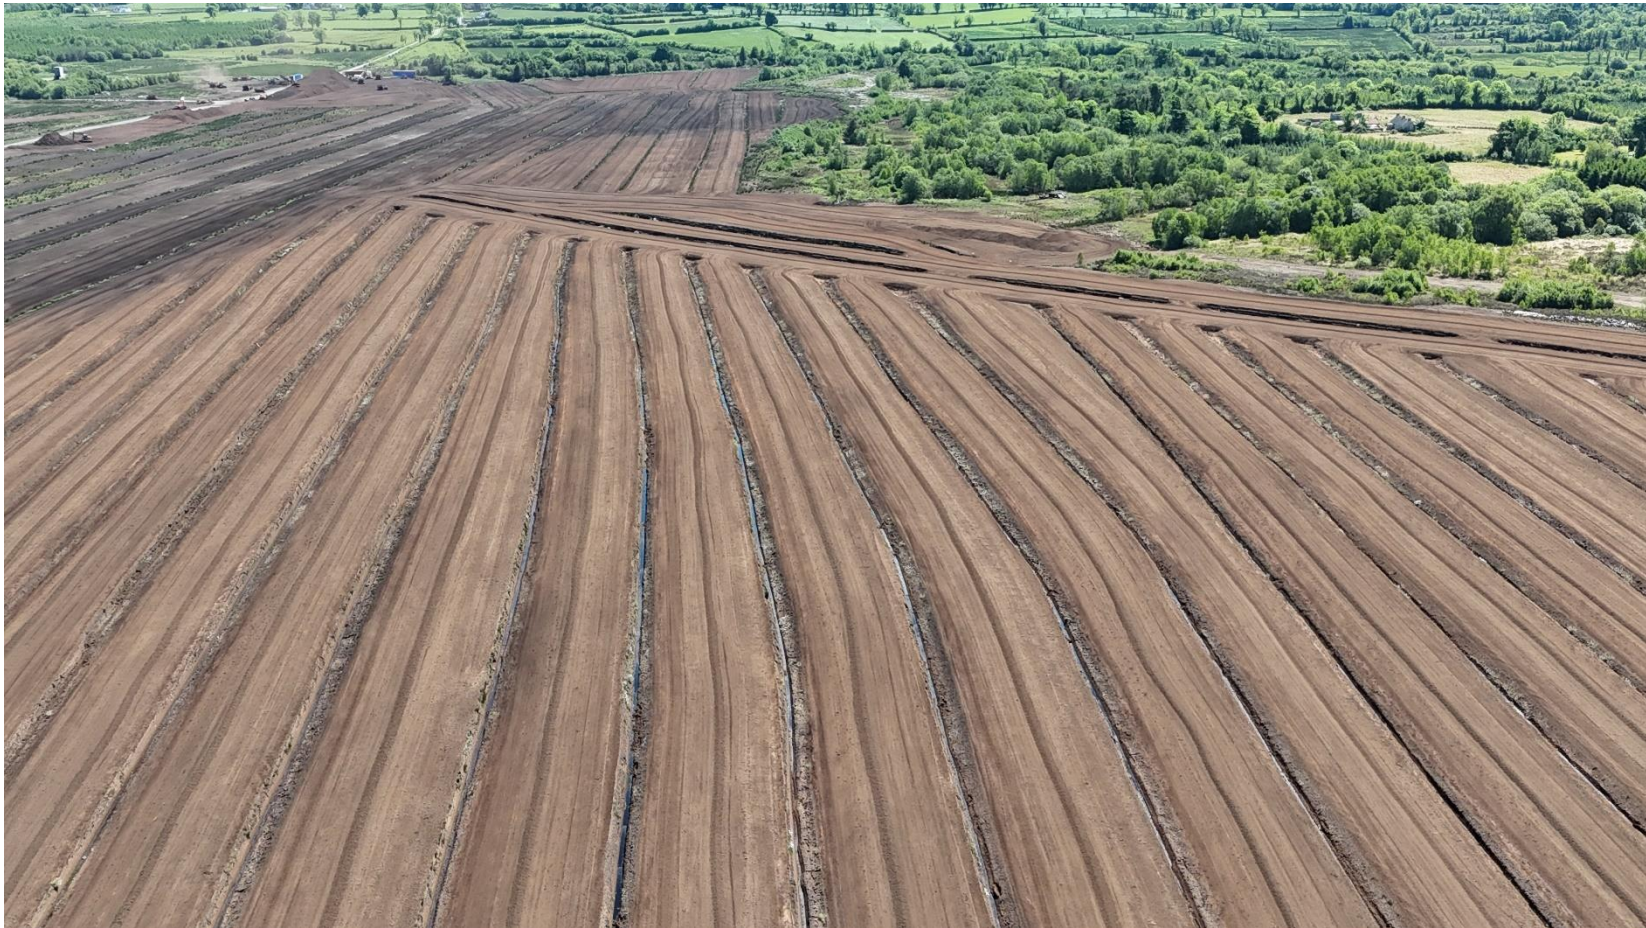
**Photo 2: Milled peat which was ‘ridged’ and awaiting collection from the peatland.**

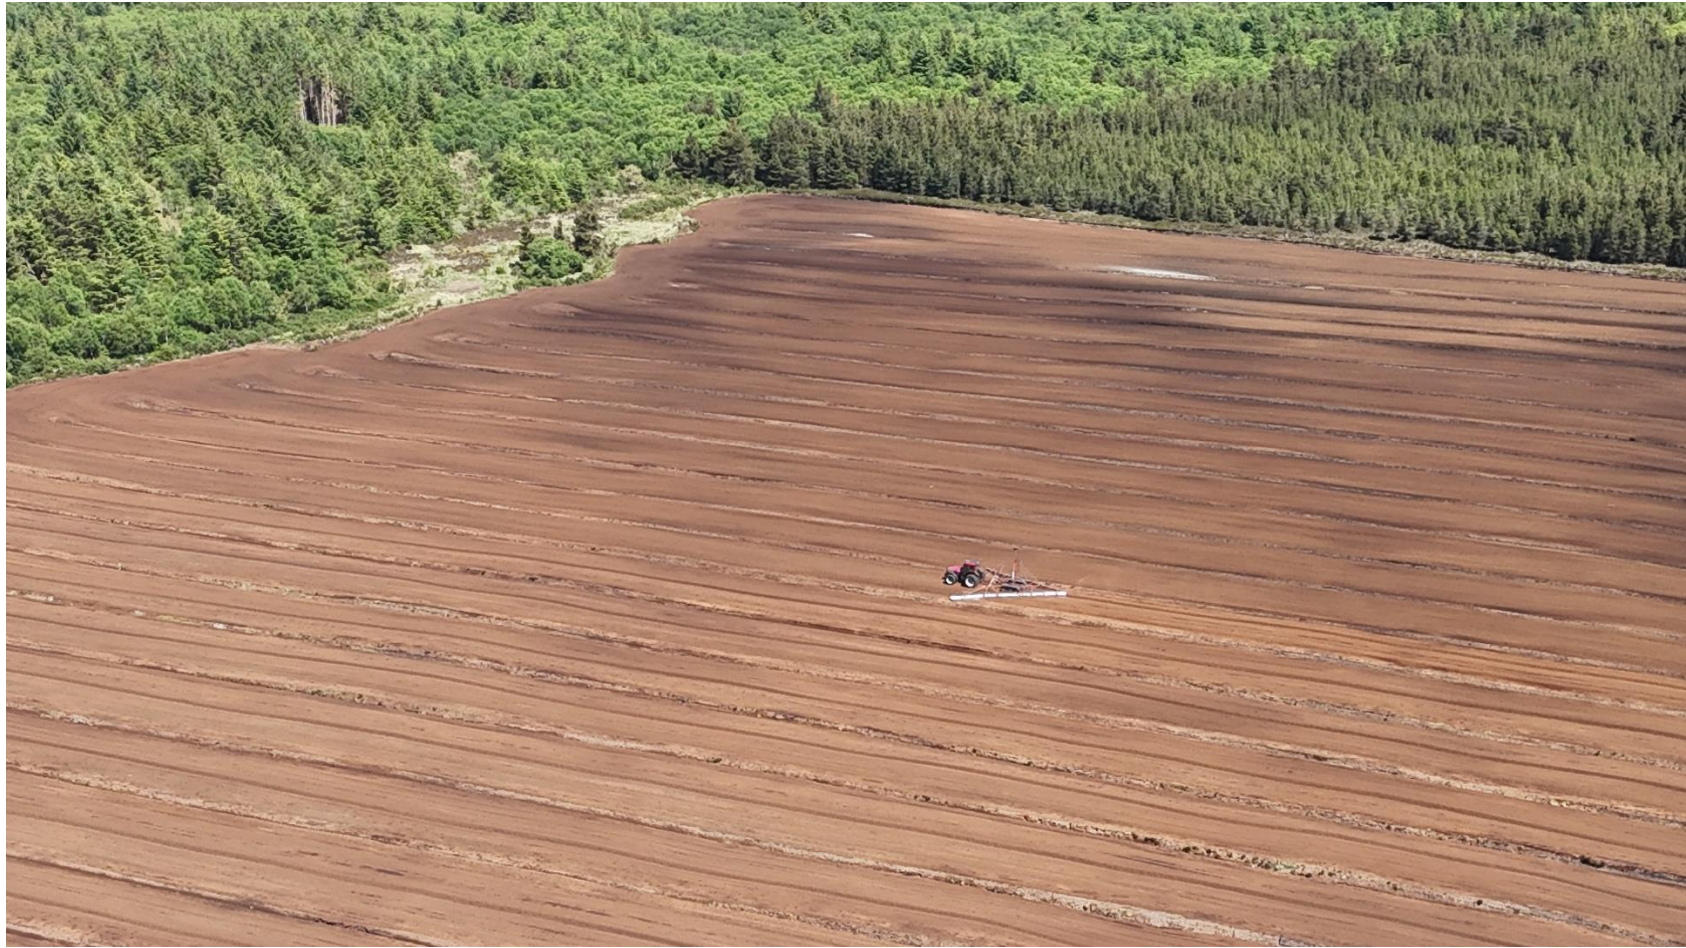
**Photo 3: The ‘ridging’ of milled peat which was ongoing during the visit.**

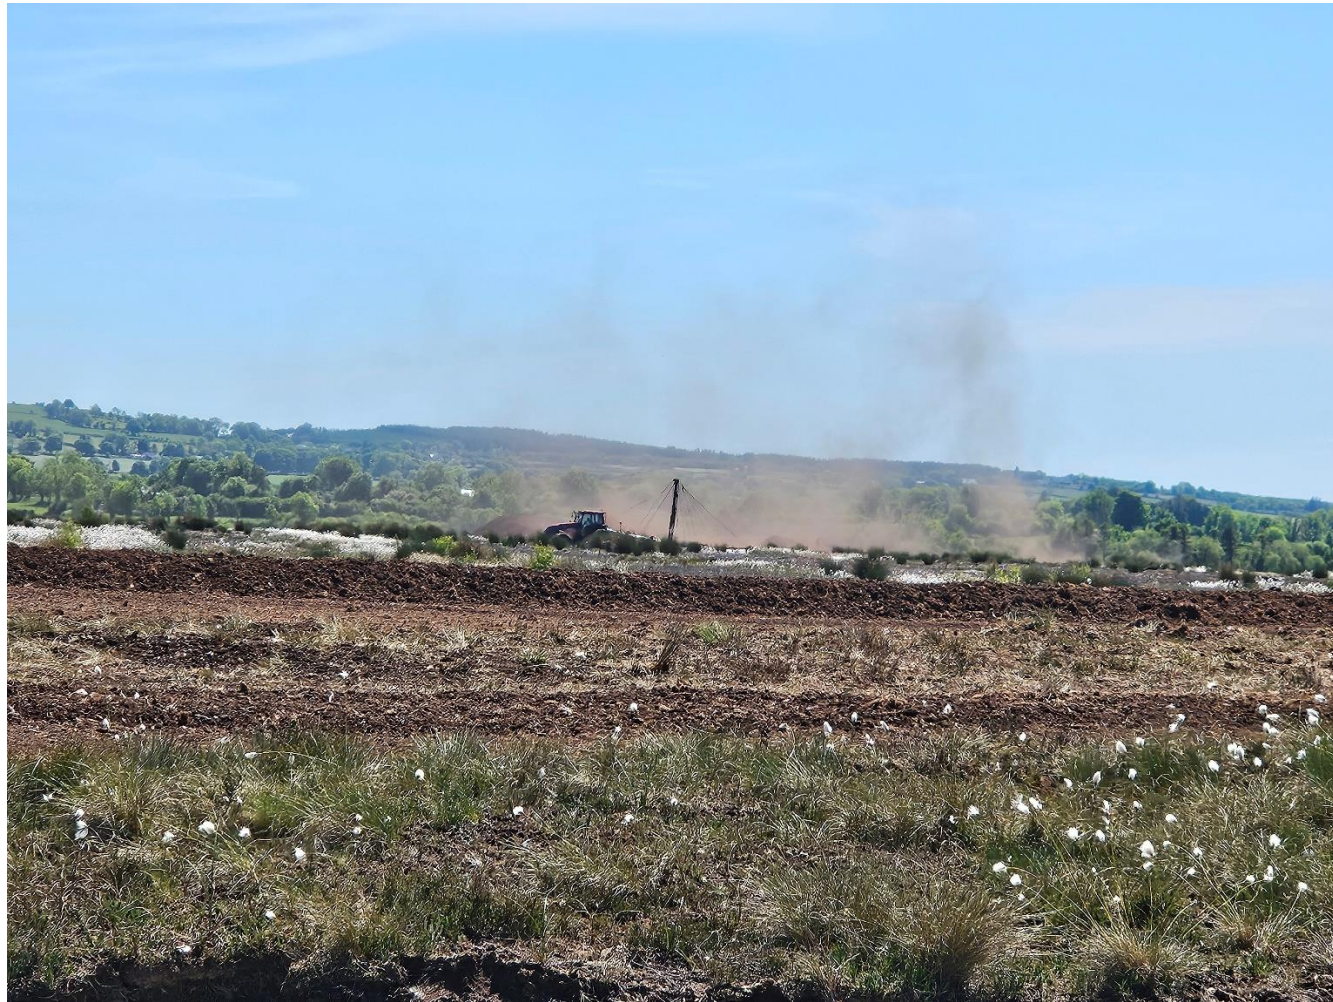
**Photo 4: Significant dust emissions noted from the ‘ridging’ of milled peat.**

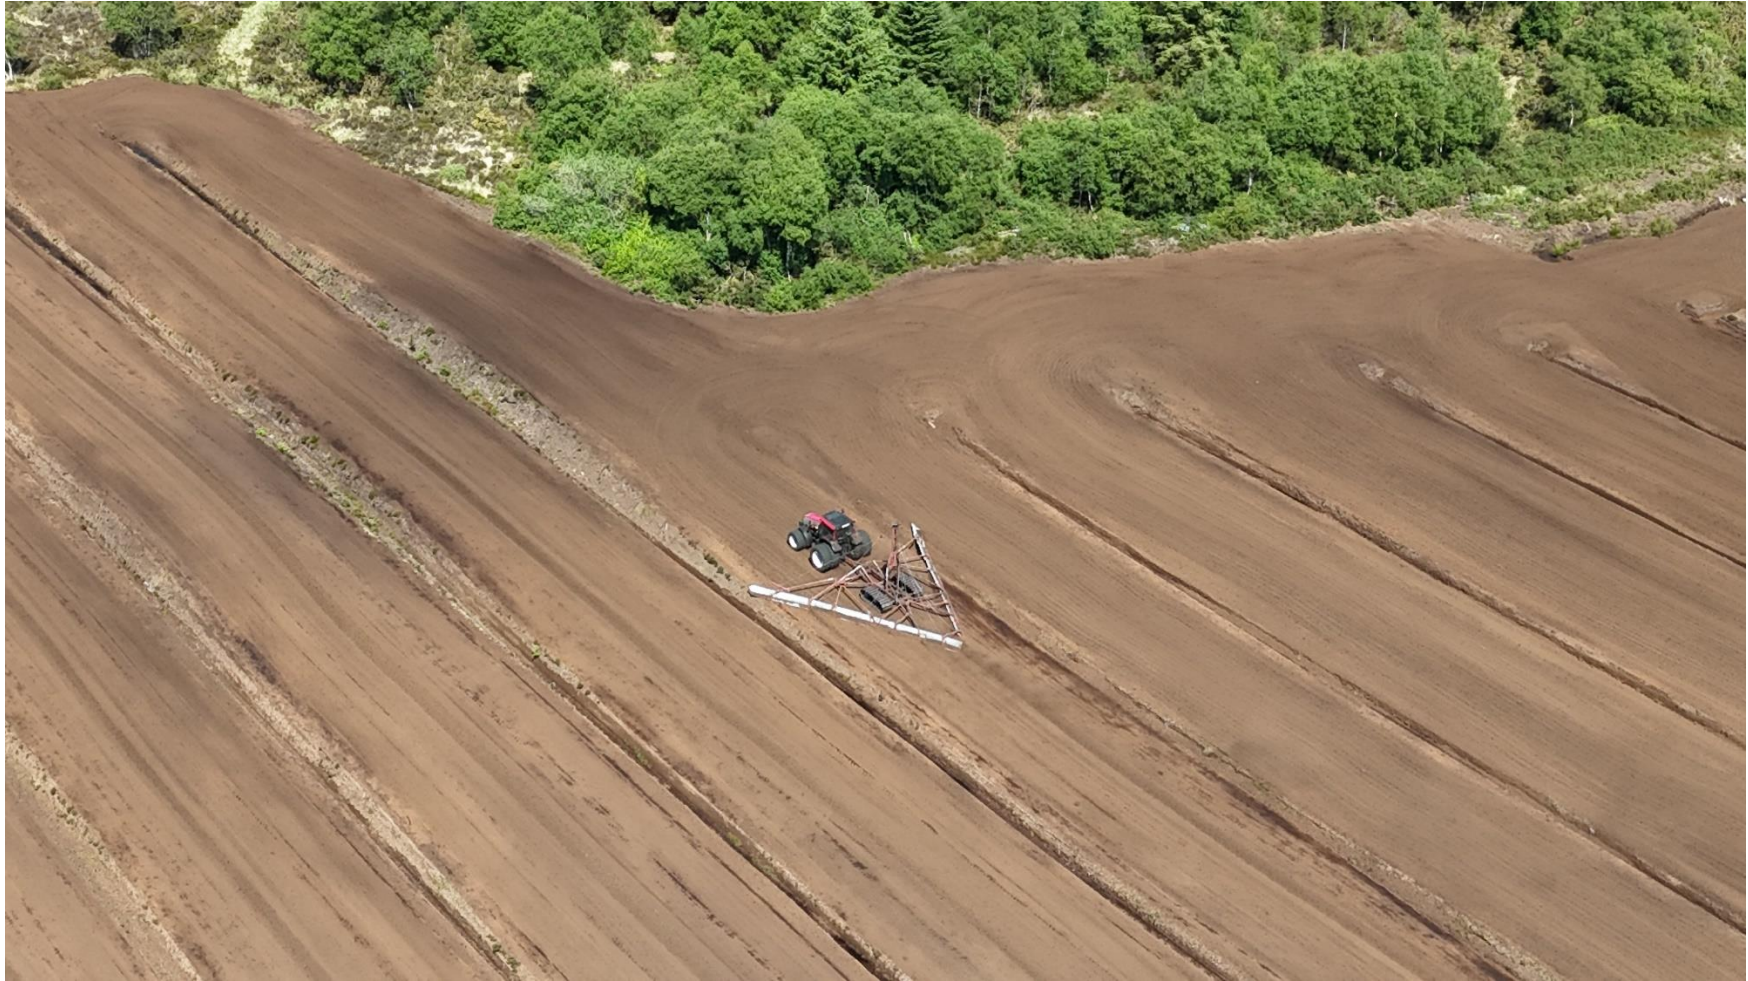
**Photo 5: The ‘ridging’ of milled peat which was ongoing during the visit.**

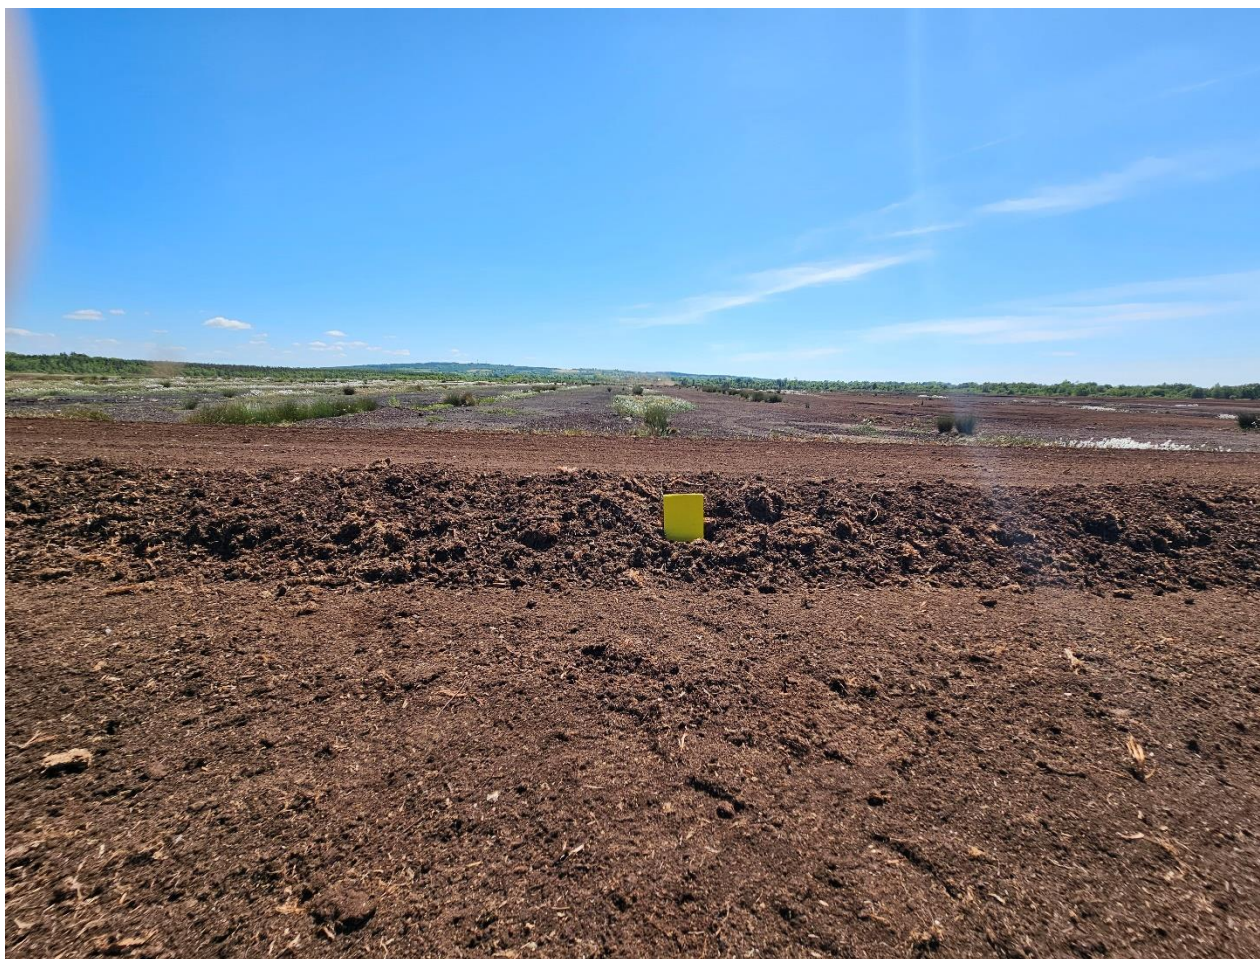
**Photo 6: Photo showing the ‘ridged’ milled peat on the peatland.**

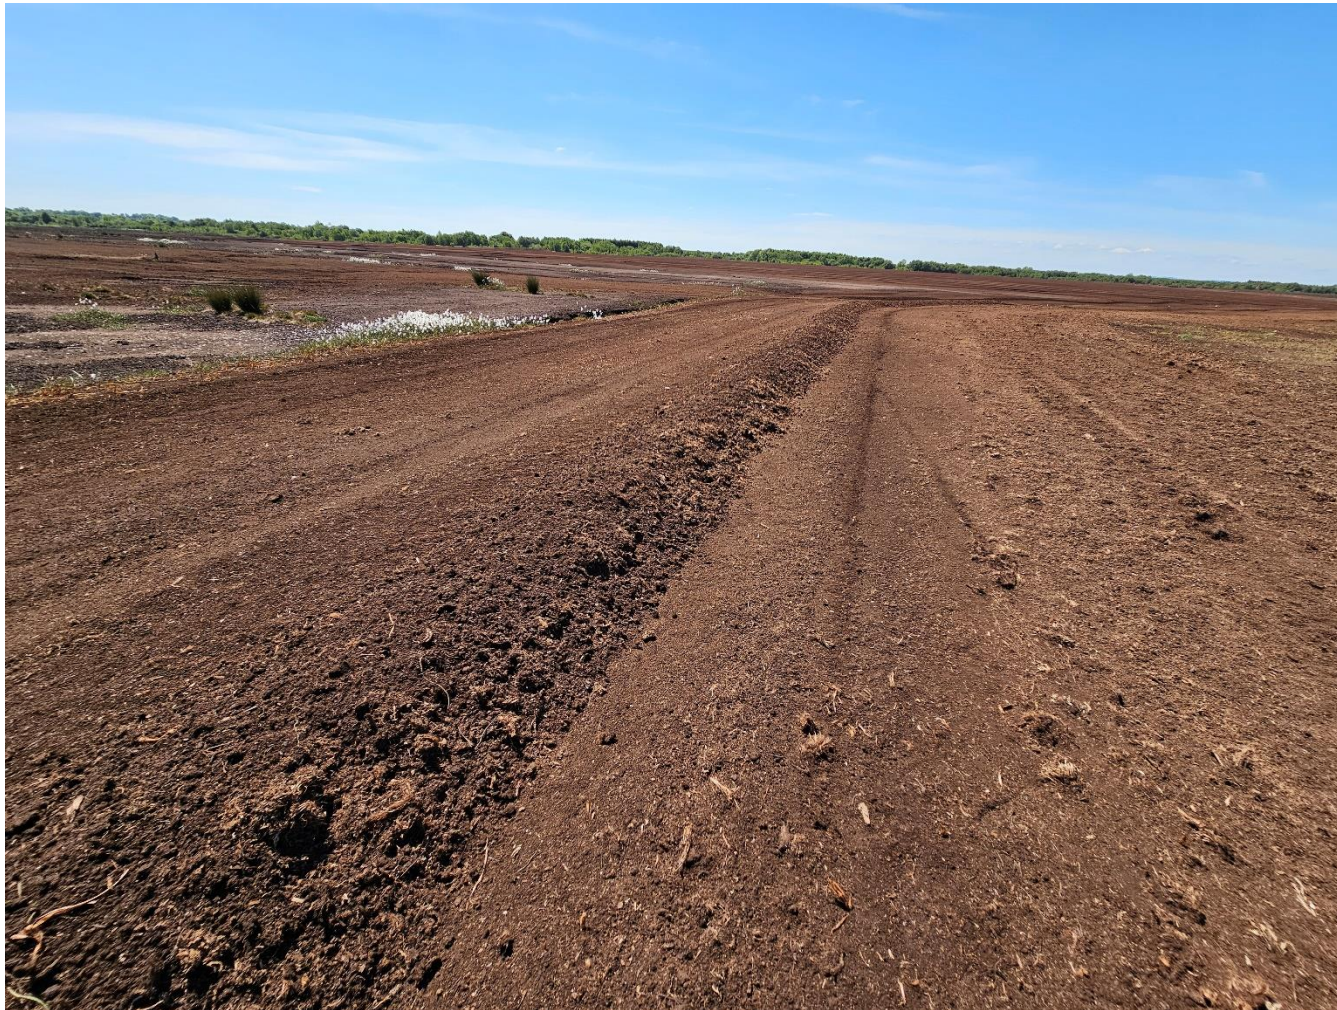
**Photo 7: Photo showing the ‘ridged’ milled peat on the peatland.**

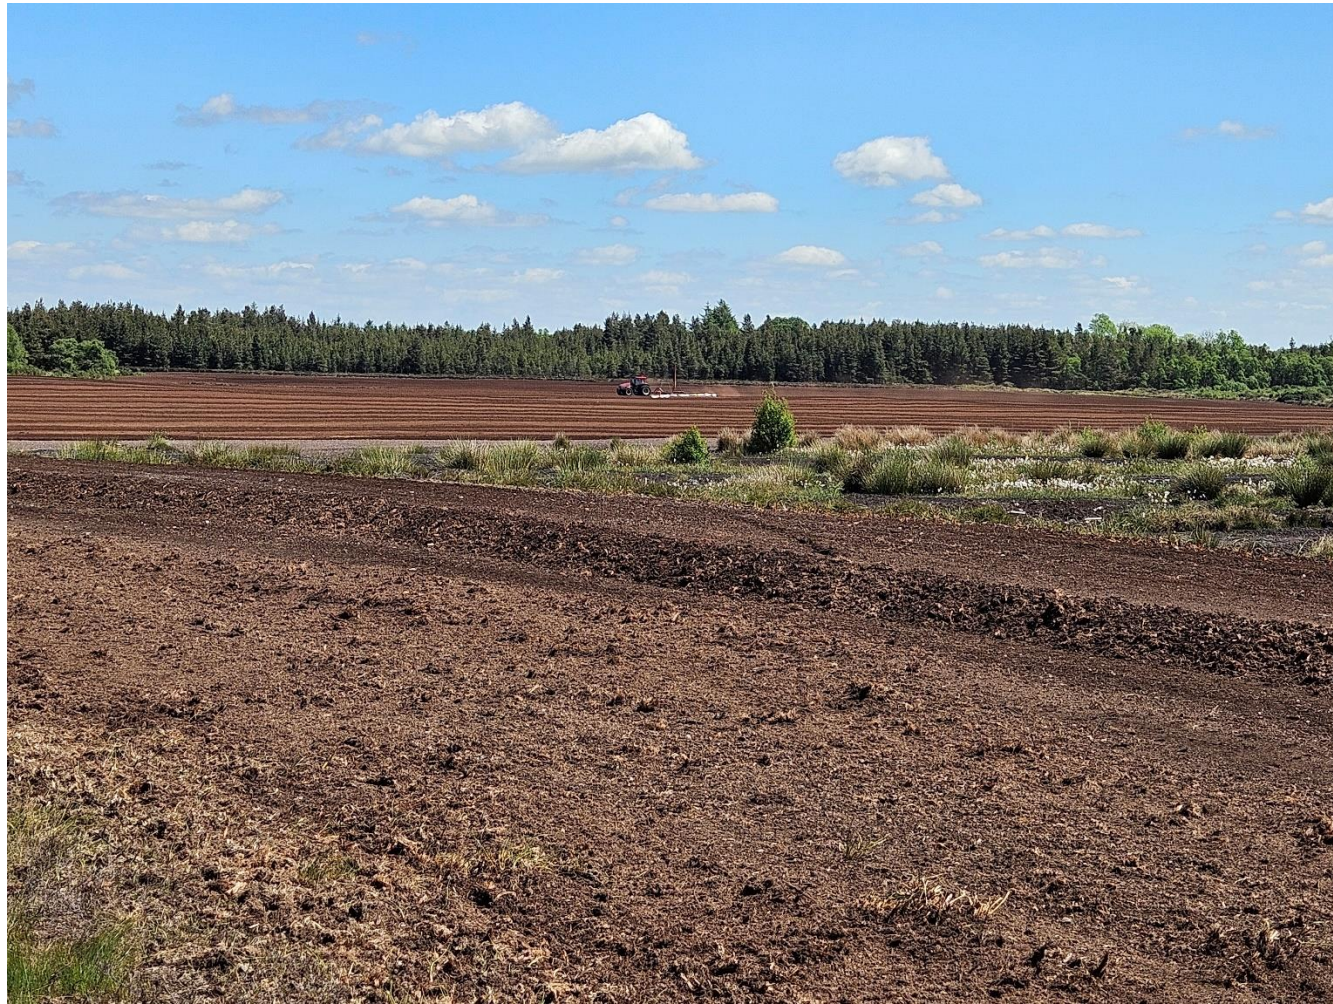
**Photo 8: The ‘ridging’ of milled peat which was ongoing during the visit.**

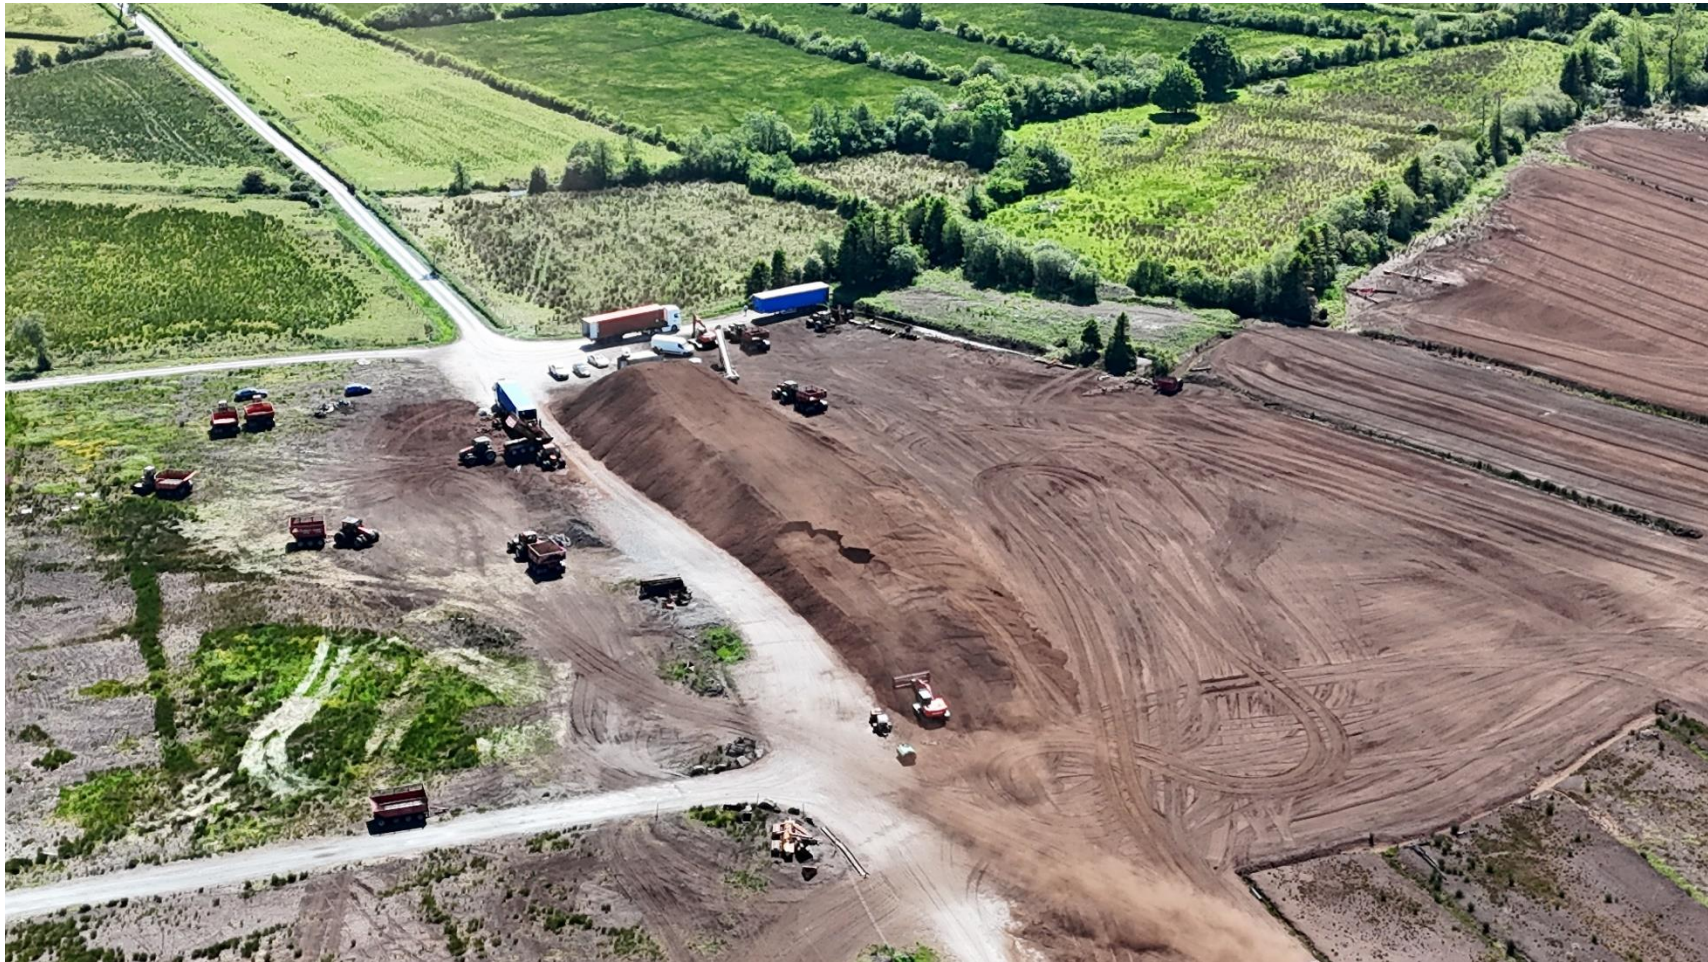
**Photo 9: Photo showing one of the stockpiles of milled peat at the loading area which was noted to have got significantly bigger since the Agency's previous visits. Also note the presence of articulated vehicles.**

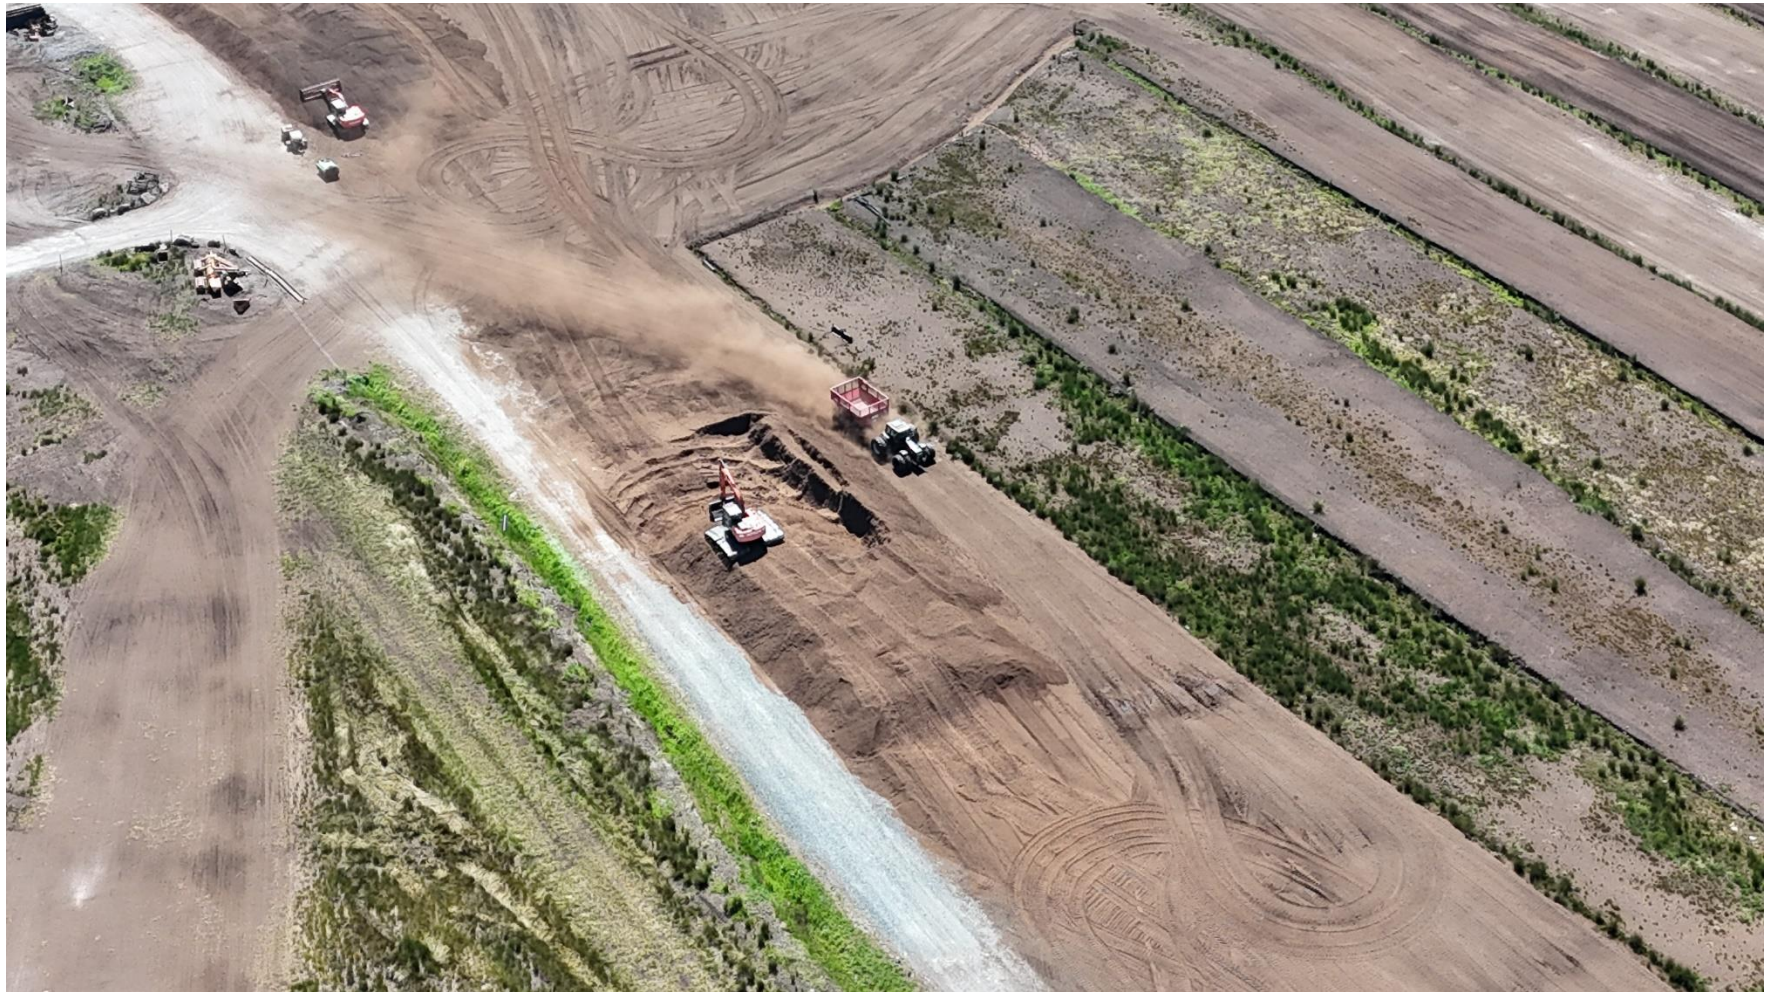
**Photo 10: A second stockpile of milled peat noted at the loading area. Note also significant dust emissions arising from the movement of machinery.**

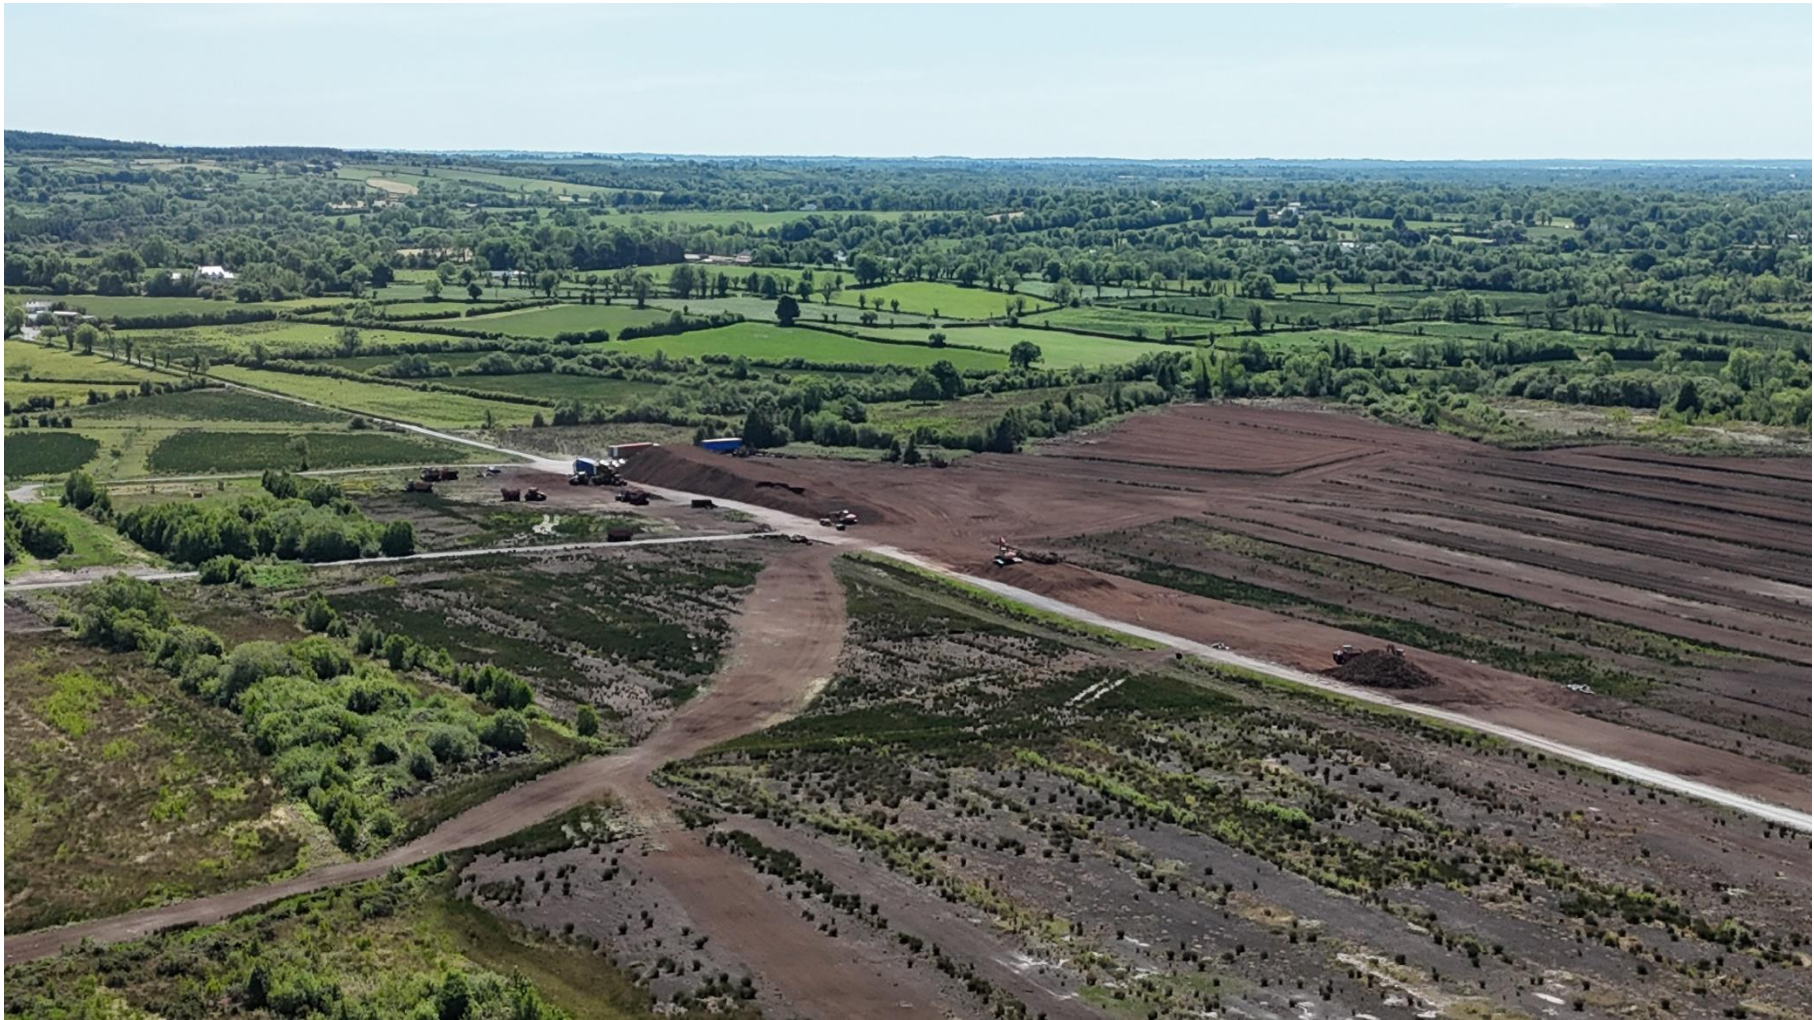
**Photo 11: General overview of the loading area showing the two stockpiles of milled peat and a stockpile of large sod peat.**
