Archaeological assessment has been undertaken by Aegis Archaeology Ltd. for the site of the proposed treatment plant and all on-shore pipeline corridors. ADCO Ltd. has been contracted to carry out archaeological survey of the works corridor for a 390m long marine pipeline crossing and a c.2.4km long foreshore pipeline (Figure 2).

Client
Aegis Archaeology Ltd / Mott MacDonald Pettit
Consultant Engineers
Project
Cork Harbour Lower Drainage Scheme

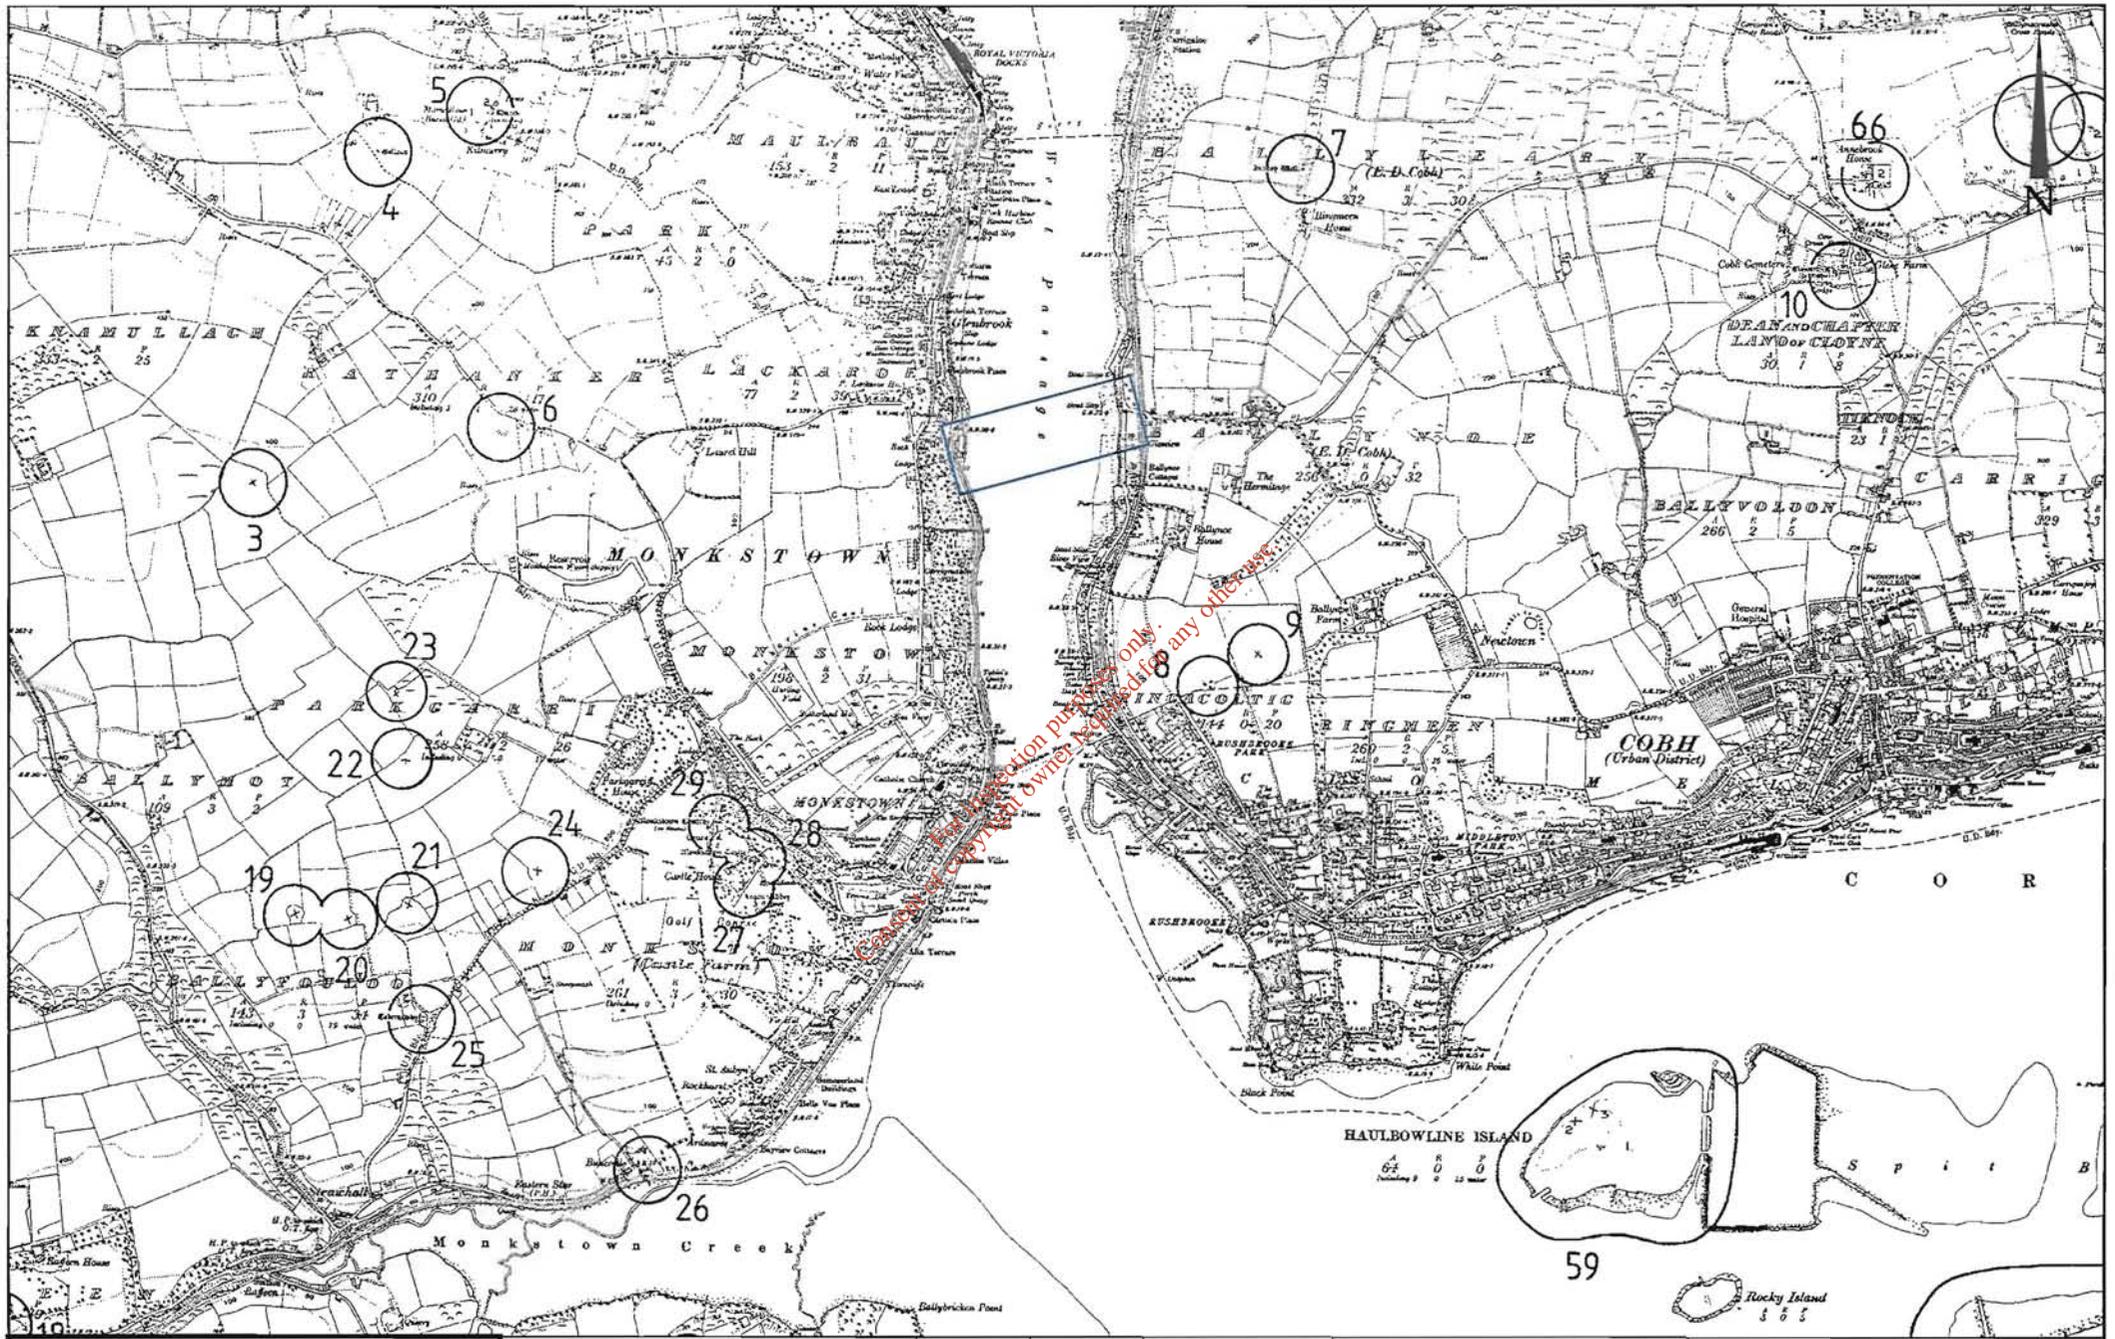
Title
 Figure 3- OS 6" mapping (RMP Sheet CO: 087)
 showing location of listed RMP sites within the
 vicinity of the proposed marine pipeline crossing
 site.

There are no archaeological sites listed in the Record of Monuments and Places for the immediate vicinity of the Marine Pipeline Crossing, the nearest sites lying 900m to the southeast of the proposed impact area; CO087:008: Possible Ringfort, and CO087:009: Graveyard (Figure 3). However, the history of maritime activity within this area is well established; an activity that is further attested to by the number of vessels listed in the Shipwreck Inventory for this stretch of coastline (Appendix 1)³.
