**ARRABAWN CO-OPERATIVE CREAMERY, NENAGH,
COUNTY TIPPERARY**

**BIOLOGICAL ASSESSMENT OF SURFACE WATER
QUALITY**

July 2018

Client:	Arrabawn Co-Operative Creamery
Project	Biological monitoring of water quality in the vicinity of Arrabawn Co-Operative Creamery, Nenagh, Co. Tipperary
Report No:	18106/F
Date	08/08/18
Status	Final
Prepared by	Helena Twomey BA(Mod) , PhD
Reviewed by	Bill Quirke BSc, MSc, MCIEEM

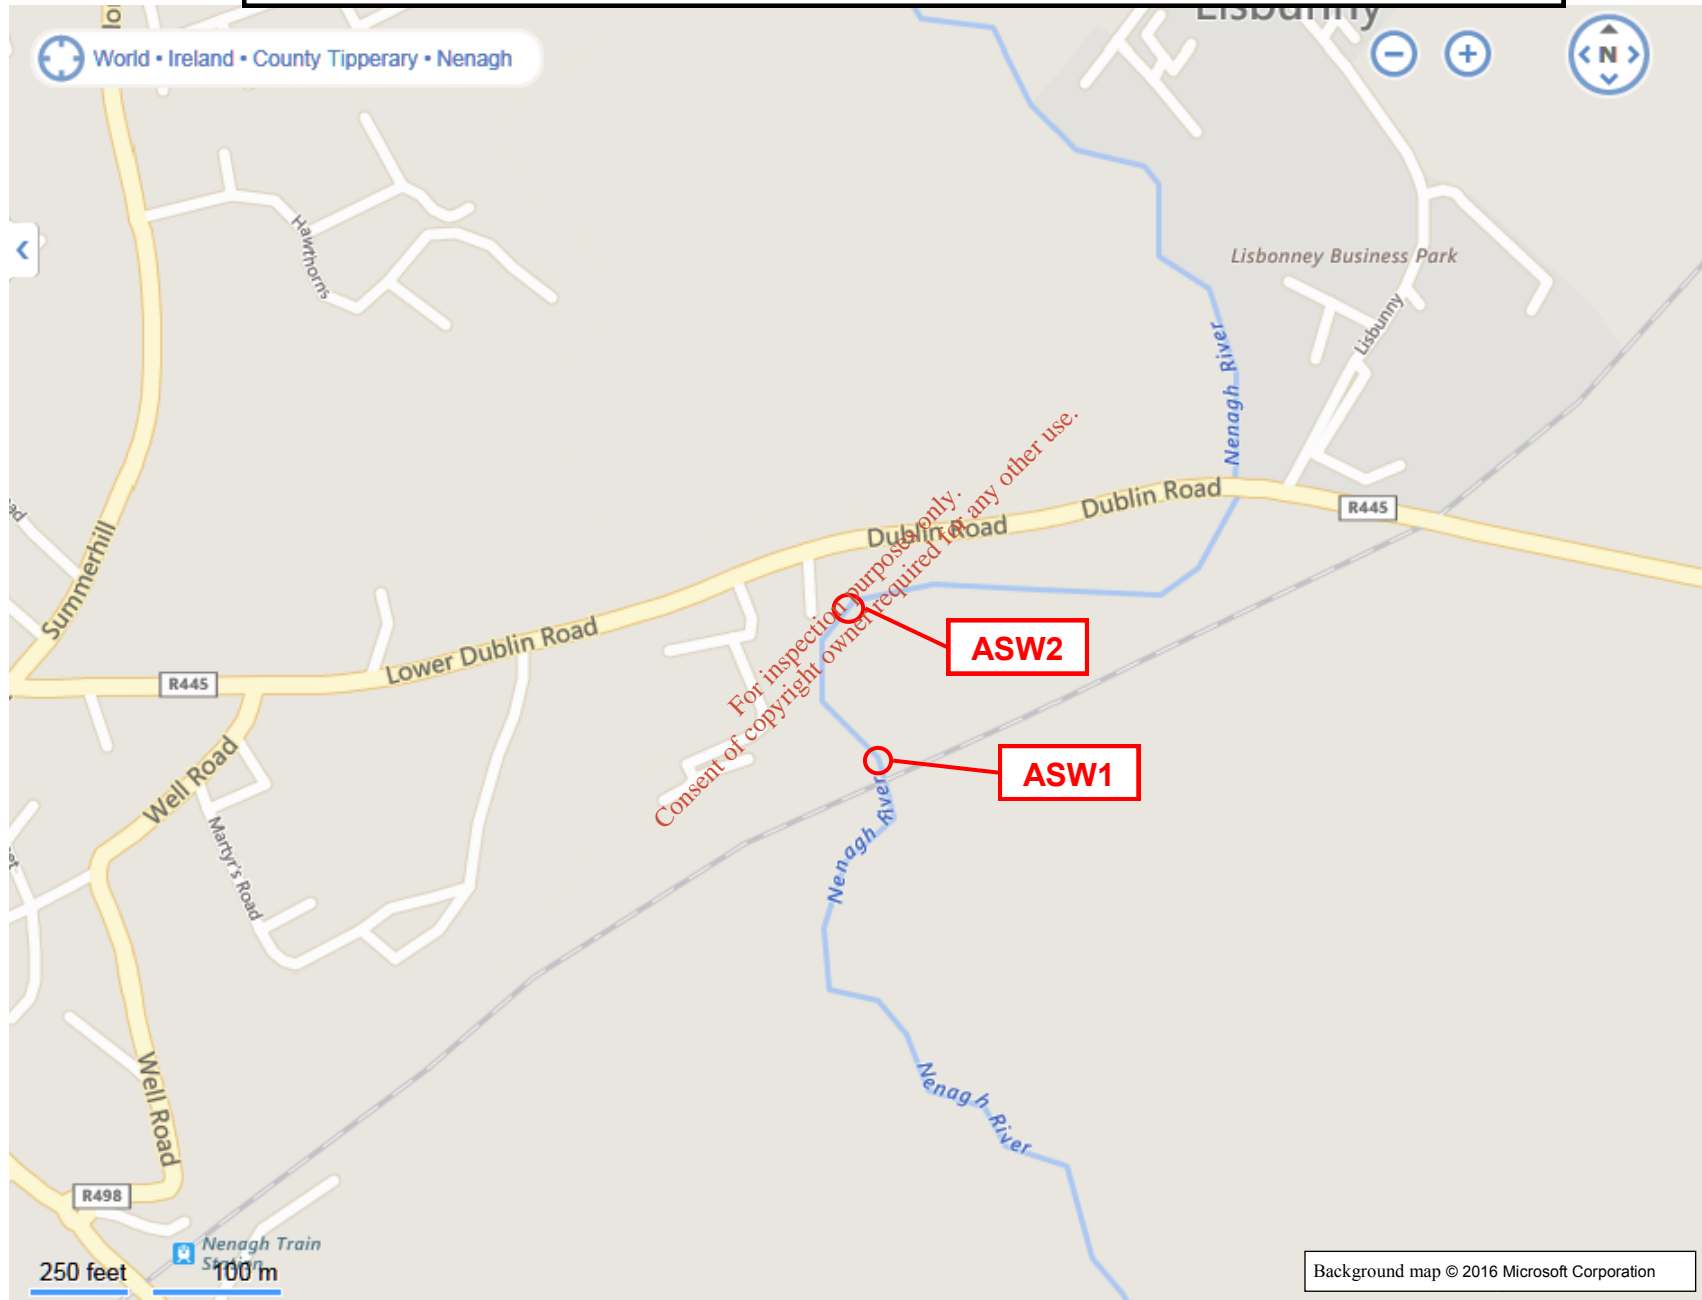
MAP 1 LOCATION OF BIOLOGICAL ASSESSMENT SITES
Locations shown are approximate; for exact locations, see Grid References in text

The location of the sites is shown on Map 1.

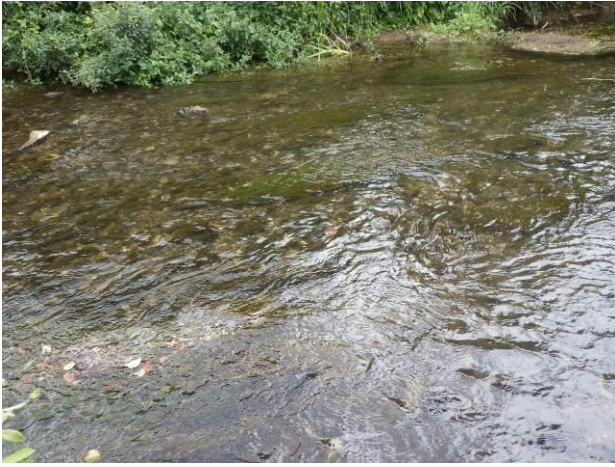
Grid Reference	R 87433 79197		
Site Photograph

The invertebrate community tabulated below merits a Q-rating of Q4 indicating unpolluted conditions and Good ecological quality, an improvement compared with Q3-4 in 2017.

Width (m)	9	Depth (cm)	10-15
DO (% sat)	109	DO (mg/l)	9.6
pH	7.2	Conductivity	507
Temperature °C	17.4	Water clarity	Clear
Substrate (in order of dominance)	1. Cobble 2. Gravel 3. Sand		
Flow Type	Riffle 80% Glide 20%		
Instream Vegetation	Bryophytes 10% Filamentous algae 25% <i>Ranunculus sp.</i> 10% <i>Phalaris arundinacea</i> <1%		
Dominant Bankside Vegetation	Willow, Alder, Elder, Willowherb		
Estimated % Summer Shade of Stream by Bankside Vegetation	<5		
Salmonid Adult Habitat	Fair		
Salmonid Nursery Habitat	Good		
Salmonid Spawning Habitat	Fair-Good

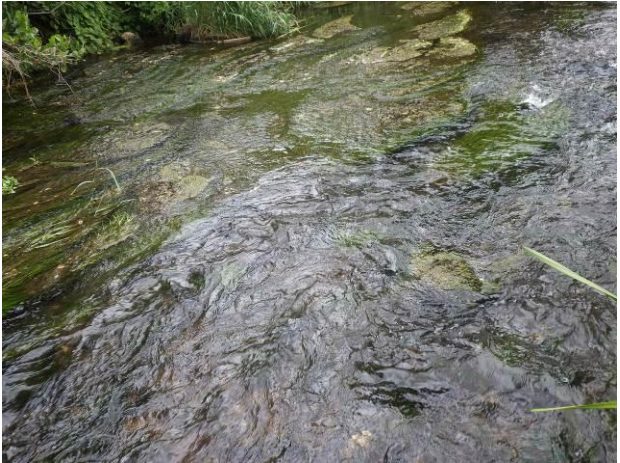
Grid Reference	R 87413 79304		
Site Photograph

The invertebrate community tabulated below merits a Q-rating of Q4 indicating unpolluted conditions and Good ecological quality, an improvement compared with Q3-4 in 2017.

Width (m)	10-12	Depth (cm)	10-20
Temperature °C	17.5	Water clarity	Clear
DO (% sat)		DO (mg/l)	9.5
pH	7.2	Conductivity	667
Substrate (in order of dominance)	<ol style="list-style-type: none"> 1. Cobble 2. Large rocks 3. Gravel 4. Sand 5. Mud 		
Flow Type	Riffle 80% Glide 20%		
Instream Vegetation	Filamentous algae 20% Bryophytes 15% <i>Ranunculus sp.</i> 30%		
Dominant Bankside Vegetation	Alder, <i>Phalaris arundinacea</i> , <i>Sparganium erectum</i> , Nettles		
Estimated % Summer Shade of Stream by Bankside Vegetation	5		
Salmonid Adult Habitat	Good - Fair		
Salmonid Nursery Habitat	Good		
Salmonid Spawning Habitat	Fair
