Kilford Town Closed Landfill.

Introduction

Below is a worked example of the application of the EPA Code of Practice Matrices to a fictional unregulated closed landfill. This example will show the user how to:

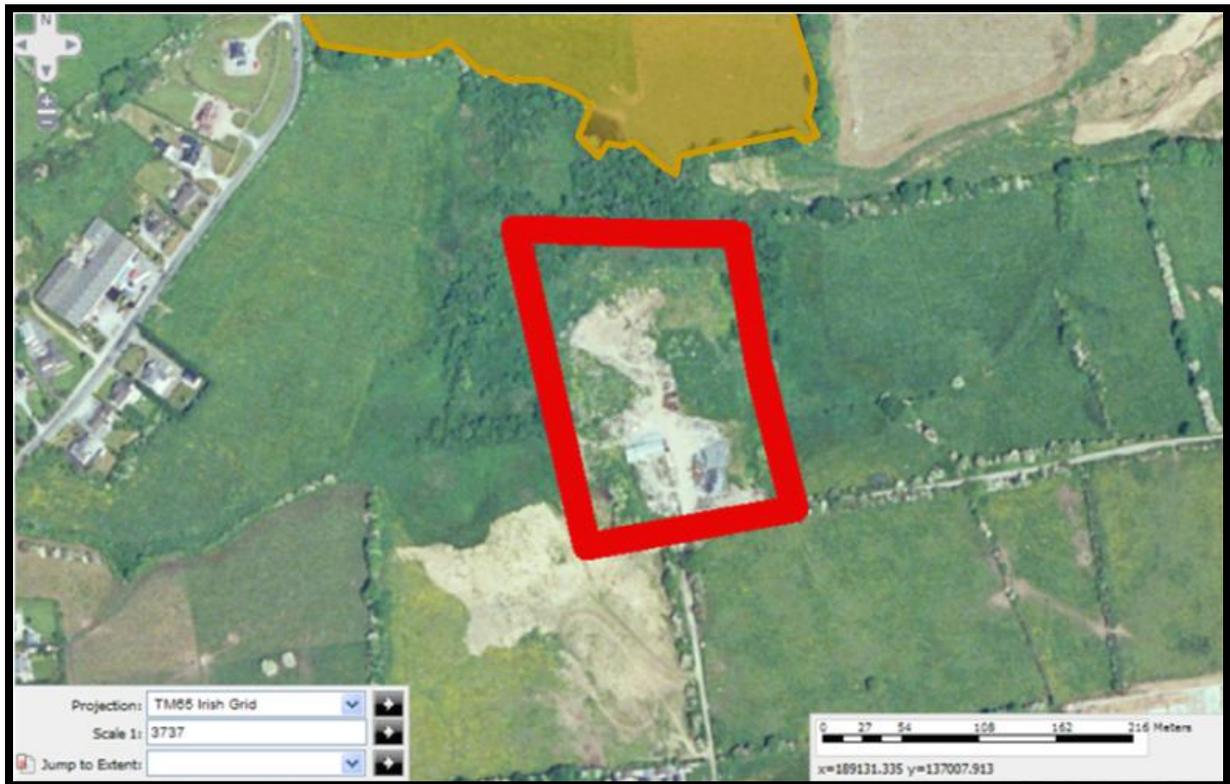
Figure 1. Aerial photograph of the site. Outline of landfill shown in red. Note: residential areas to the west and south. Presence of a SAC to the north, shown in beige.

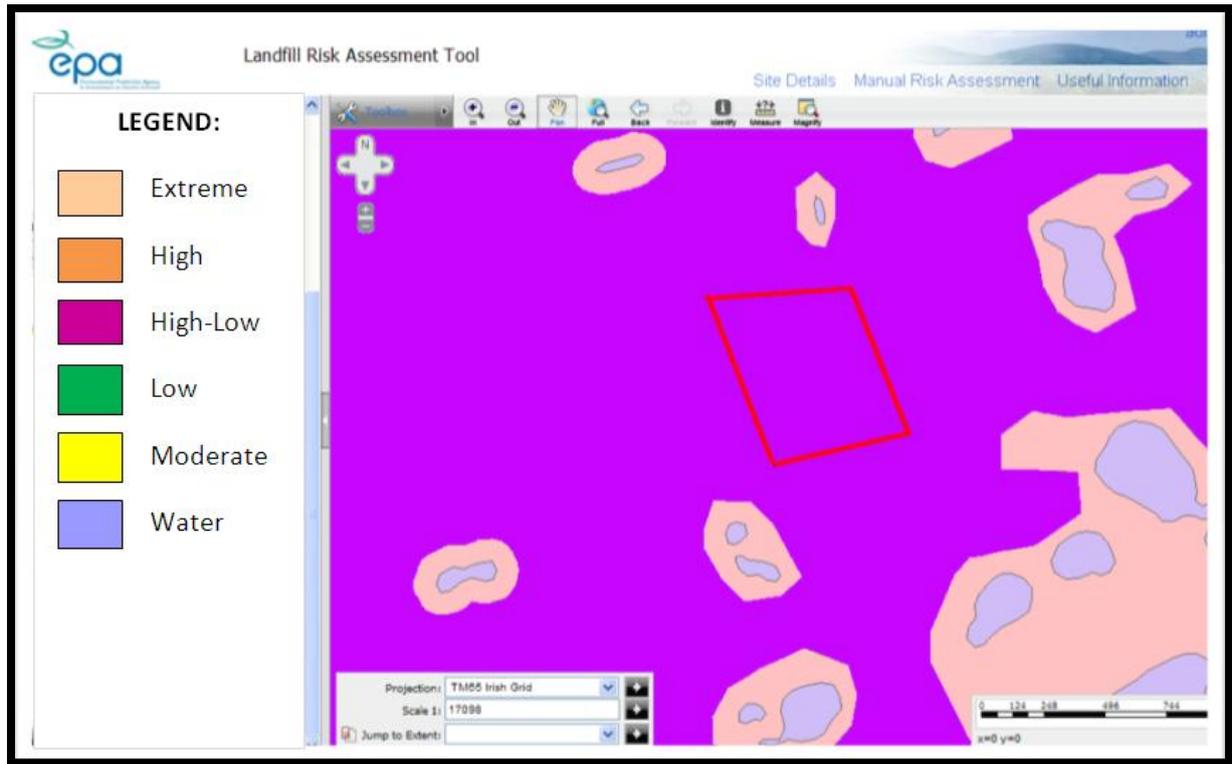
Figure 2. Ground Water Vulnerability. Source: Geological Society of Ireland (GSI, 2005). Outline of landfill shown in red.

Ref:	Pathway	Score	Rational
2a	Groundwater vulnerability	2	Regional mapping incomplete, variable H-L given, assumed high therefore score of 2: GSI data. See Figure 2.
2b	Groundwater flow regime	1	Poor Bedrock Aquifer PL: GSI data. See Figure 3.
2c	Surface water and drainage	2	Landfill drainage system connected to marsh area: confirmed by site walk over survey.
2d	Landfill gas lateral migration	1.5	Workers shed on the landfill, subsoil is predominately sandstone till. See Figure 4.
2e	Landfill gas vertical migration	2	Workers shed on the landfill, subsoil is variety of tills: sandstone till, shale till and quartzite till. See Figure 4.

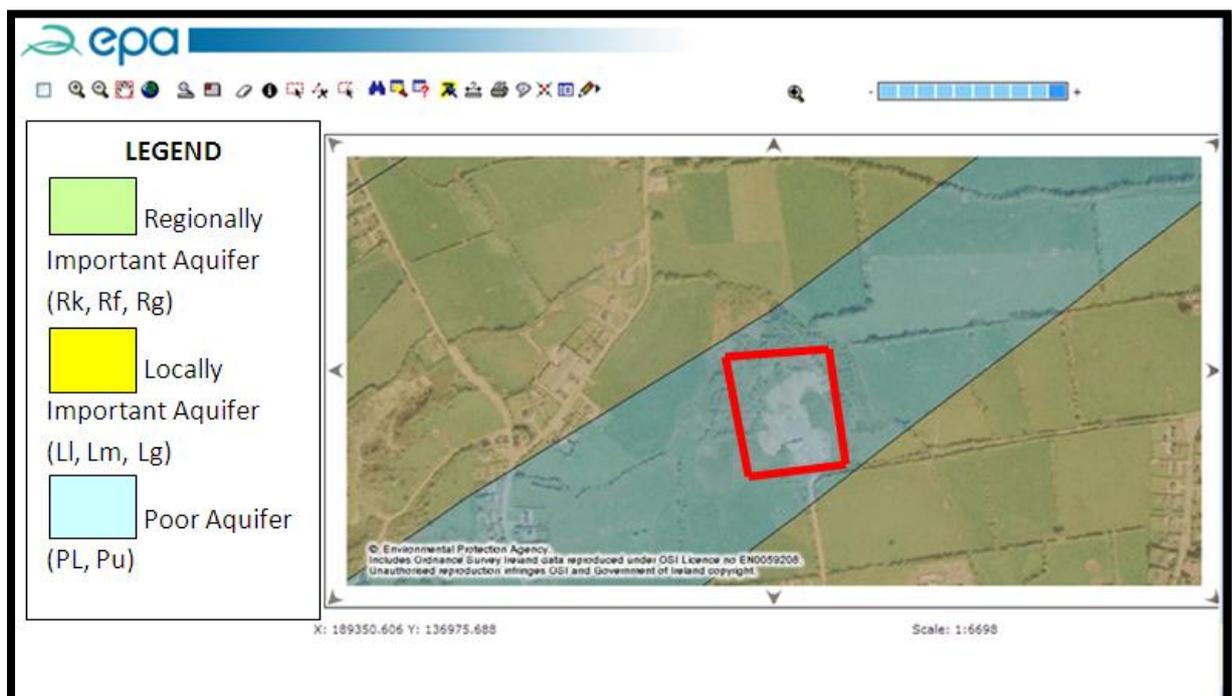
Figure 3. Aquifer Classification. Source: GSI River Basin Districts Management Projects. Outline of landfill shown in red.

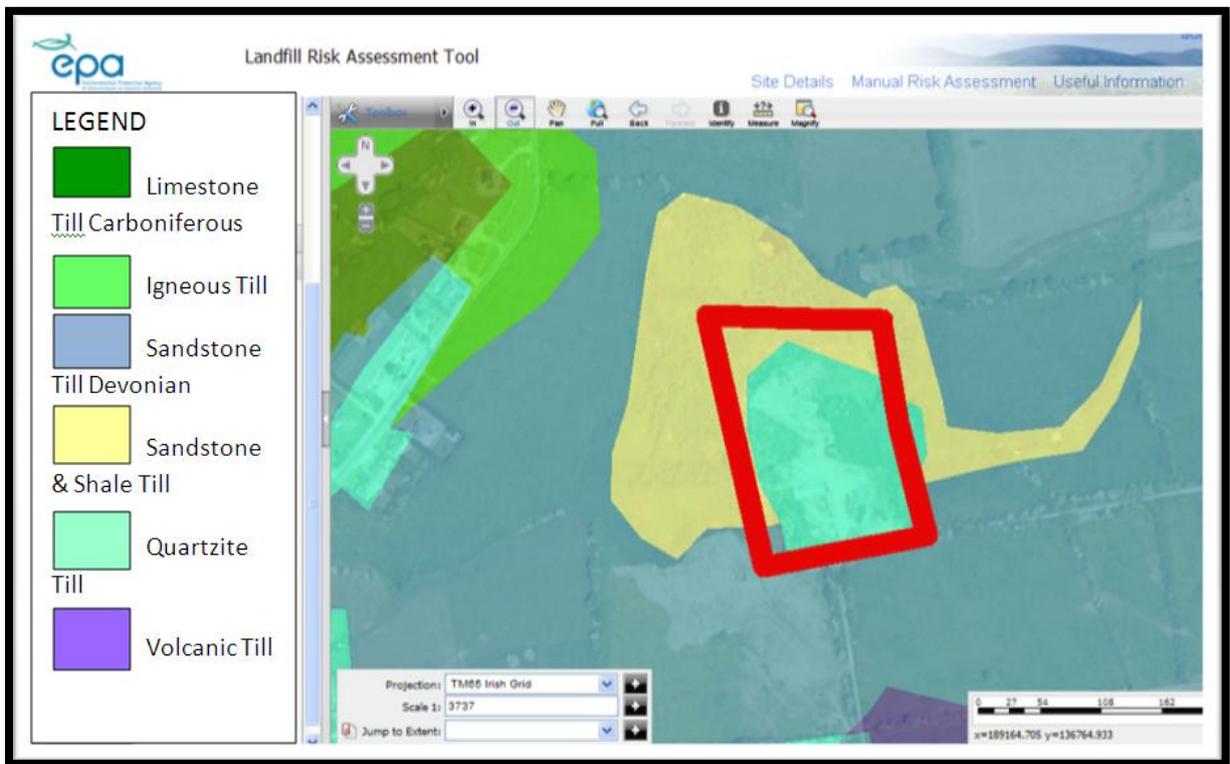
Figure 4. Subsoil Classification. Source: Teagasc Subsoil Map 2006. Outline of landfill shown in red.

The GSI data base should be consulted to see if any groundwater wells have been recorded within one kilometre of the site (see figure 4). A door to door survey should be conducted in the area where there is potential for any existing wells or active abstraction boreholes in the relevant areas.

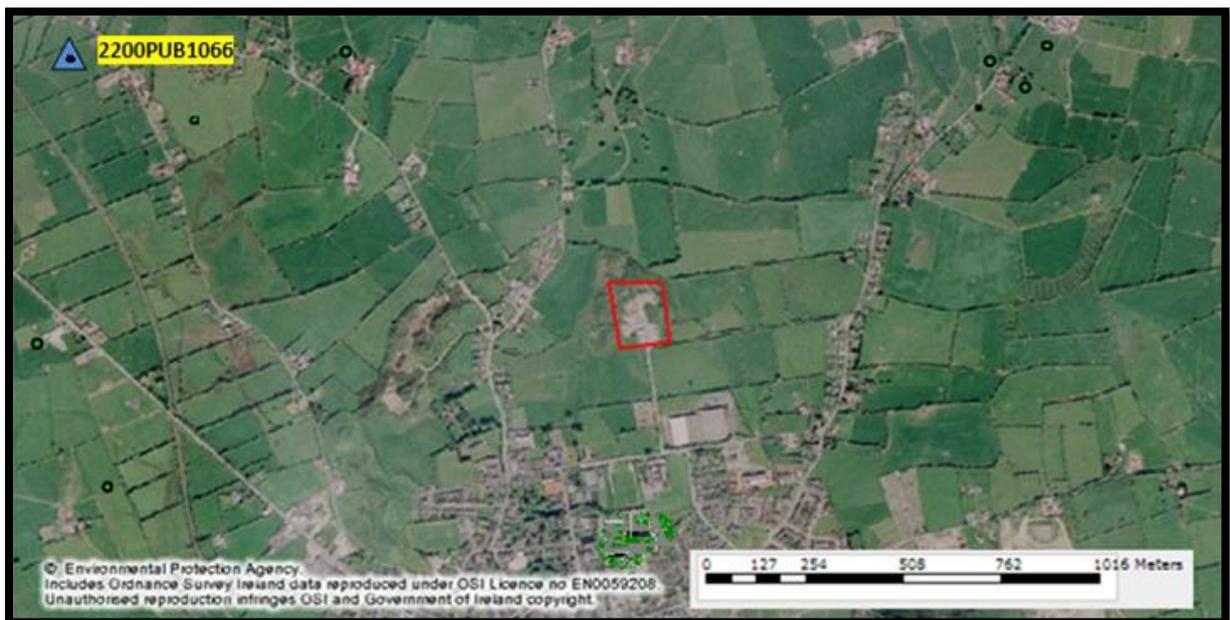
Figure 5. Public Water Supply Search: Council Records. Public water supply shown as a blue triangle. Active drinking water wells are shown as green circles.

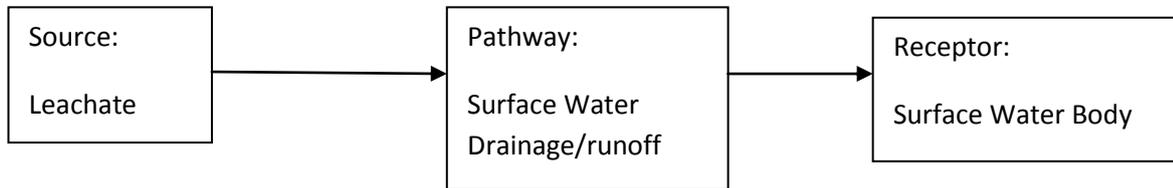
Table 5: Network Diagram for SPR 8

Leachate migration through surface water pathways only					
SPR 8	1a X 2c X 3e	42		70%	A - High Risk
Surface Water Body	7 X 2 X 3	(60)			(≥70%)
SPR 9	1a X 2c X 3b	42		70%	A - High Risk
Protected Area (SWDTE)	7 X 2 X 3	(60)			(≥70%)
Landfill gas migration pathways

Overall site Risk Classification is high for SPR 8 and SPR 9 and low for all other linkages.

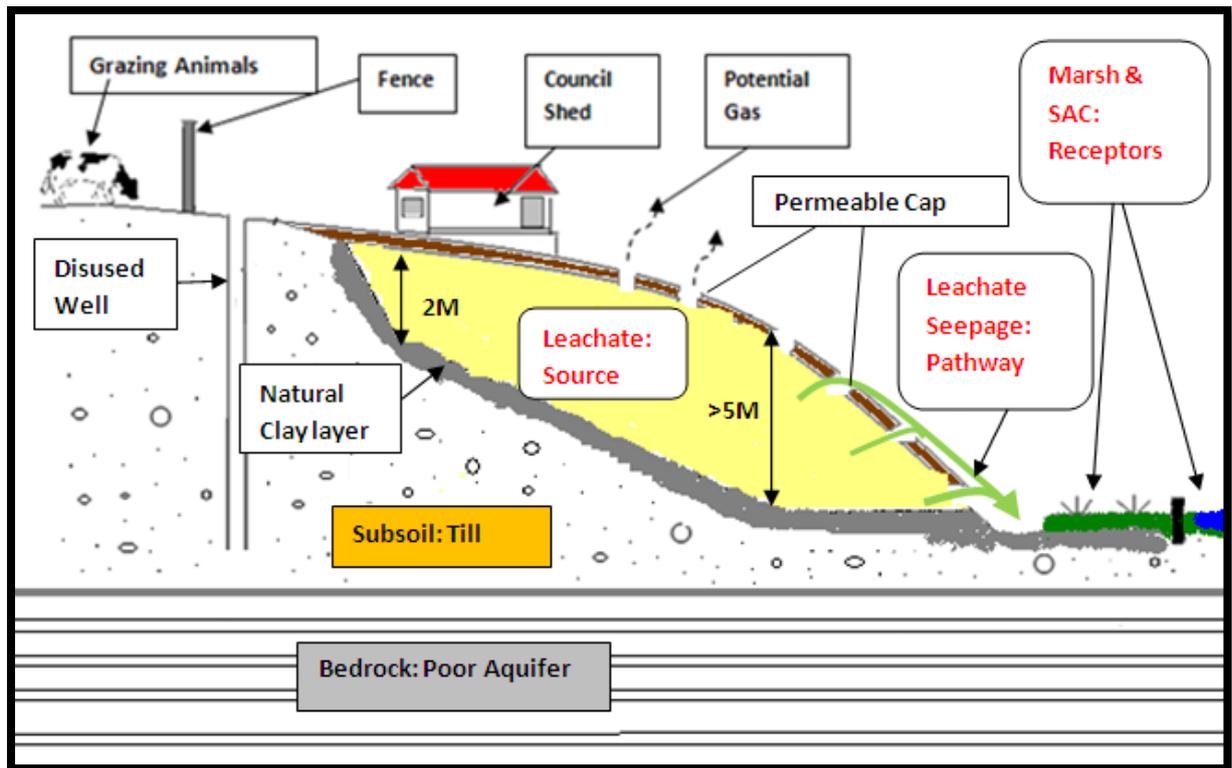
Refined CSM

The Exploratory investigation as outlined in the EPA COP Matrix 1 broadly confirmed the assumptions of the Tier 1 Risk Assessment. Although the area of the landfill has increased from 2 hectares to 2.6 hectares, this increase in size does not change the scoring for Tables 1a and 1b of chapter 4 of the COP.

Sampling of the surface water drainage showed that it was contaminated by leachate proving the linkage from the landfill source to the water receptor. The leachate itself is an aged leachate which could still pose a risk to human health or the environment.

Although landfill gas was observed in the body of waste, none was recorded in the council shed and canteen. These buildings have a concrete floor which may prevent vertical migration. The trial pitting showed the integrity of the existing cap is not to the standards in the EPA Landfill restoration manual 1999.
