**Tonroe Quarry,  
Ardrahan, Co. Galway**

**Development of an Asphalt Plant & Associated Works,  
in Former Quarry Processing/Dispatch Yard Area  
and  
Completion of Restoration of Previously Quarried  
Area**

**Natura Impact Statement**

Sept 2017

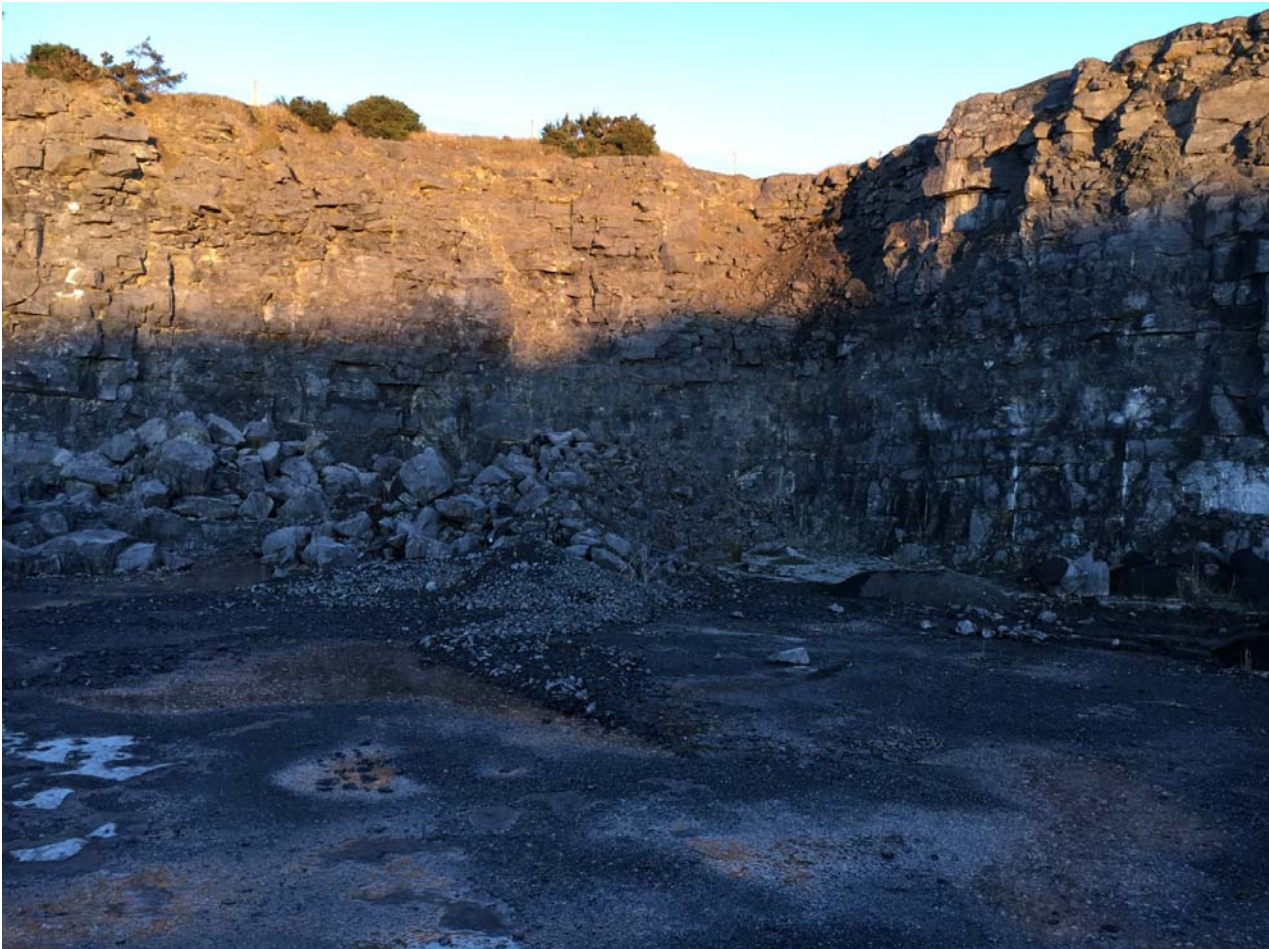
Plate 1: Boulders and rock on site. Photograph taken November 2016.

This habitat classification is used to describe a large excavated steep-sided pit that is largely devoid of vegetation, boulders and rock onsite (Plates 1 and 2 below) and inert stockpiles of processed or imported materials including cobbles and finer material (Stockpiles 3 - 7). These stockpiles have not colonised in the 8 years since quarrying activities took place at the site. Vegetation is sparse and includes occasional coltsfoot (*Tussilago farfara*), annual meadowgrass (*Poa annua*), common centaury (*Centaureum erythraea*), foxglove (*Digitalis purpurea*) and yellow-wort (*Blackstonia perforate*).

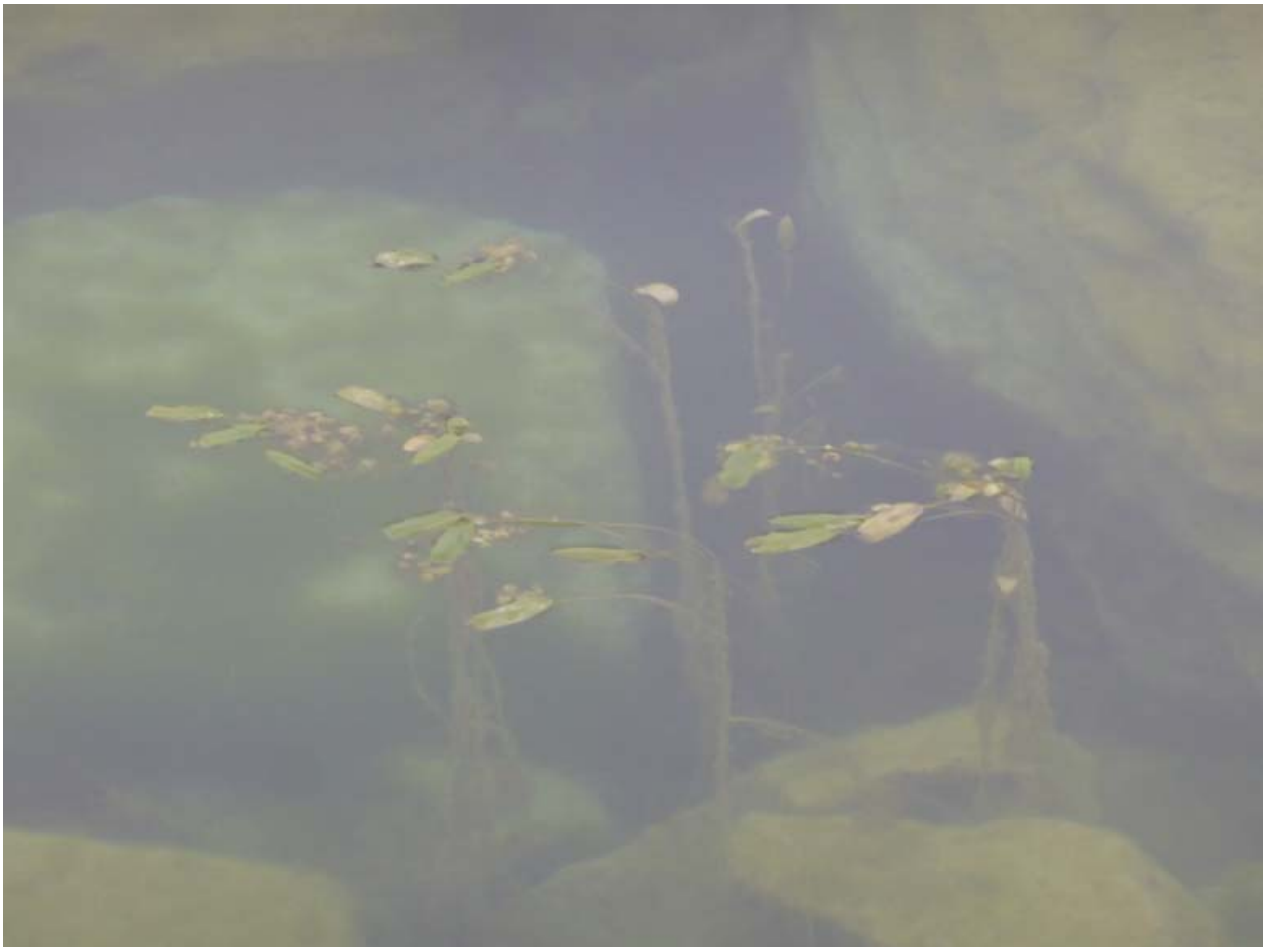
**Plate 3: Broadleaved pondweed. Photograph taken October 2016**

This habitat classification is used to describe to lower bench of the quarry. This body of water is groundwater fed and is likely to dry during summer months. Broad-leaved pondweed (*Potamogeton natans*) was identified in this area during the site visit in October 2016 (see Plate 3 below).

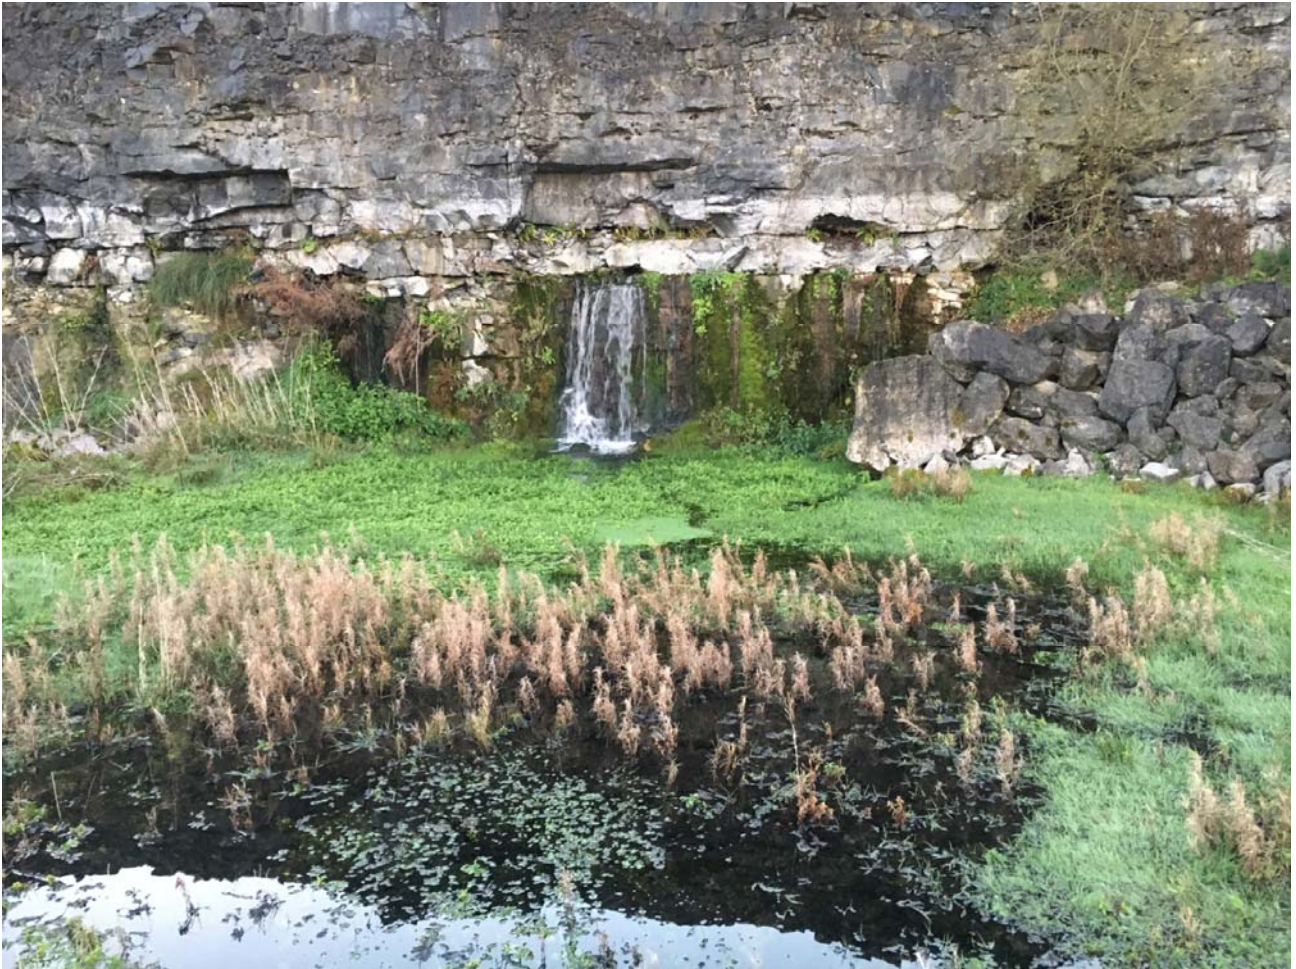
A small portion of the middle bench is groundwater fed, creating ponds (see Plates 4 and 5 below). This groundwater fed area has the potential for Annex I habitat (Petrifying Springs with tufa formation (*Cratoneurion*) [7220]).

Plate 4: Groundwater fed pond on the middle shelf. Photograph taken November 2016.

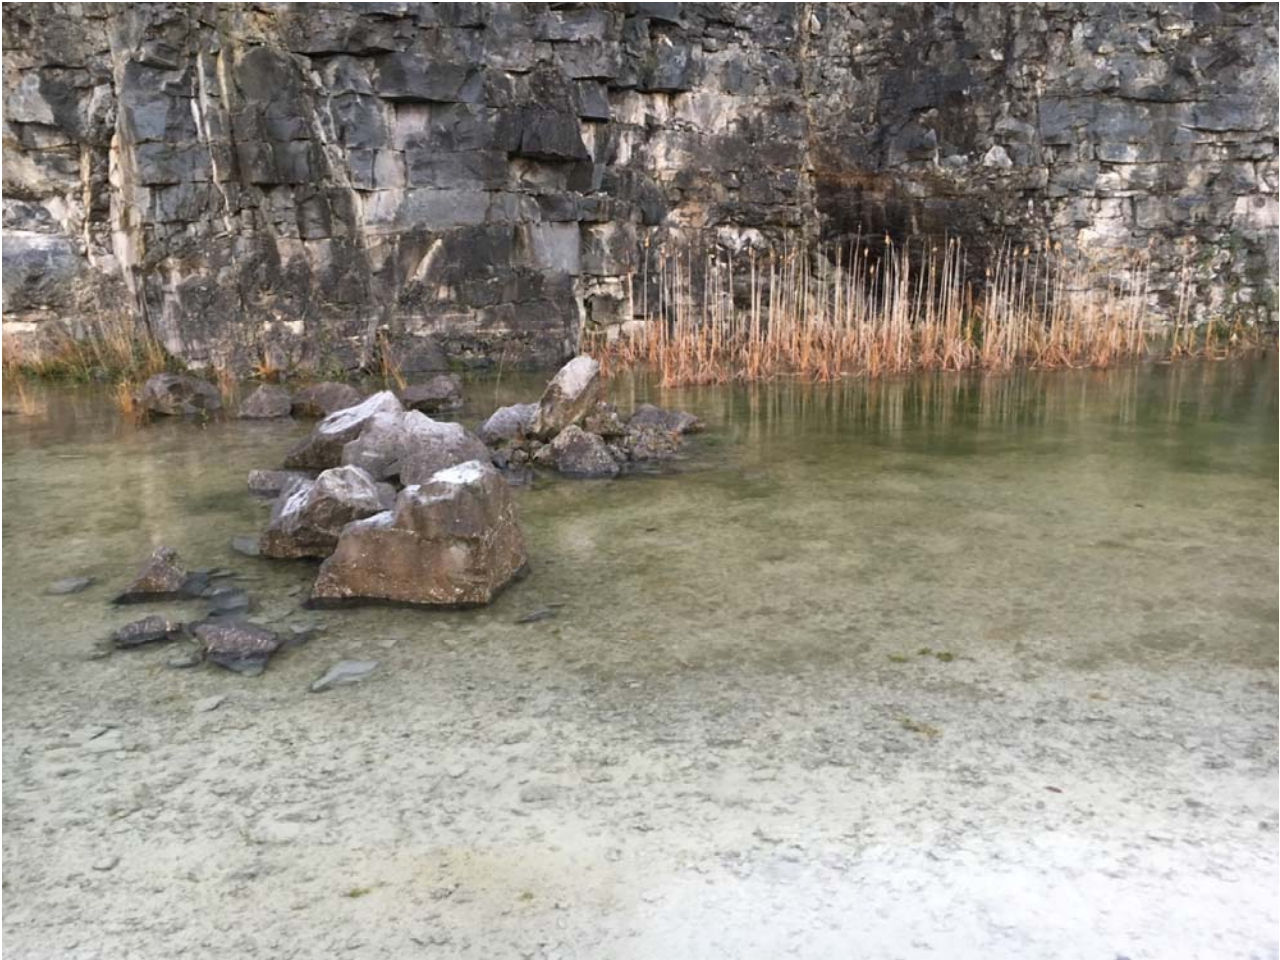
Plate 5: Groundwater fed pond on the middle shelf. Photograph taken November 2016.

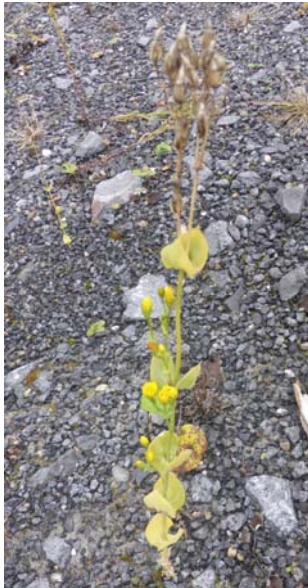
Plate 6: Yellow-wort on site

Also present on the upper bench are areas of disturbed ground and gravel, some of which form part of the access track around the upper bench. These areas were colonising by calcareous species such as Carline Thistle and Yellow-wort (see Plates 6 and 7 below). It is proposed that this access track will be visited periodically by a tracked machine in order to keep the track accessible for ongoing monitoring of the water quality at the site. This ongoing moderate level of disturbance will ensure that growth of 'disturbed ground' species such as these will prevail and not be out competed by gorse.

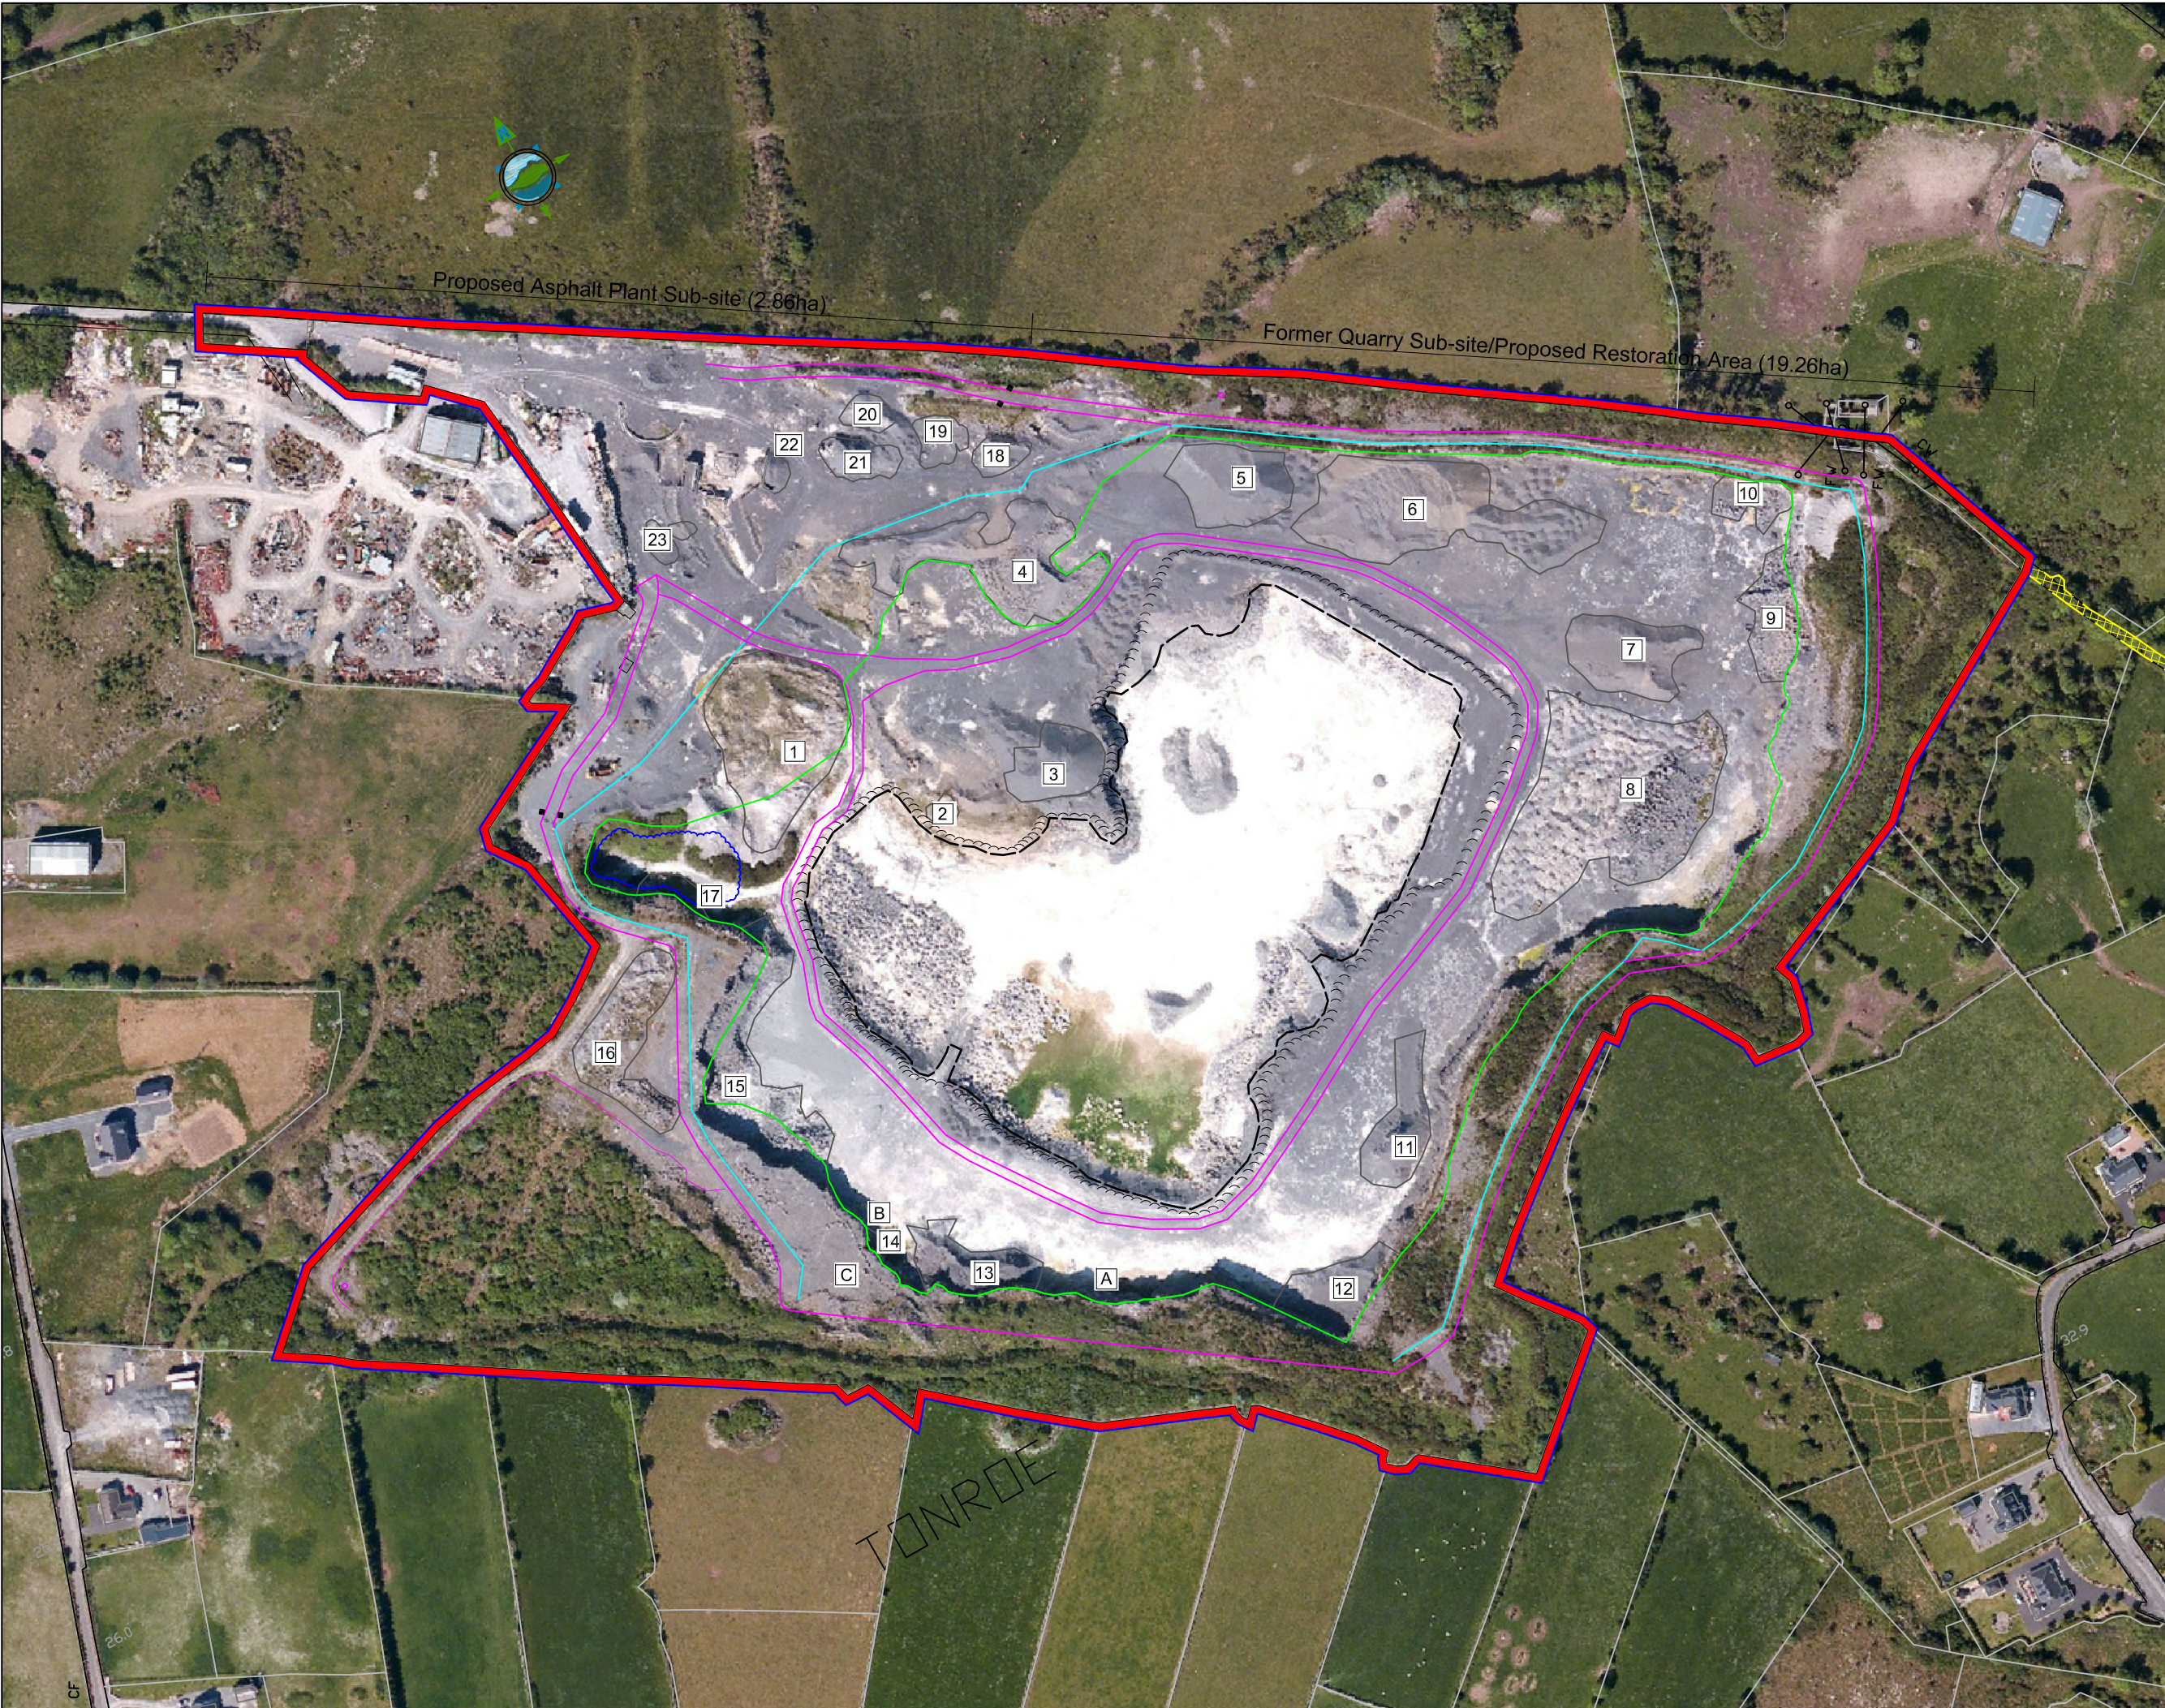
Figure 2: Existing Aerial Site Layout Plan Showing Stockpiles, Fences, Tracks and Planting

- Legend**
- Application Boundary —
  - Land Ownership Boundary —
  - Existing Security Fence —
  - Proposed Security Fence - - -
  - Upper Quarry Face —
  - Lower Quarry Face - - -
  - Access for Maintenance of Fence & Planting —
- Existing Stockpiles & Stockpile No. 1-23

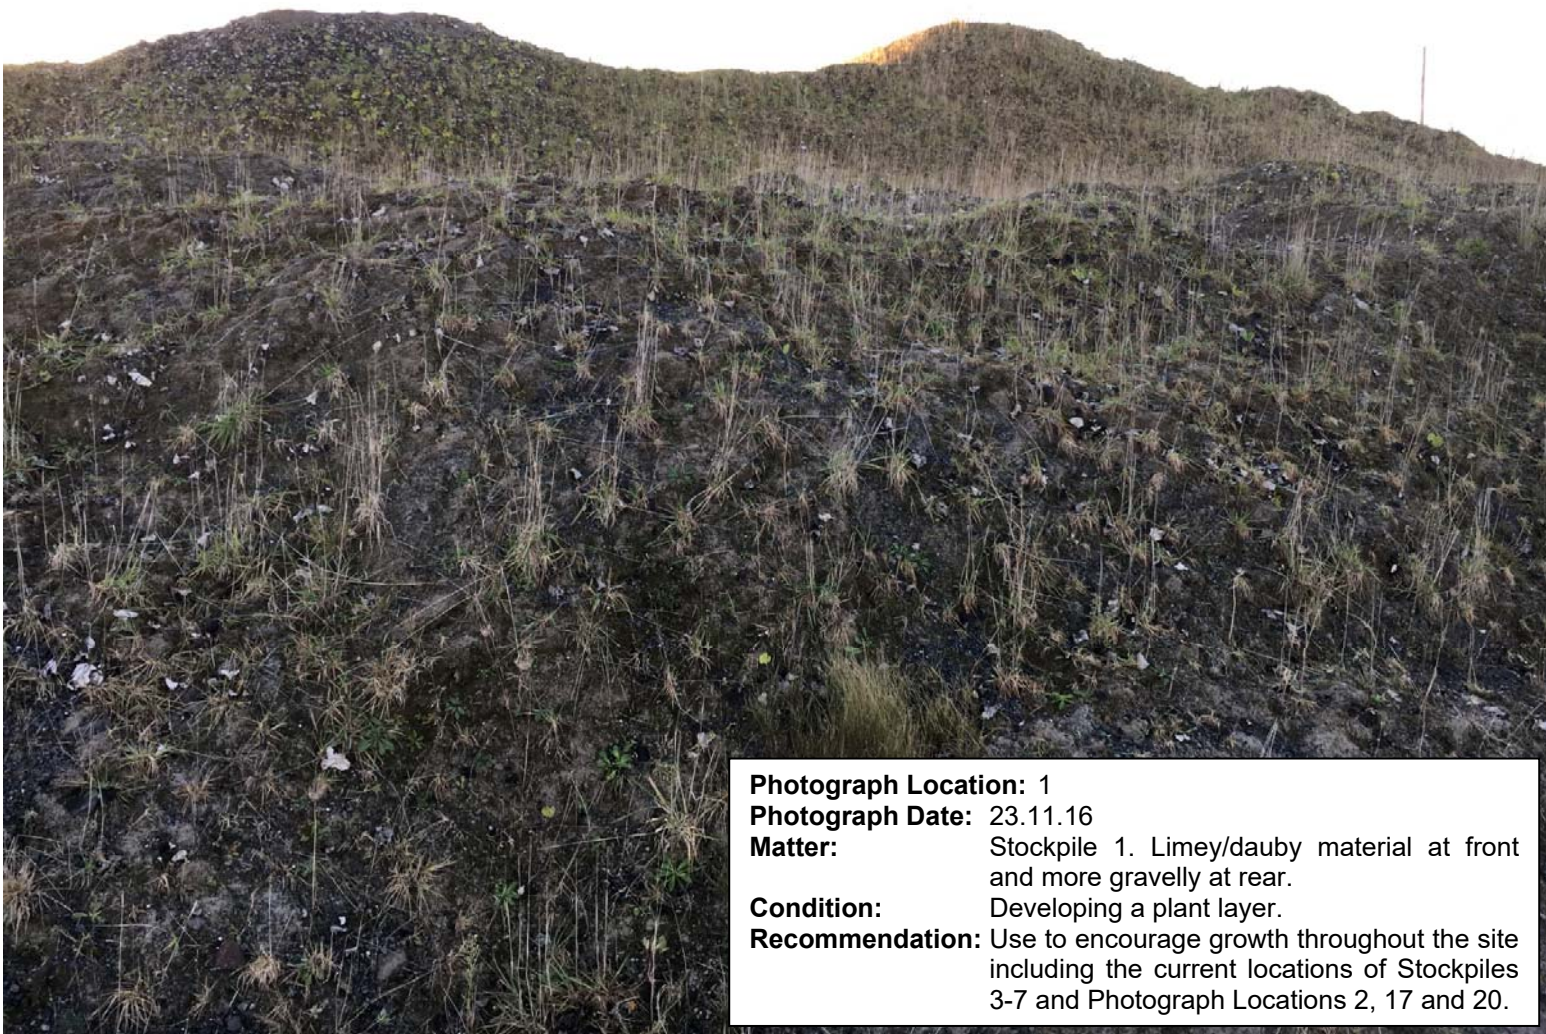
Appendix A - Plate 9: Photograph Location 1. Stockpile 1

**Photograph Location:** 1  
**Photograph Date:** 23.11.16  
**Matter:** Stockpile 1. Limey/dauby material at front and more gravelly at rear.  
**Condition:** Developing a plant layer.  
**Recommendation:** Use to encourage growth throughout the site including the current locations of Stockpiles 3-7 and Photograph Locations 2, 17 and 20.

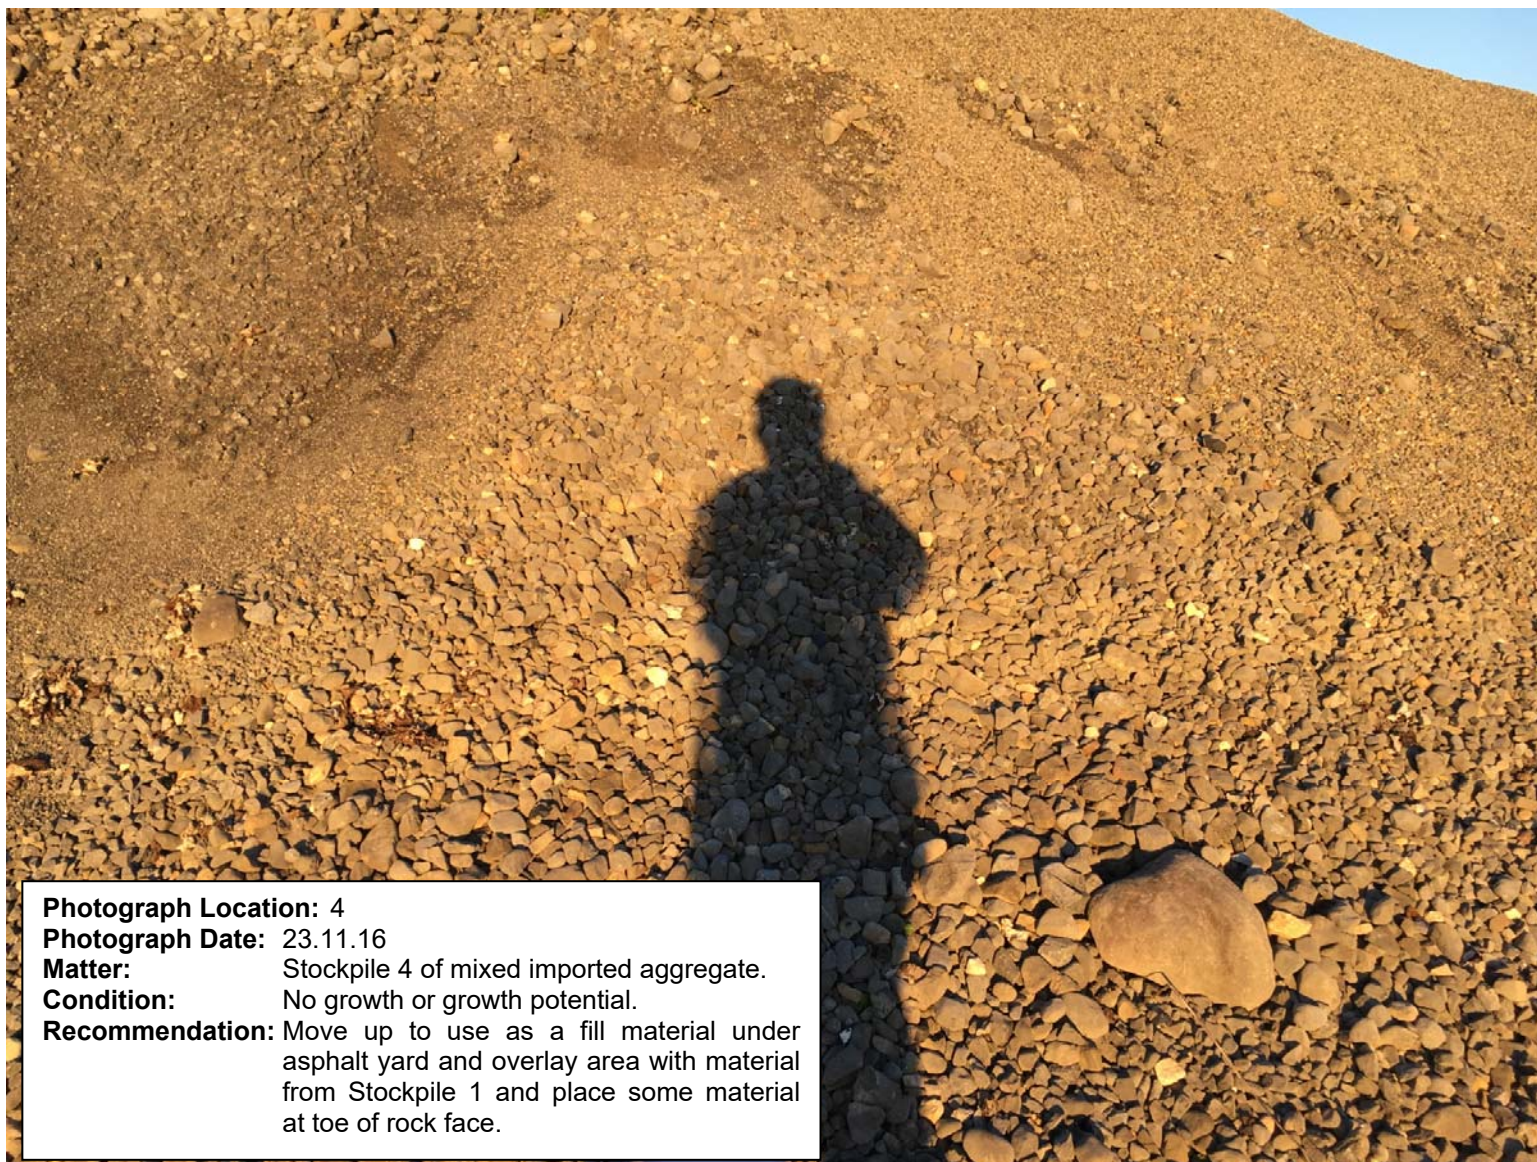
Appendix A - Plate 12: Photograph Location 4. Stockpile 4

**Photograph Location:** 4  
**Photograph Date:** 23.11.16  
**Matter:** Stockpile 4 of mixed imported aggregate.  
**Condition:** No growth or growth potential.  
**Recommendation:** Move up to use as a fill material under asphalt yard and overlay area with material from Stockpile 1 and place some material at toe of rock face.

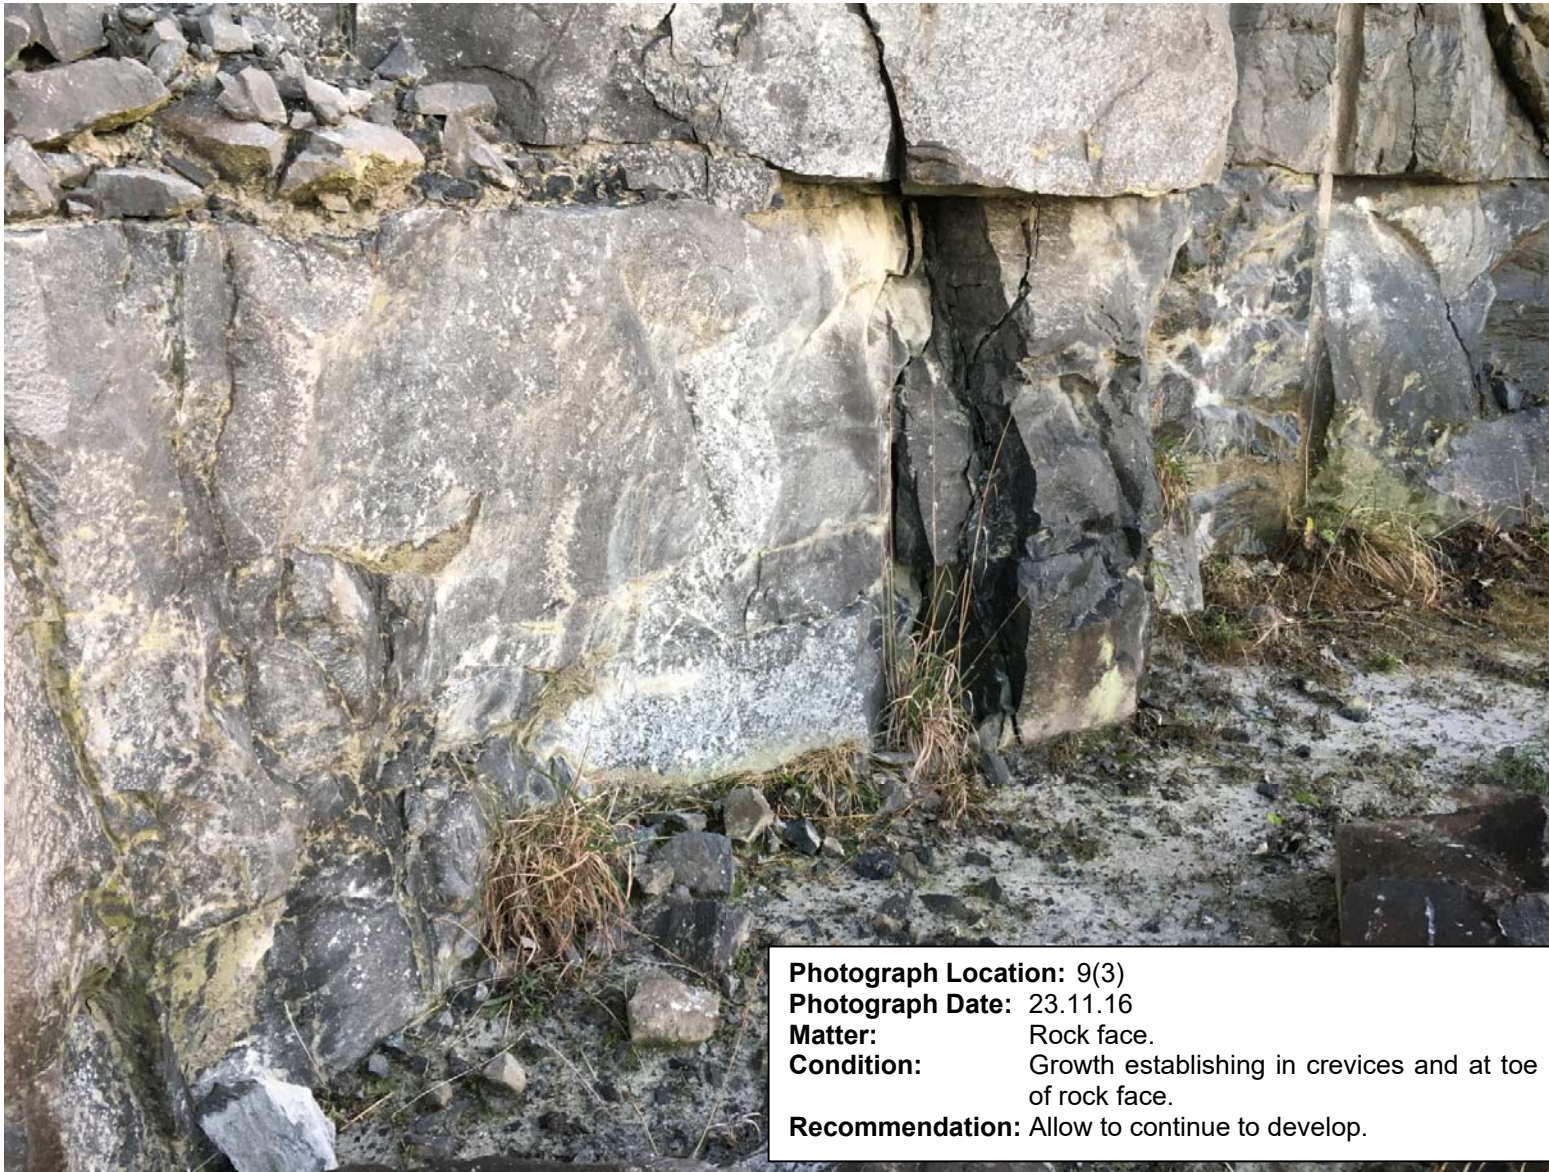
Appendix A - Plate 19: Photograph Location 9(3)

**Photograph Location:** 9(3)  
**Photograph Date:** 23.11.16  
**Matter:** Rock face.  
**Condition:** Growth establishing in crevices and at toe of rock face.  
**Recommendation:** Allow to continue to develop.

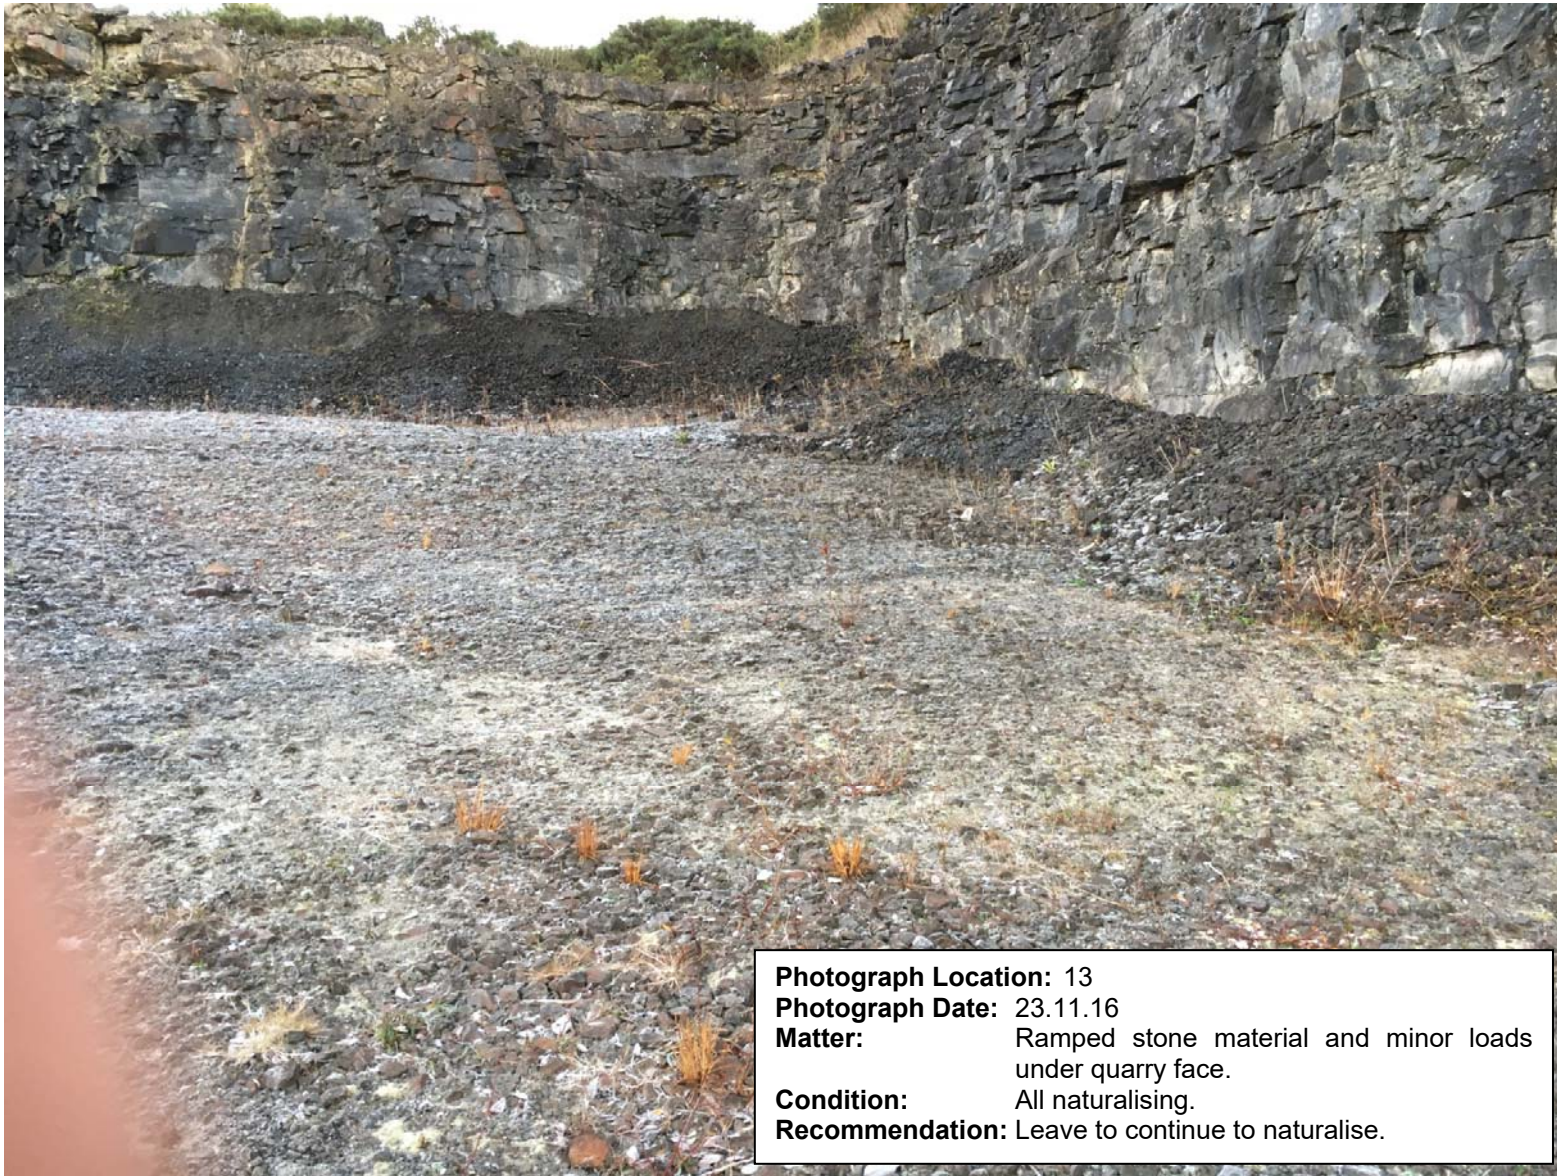
Appendix A - Plate 24: Photograph Location 13

**Photograph Location:** 13  
**Photograph Date:** 23.11.16  
**Matter:** Ramped stone material and minor loads under quarry face.  
**Condition:** All naturalising.  
**Recommendation:** Leave to continue to naturalise.

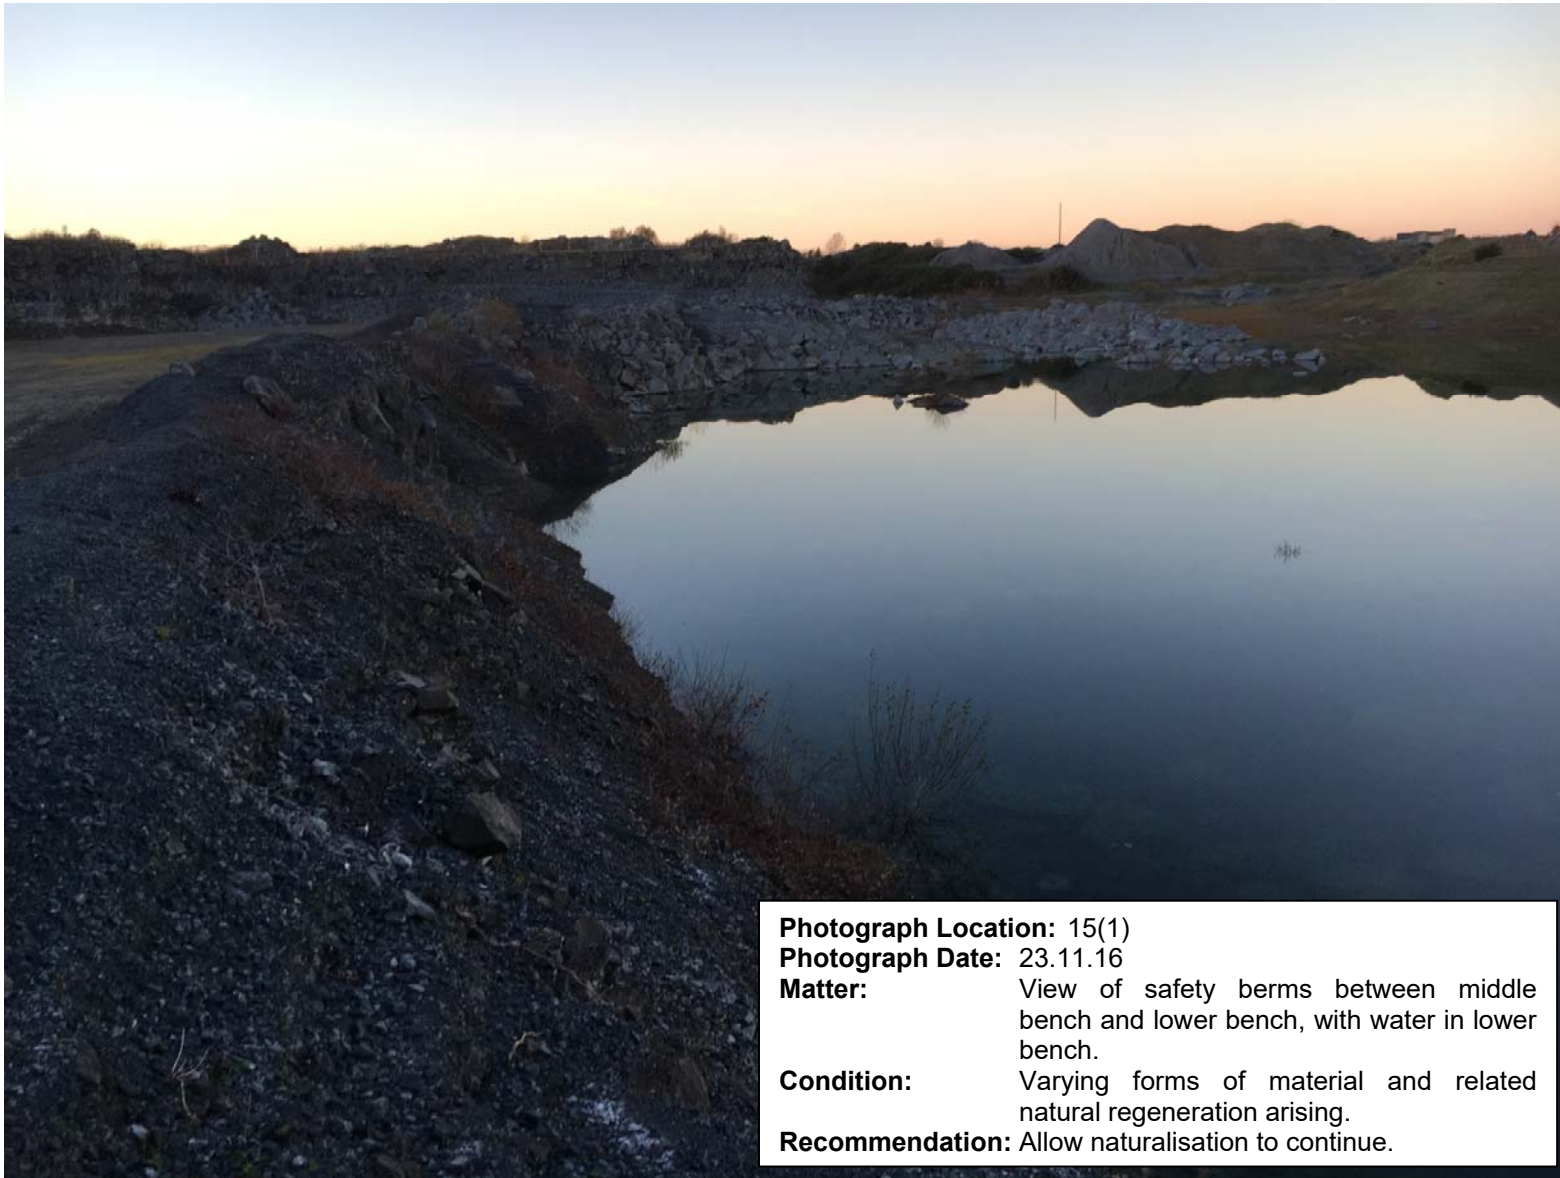
Appendix A - Plate 26: Photograph Location 15(1)

**Photograph Location:** 15(1)  
**Photograph Date:** 23.11.16  
**Matter:** View of safety berms between middle bench and lower bench, with water in lower bench.  
**Condition:** Varying forms of material and related natural regeneration arising.  
**Recommendation:** Allow naturalisation to continue.

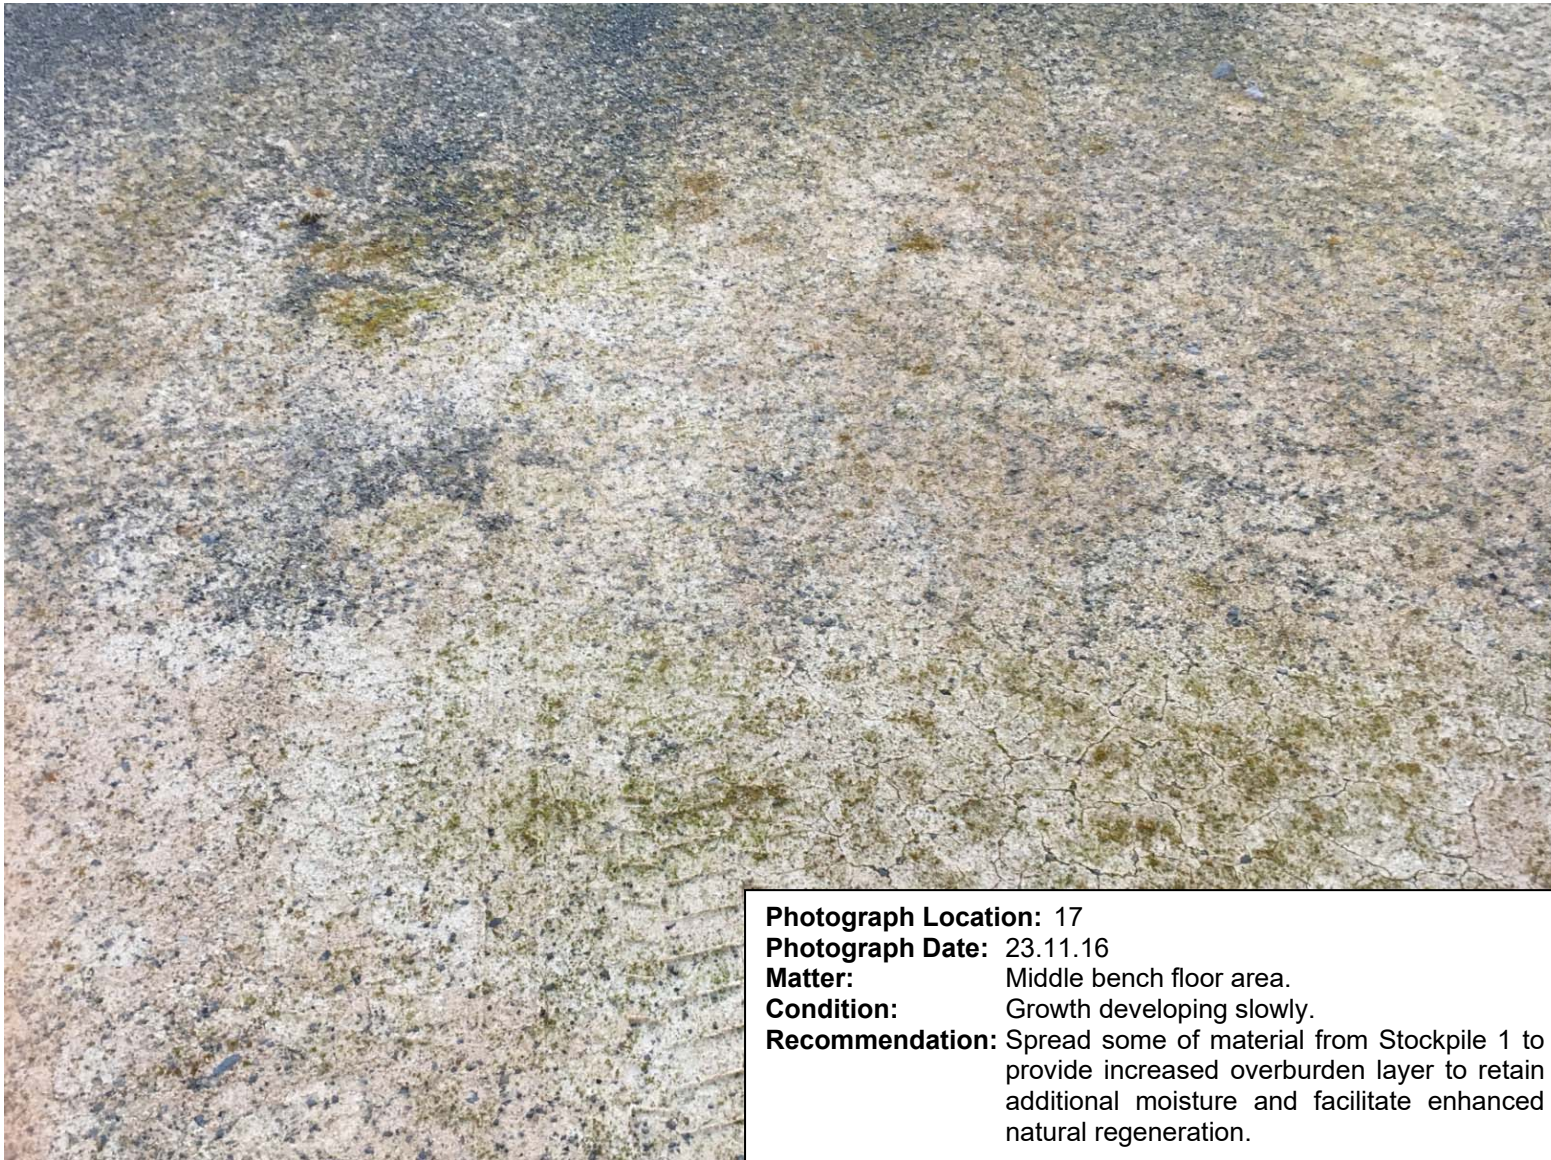
**Photograph Location:** 17  
**Photograph Date:** 23.11.16  
**Matter:** Middle bench floor area.  
**Condition:** Growth developing slowly.  
**Recommendation:** Spread some of material from Stockpile 1 to provide increased overburden layer to retain additional moisture and facilitate enhanced natural regeneration.

Appendix A - Plate 32: Photograph Location 17. Shallow overburden colonising

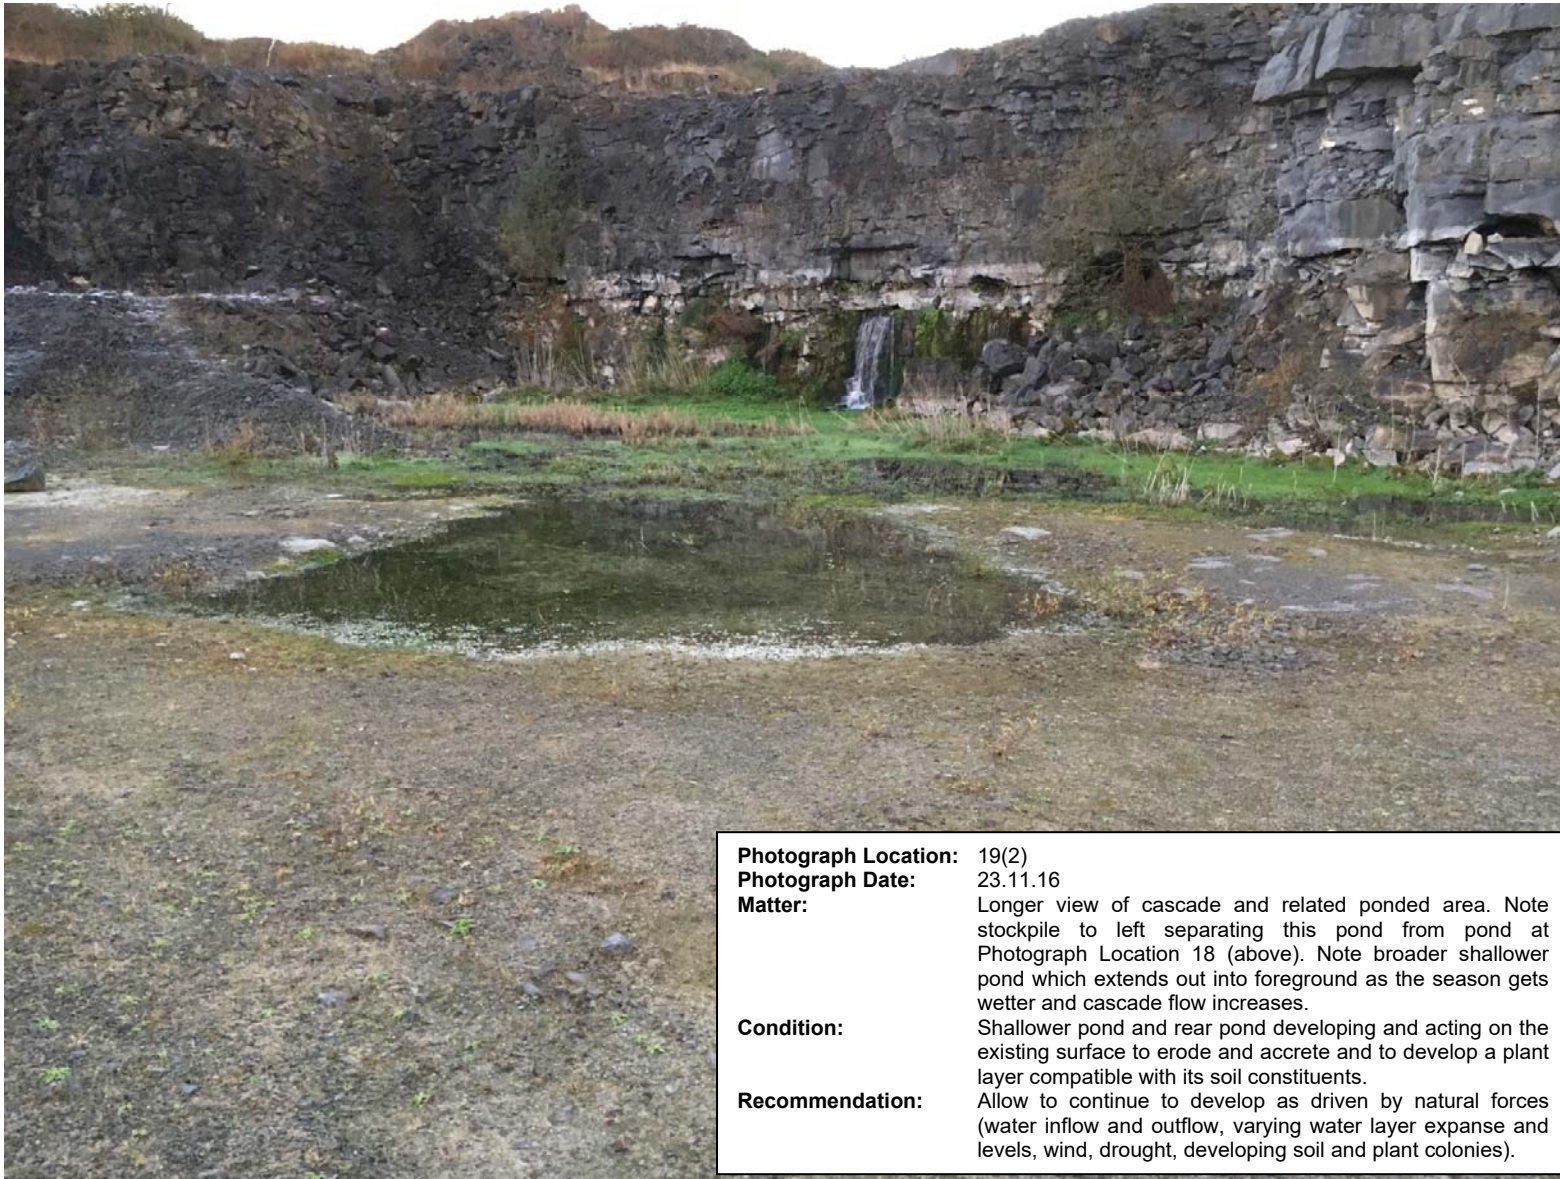
<b>Photograph Location:</b>	19(2)
<b>Photograph Date:</b>	23.11.16
<b>Matter:</b>	Longer view of cascade and related ponded area. Note stockpile to left separating this pond from pond at Photograph Location 18 (above). Note broader shallower pond which extends out into foreground as the season gets wetter and cascade flow increases.
<b>Condition:</b>	Shallower pond and rear pond developing and acting on the existing surface to erode and accrete and to develop a plant layer compatible with its soil constituents.
<b>Recommendation:</b>	Allow to continue to develop as driven by natural forces (water inflow and outflow, varying water layer expanse and levels, wind, drought, developing soil and plant colonies).

Appendix A - Plate 35: Photograph Location 19(2). Groundwater fed middle bench
