**Tonroe Quarry,  
Ardrahan, Co. Galway**

**Development of an Asphalt Plant & Associated Works,  
in Former Quarry Processing/Dispatch Yard Area  
and  
Completion of Restoration of Previously Quarried  
Area**

**Natura Impact Statement**

Sept 2017

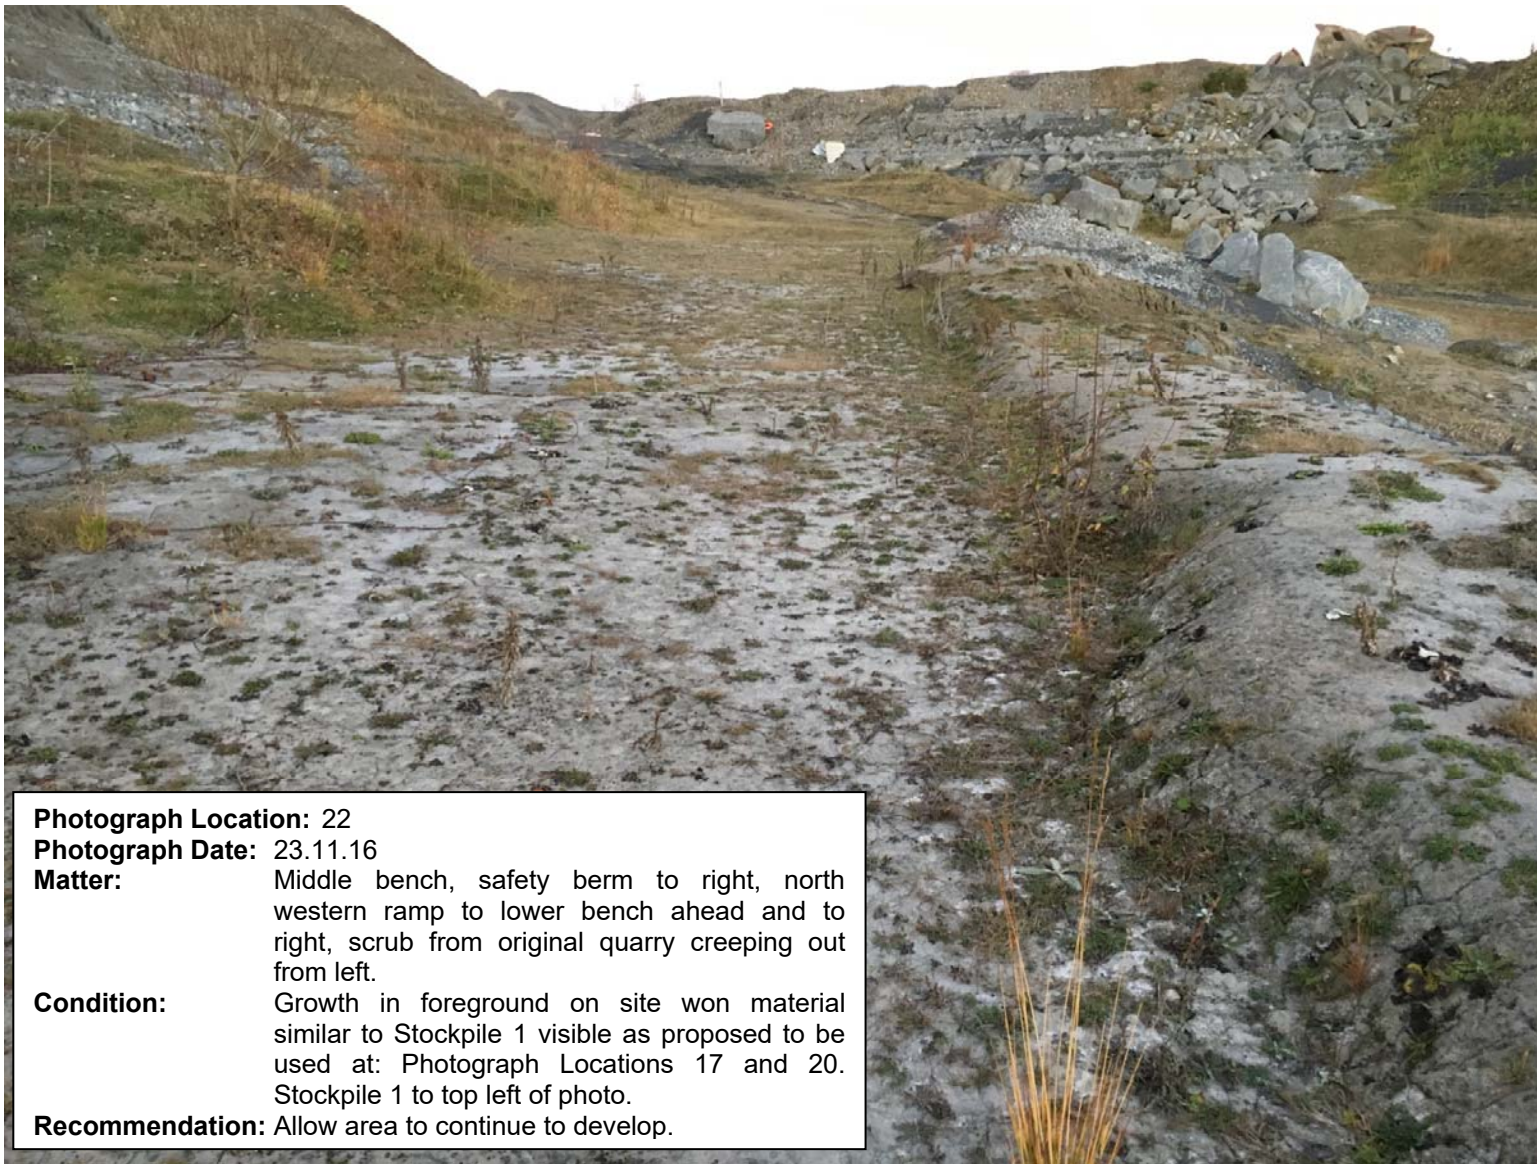
Appendix A - Plate 39: Photograph Location 22

**Photograph Location:** 22  
**Photograph Date:** 23.11.16  
**Matter:** Middle bench, safety berm to right, north western ramp to lower bench ahead and to right, scrub from original quarry creeping out from left.  
**Condition:** Growth in foreground on site won material similar to Stockpile 1 visible as proposed to be used at: Photograph Locations 17 and 20. Stockpile 1 to top left of photo.  
**Recommendation:** Allow area to continue to develop.

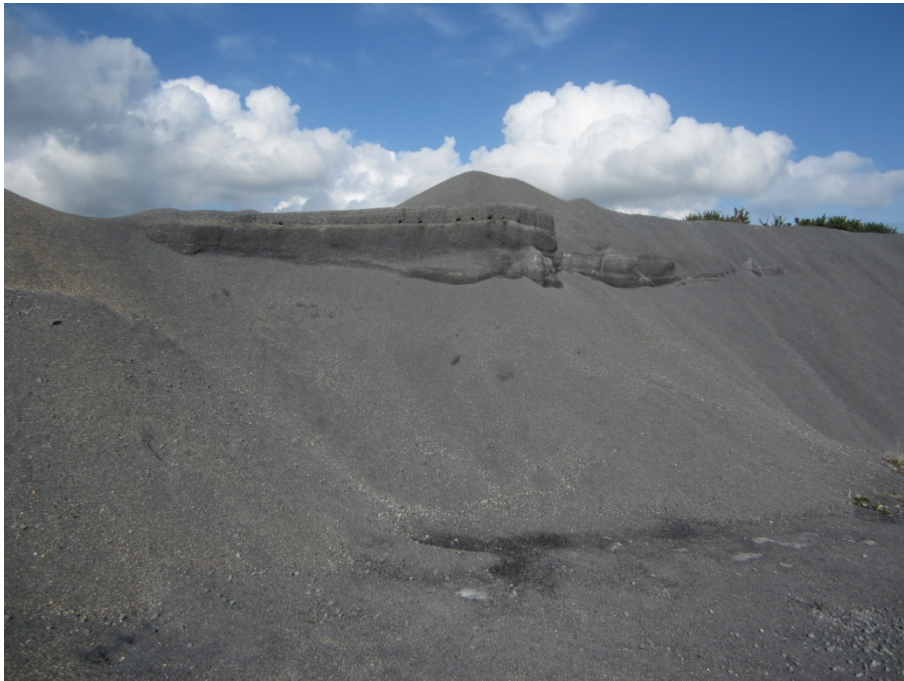
**Plate 2:** Spoilheaps with sand martin holes, within Former Quarry Subsite

Sand martin nesting holes (inactive) were identified during the site surveys, though this species was not confirmed as breeding in the March and May 2015 surveys, with the holes remaining unoccupied. Sand martin are amber-listed species of moderate conservation concern.

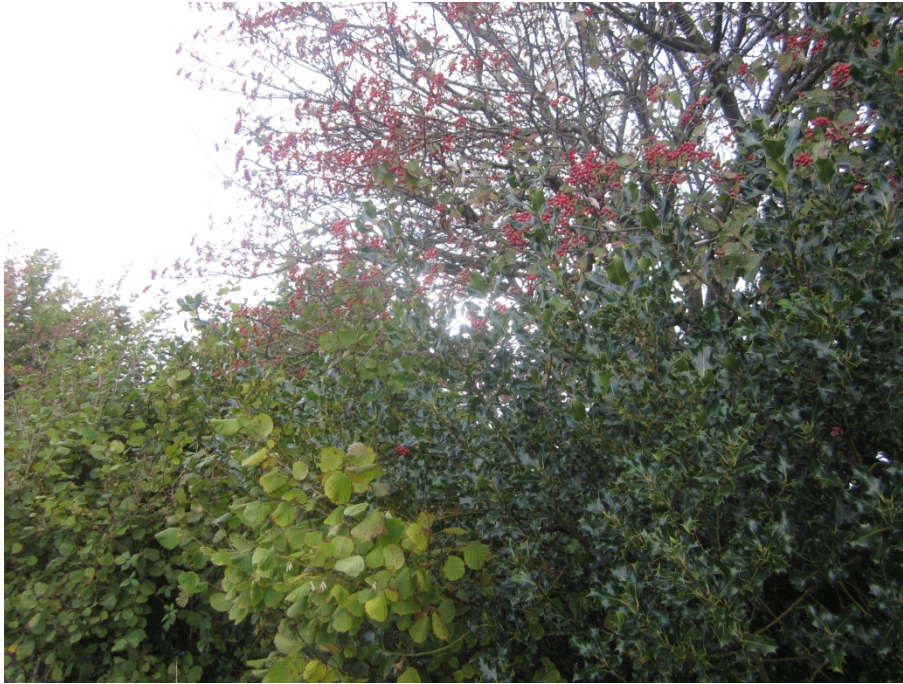
**Plate 3:** Hedgerow along northwestern boundary near entrance – Asphalt Plant Subsite

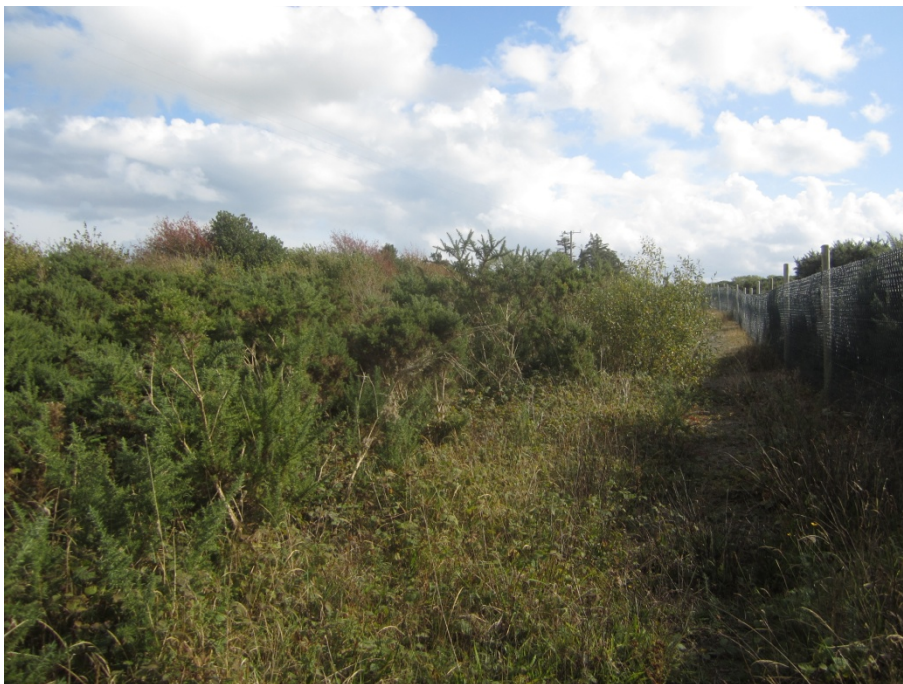
**Plate 4:** Boundary gorse scrub and pathway with recolonising vegetation

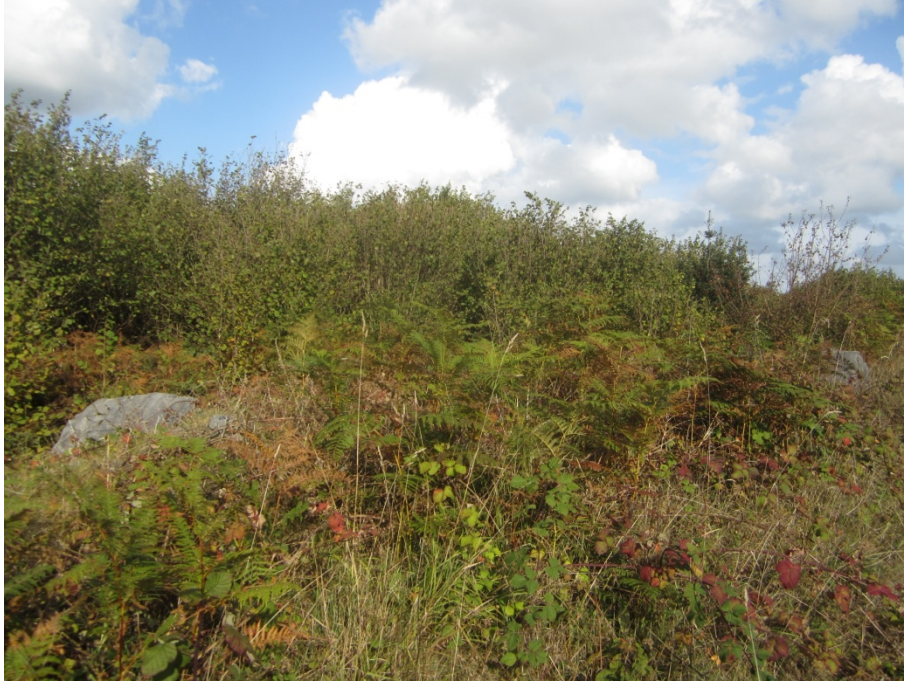
**Plate 5:** Hazel scrub in southwestern corner of site – Former Quarry Subsite
