## **Appendix B**

### **Stream Hydrographs and Flow Duration Curves**

## **Appendix C**

### **Lithological Details – Northwest Carboniferous Basin**

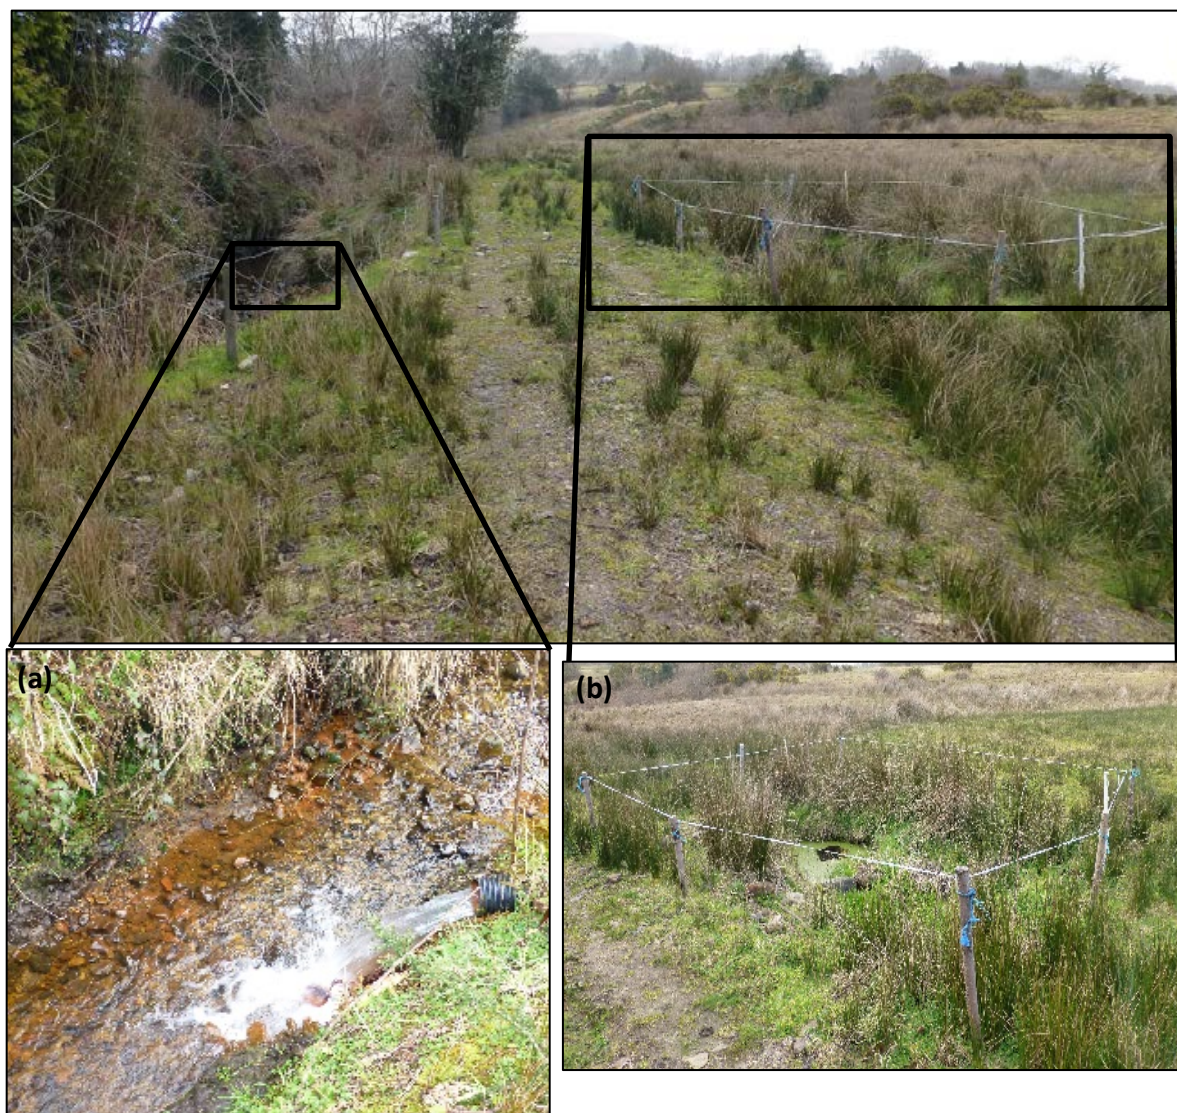
**Figure G3.3. Saint Patricks well showing (a) the piped spring flow and (b) the spring source.**

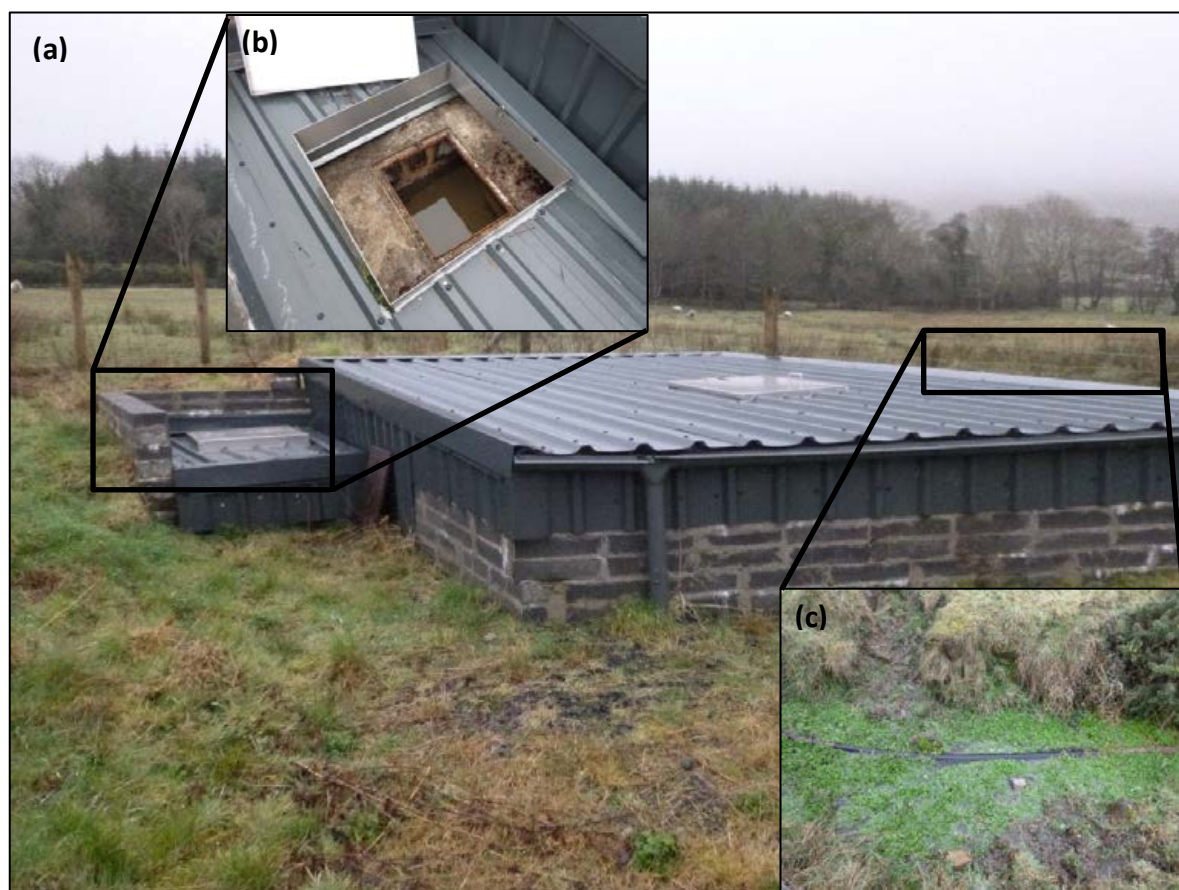
**Figure G3.4. Benbulbin G.W.S. (a) spring chamber, (b) the spring source and (c) unpiped overflow.**

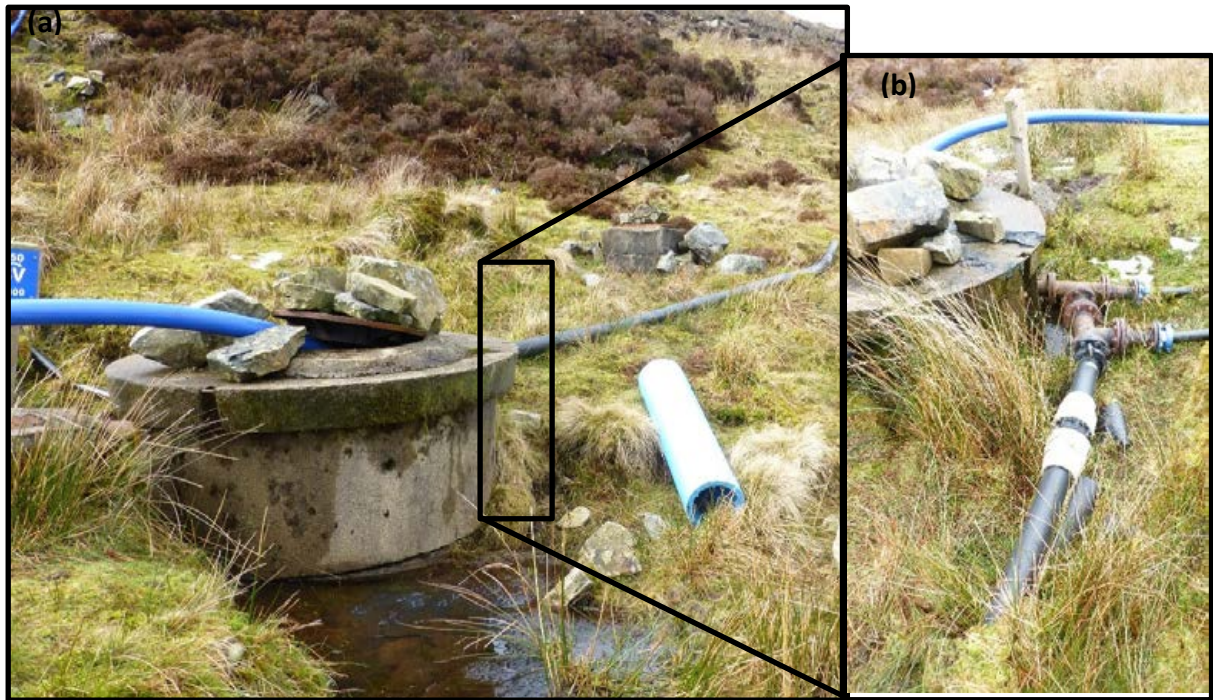
**Figure G3.6. Corlough G.W.S. showing (a) view from front and (b) view from back of the spring chamber to which all springs flow before being pumped.**

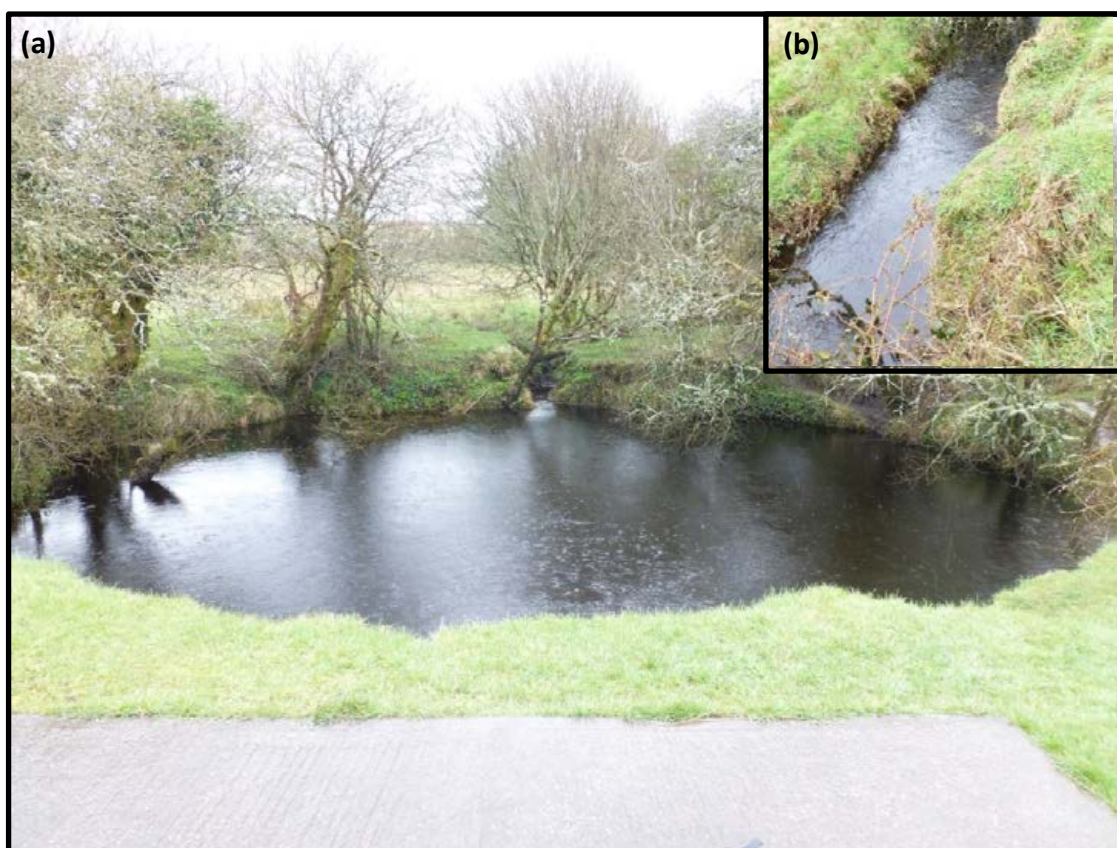
**Figure G3.9.** Shannon pot showing the (a) spring rising or 'pot' and (b) 10m spring stream section.

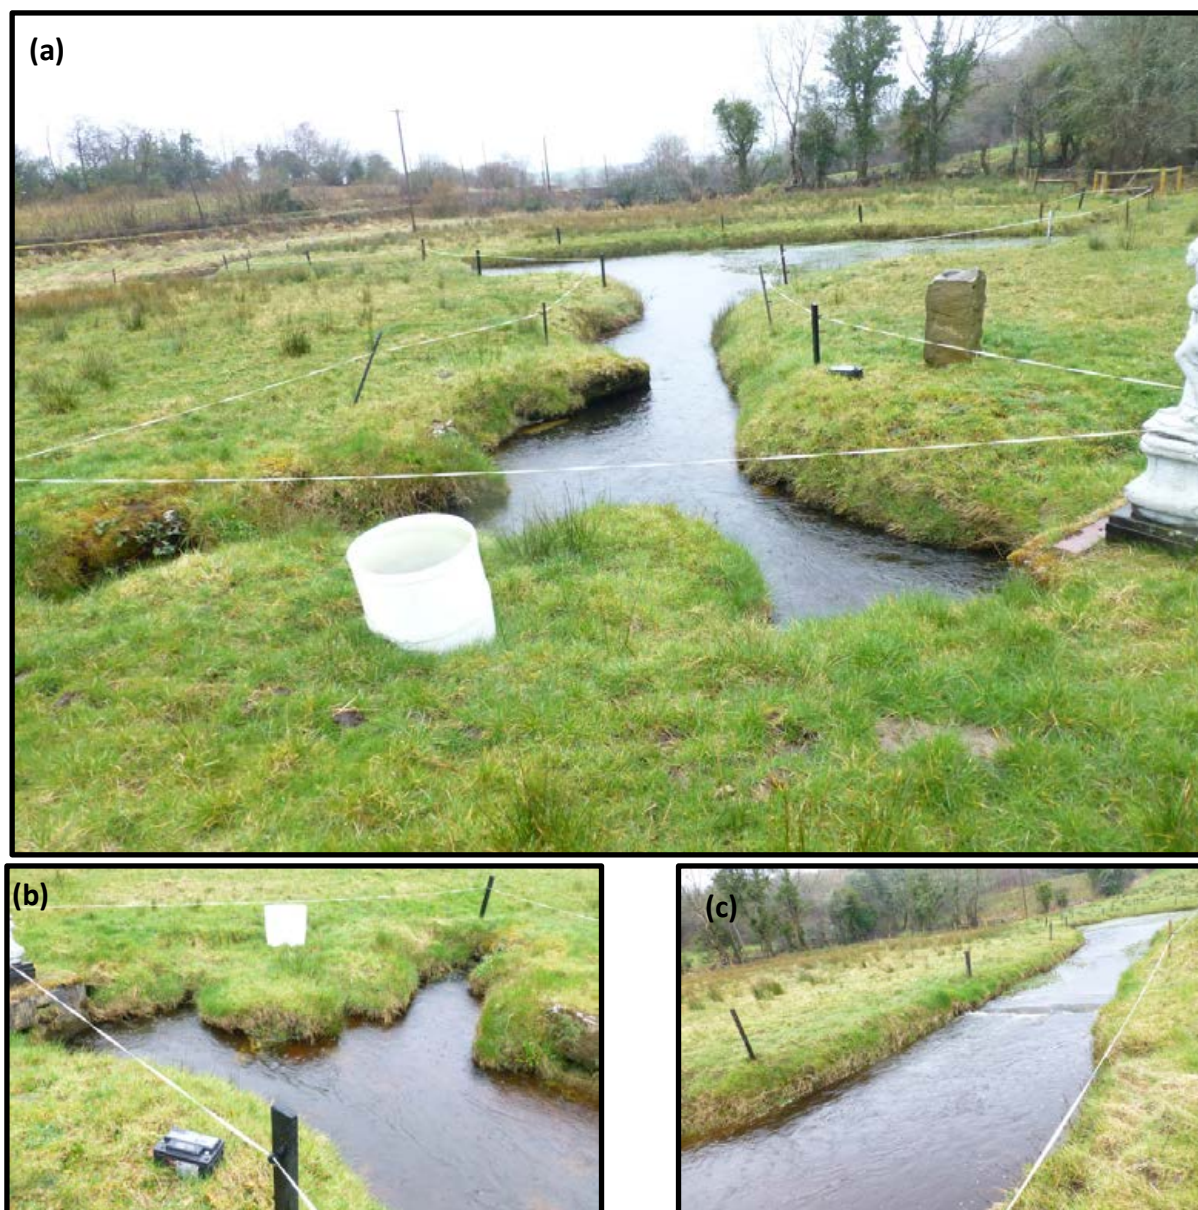
**Figure G3.11. Barran rising showing (a) locations of spring sources and circular 'pot' m spring stream section. (b) locations of two spring sources and (c) 10**

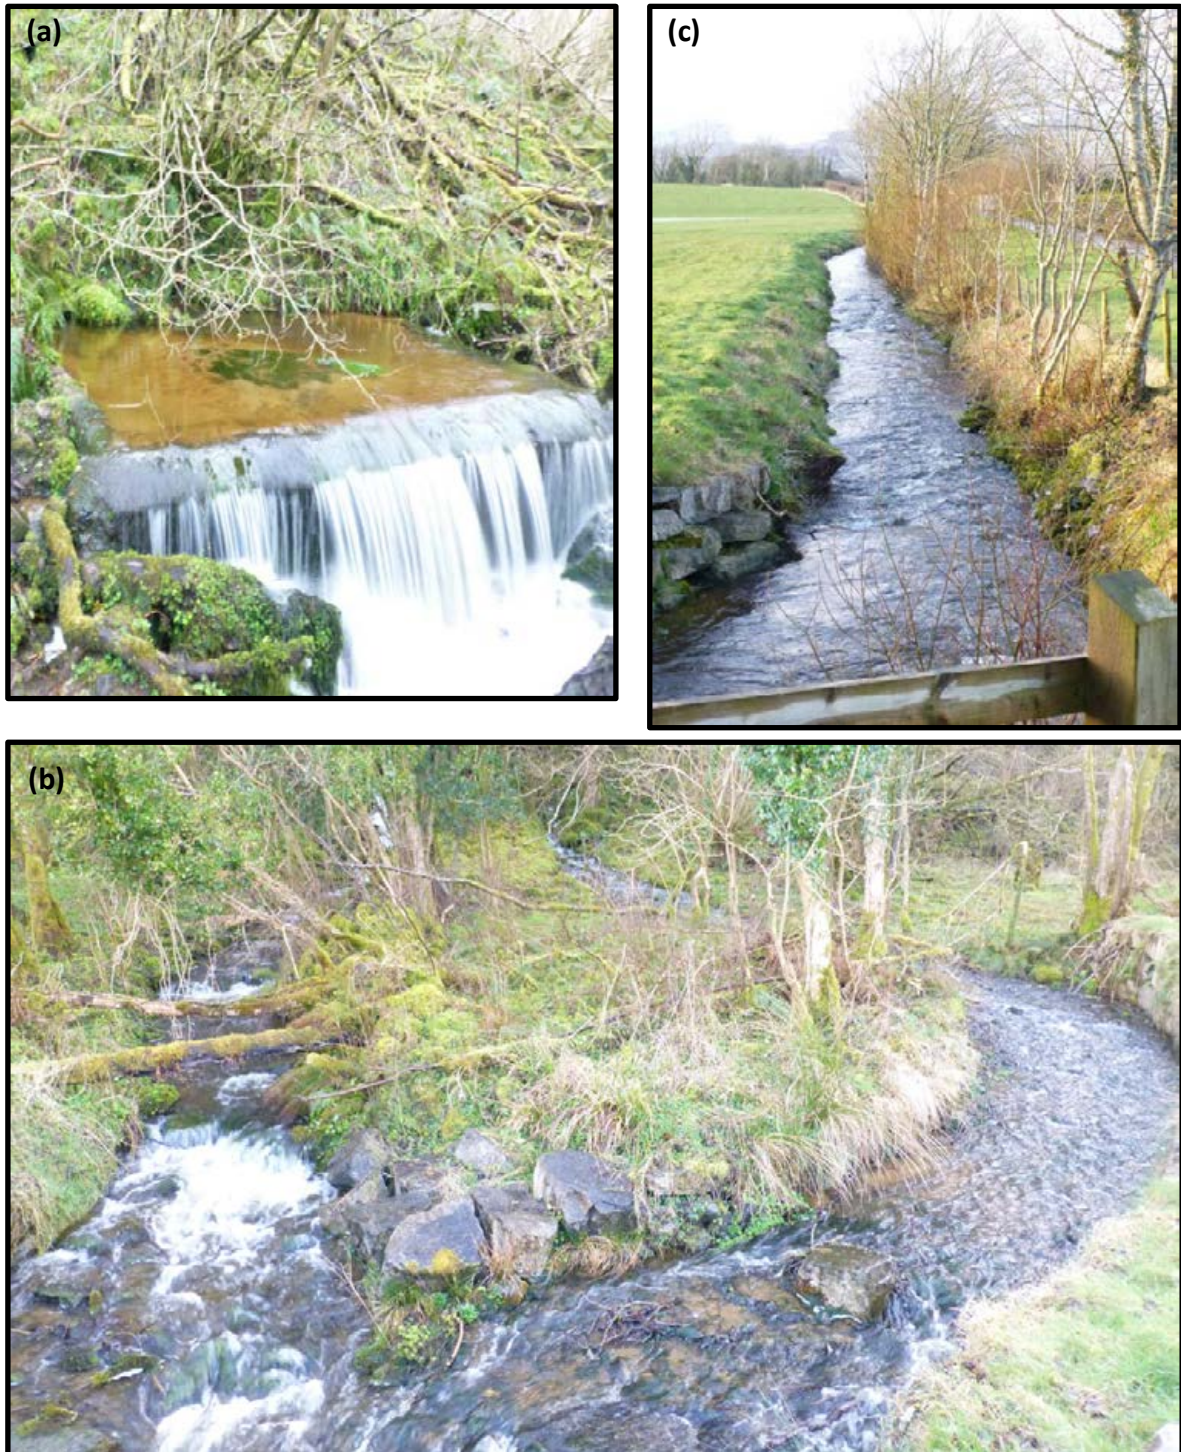
**Figure G3.12. Hanging Rock rising showing (a) one of the spring sources, (b) two spring streams, one deriving from either of the two spring sources and (c) 10 m spring stream section.**

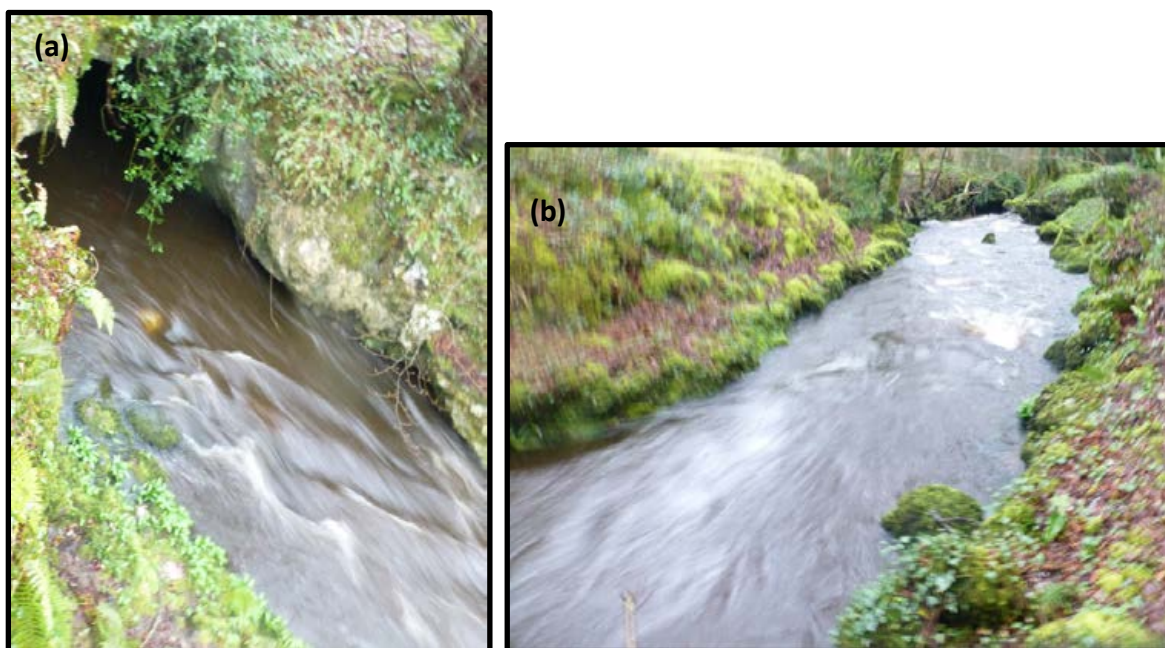
**Figure G3.14. White Fathers Cave showing (a) spring source and (b) 10 m spring stream section. Note, water in photo is blurred due to high flow velocity.**

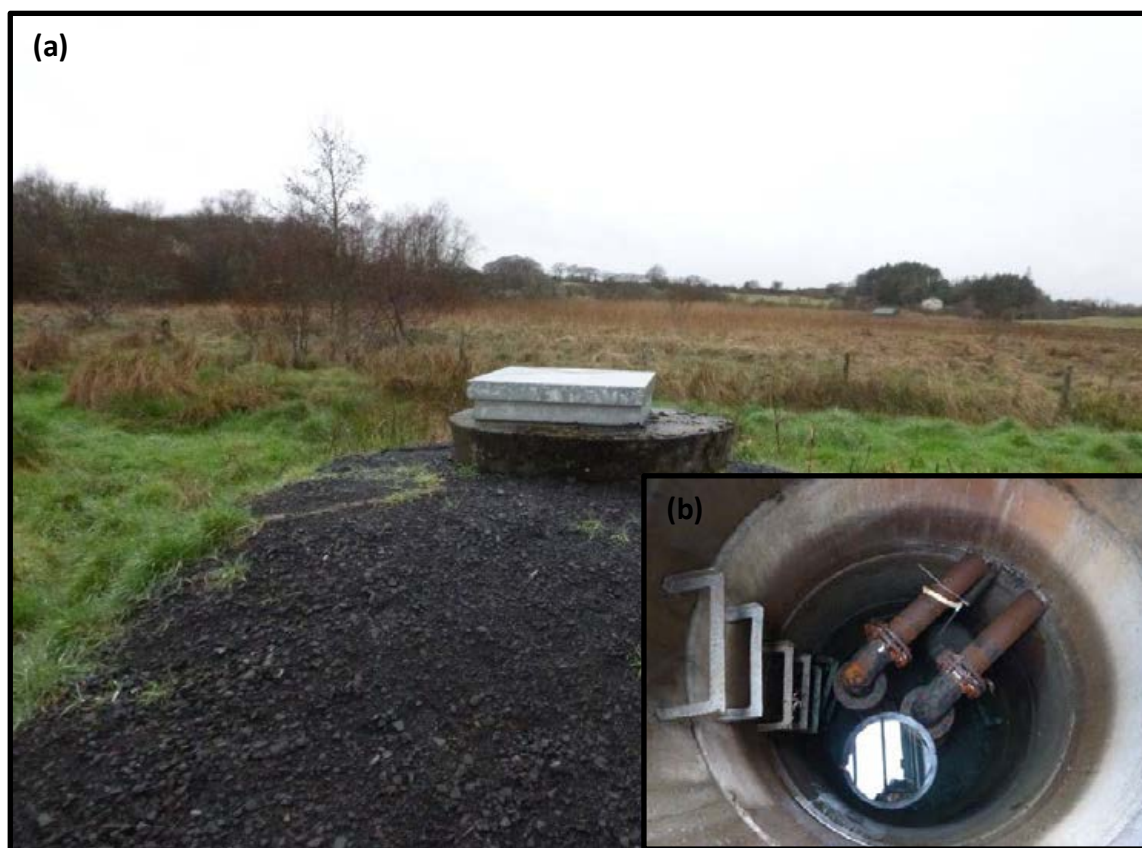
**Figure G3.20. Riverstown G.W.S. showing the (a) external view, and (b) internal view, of the spring chamber.**

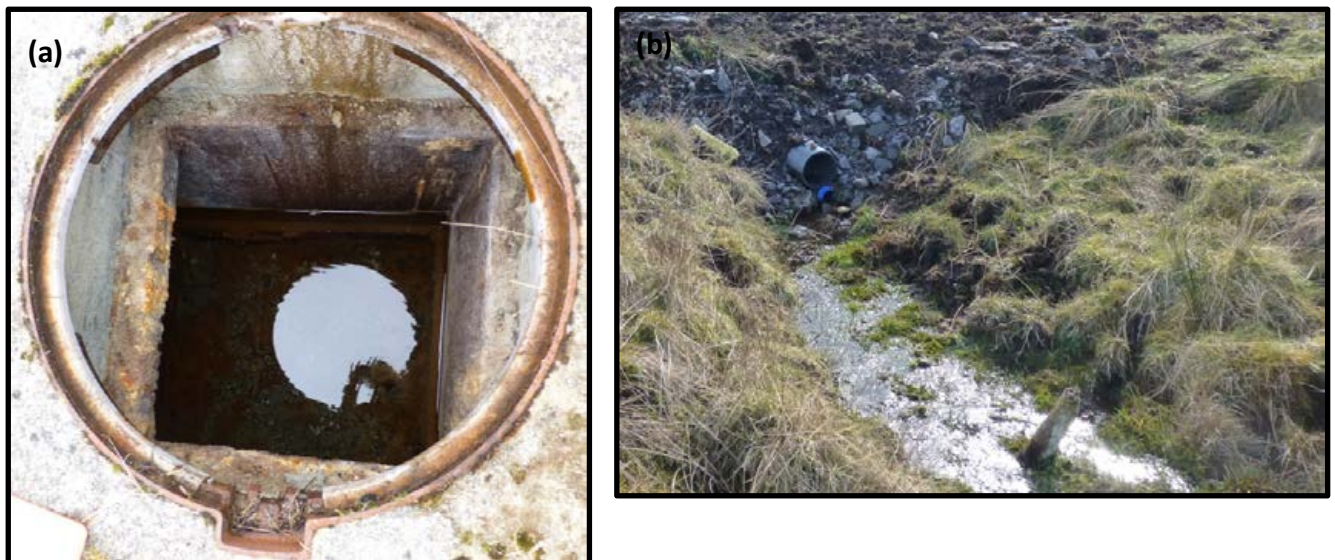
**Figure G3.22. Rossinver P.W.S. showing (a) spring chamber and (b) piped overflow.**

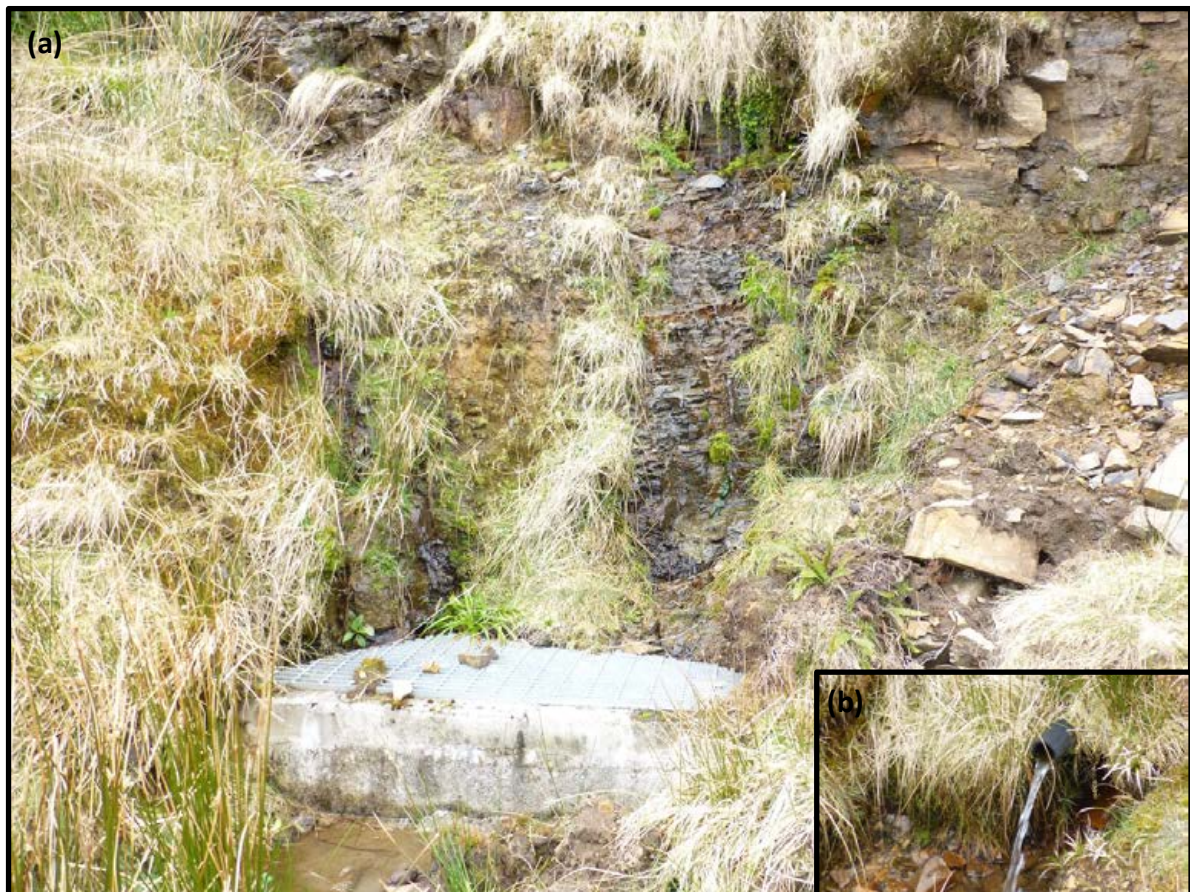
**Figure G3.23. Aghacashel G.W.S. showing (a) spring water flowing down rock face to harvesting tank and (b) piped overflow.**

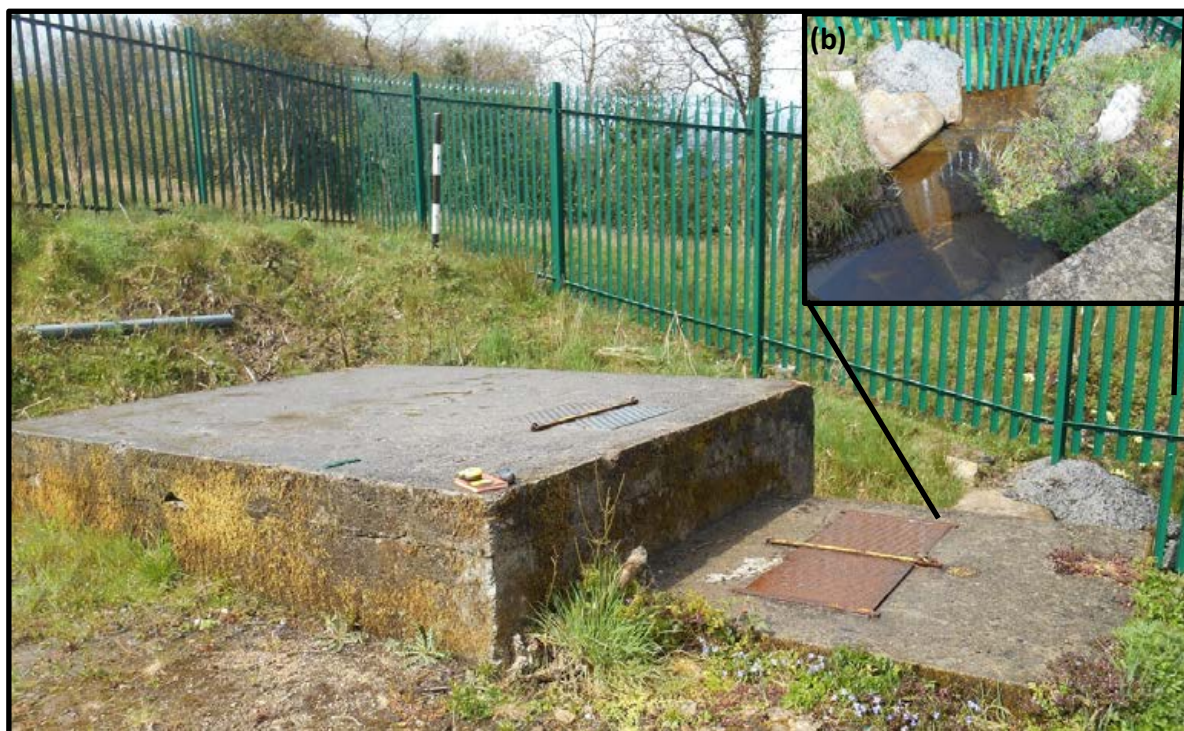
**Figure G3.24. Swanlinbar P.W.S. showing the (a) spring chamber and (b) unpiped spring overflow.**

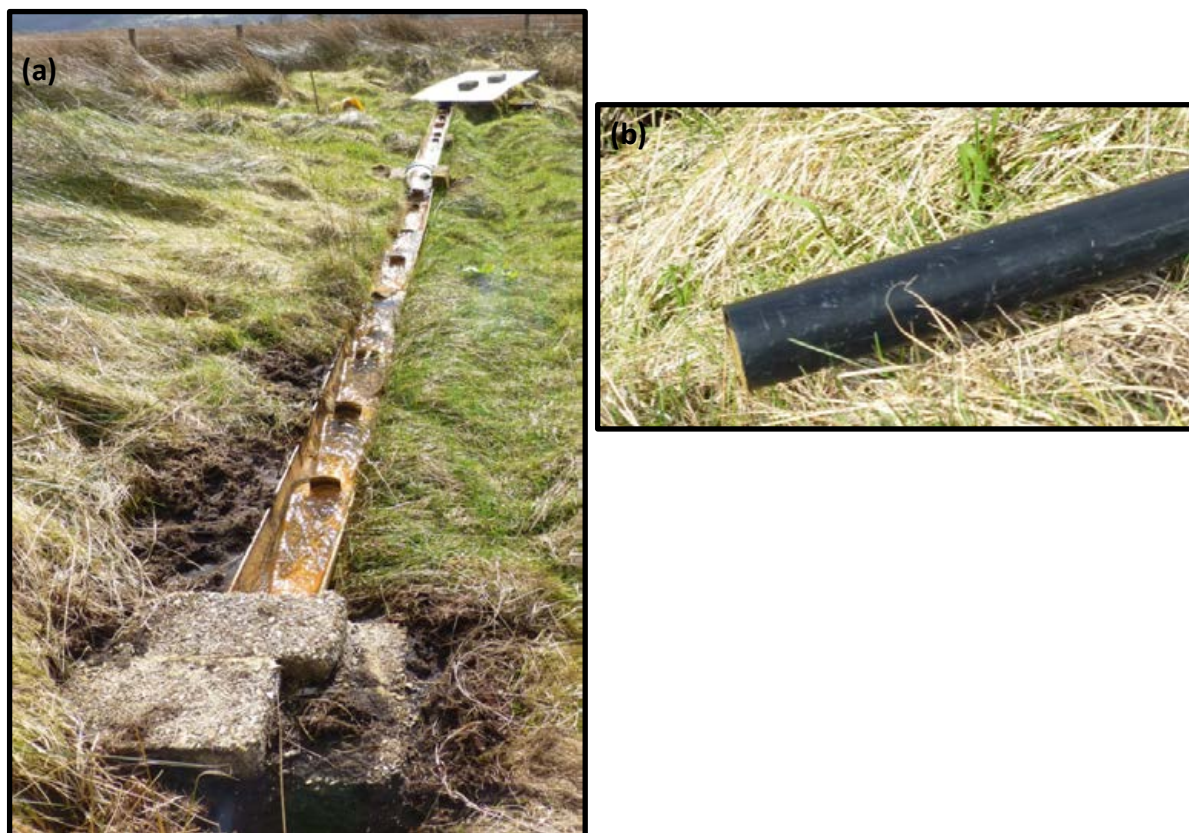
**Figure G3.25. Upper Aughagrainia G.W.S. showing (a) water channelled from spring source and (b) dry overflow pipe.**
