Drinking Water Audit Report

County:	Co. Cork	Date of Audit:	14/04/2015
Plant visited:	Crookstown PWS (Cloughduv source) (0500PUB3102)	Date of issue of Audit Report:	25/05/2015
		File Reference:	DW2010/68
		Auditors:	Cliona Ní Eidhin Michelle Roche
Audit Criteria:	<ul style="list-style-type: none"> • The <i>European Union (Drinking Water) Regulations 2014 (S.I. 122 of 2014)</i>. • The <i>EPA Handbook on the Implementation of the Regulations for Water Services Authorities for Public Water Supplies (ISBN: 978-1-84095-349-7)</i> • The recommendations specified in the <i>EPA Drinking Water Report</i>. • The recommendations in any previous audit reports.

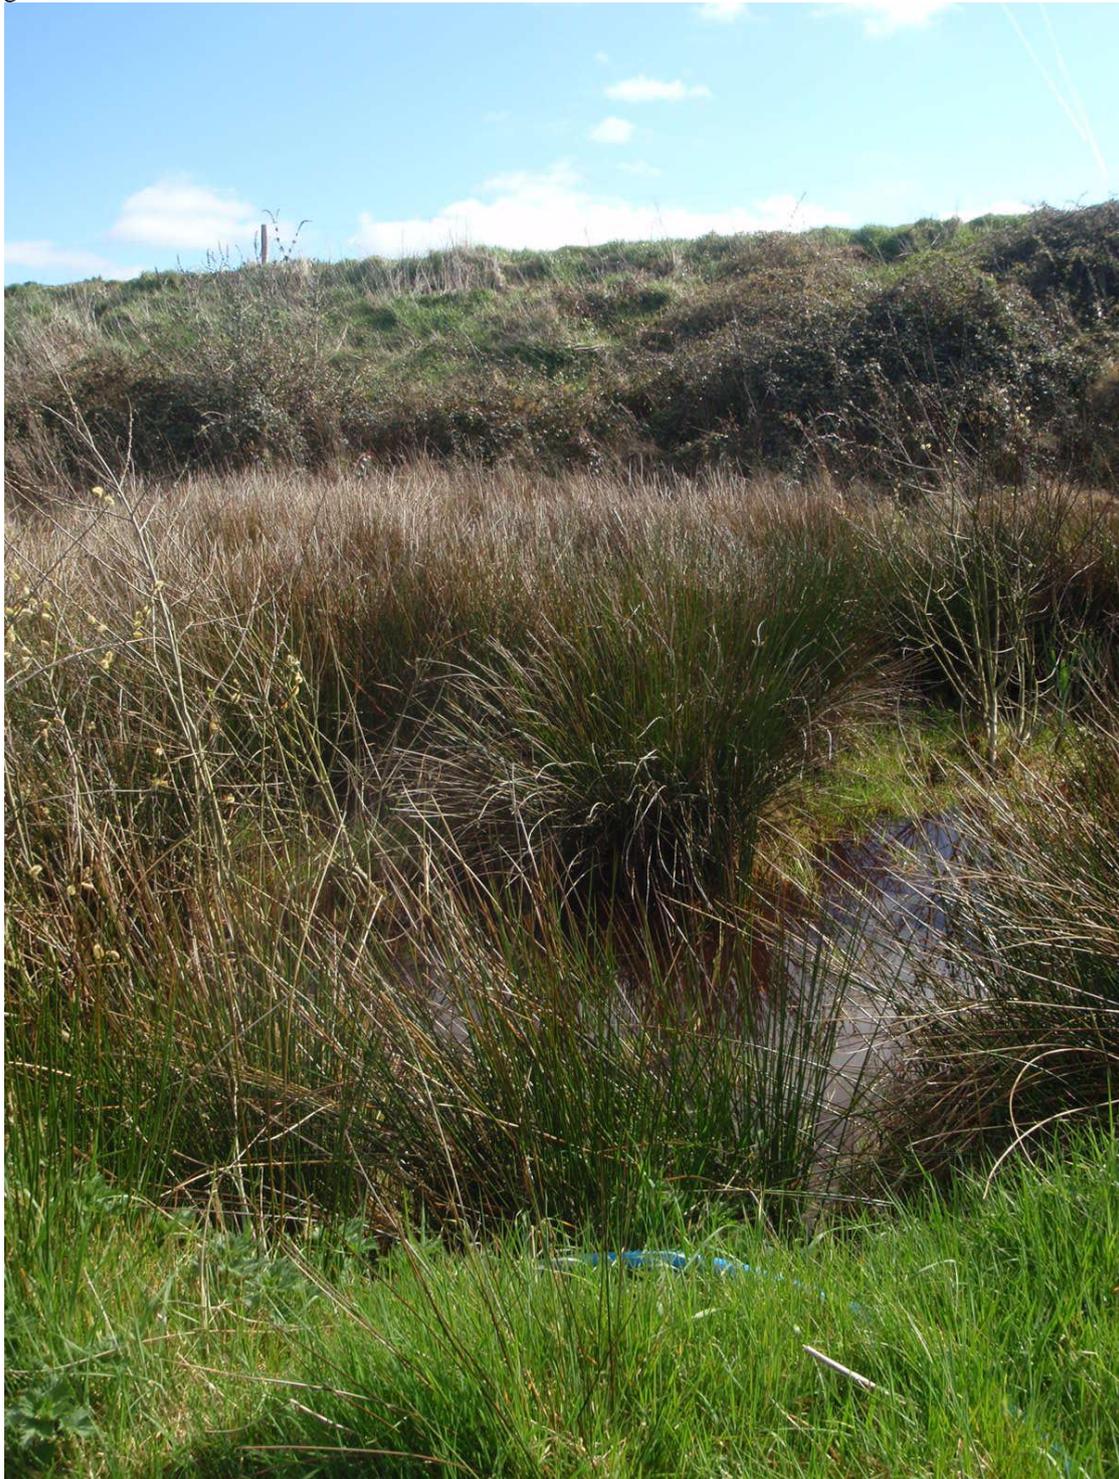
- iii. *There was no operational verification of the effectiveness of manganese removal at the treatment plant.*
- iv. *Backwash water from the pressure filters was found to be discharged to a marshy area <10 m from the working borehole from which it percolates, informally, to groundwater. This practice should cease. An alternative method for disposal for this water should be identified and put into practice as a permanent measure.*

Photograph 3: Adjacent marshy area receiving backwash water. This water percolates to groundwater.
