SITE VISIT REPORT

Purpose of Site Visit: Peat Extraction in Co. Kildare

Site Address: Ballinderry, Carbury, Co. Kildare

Date of Visit: 08/06/2022

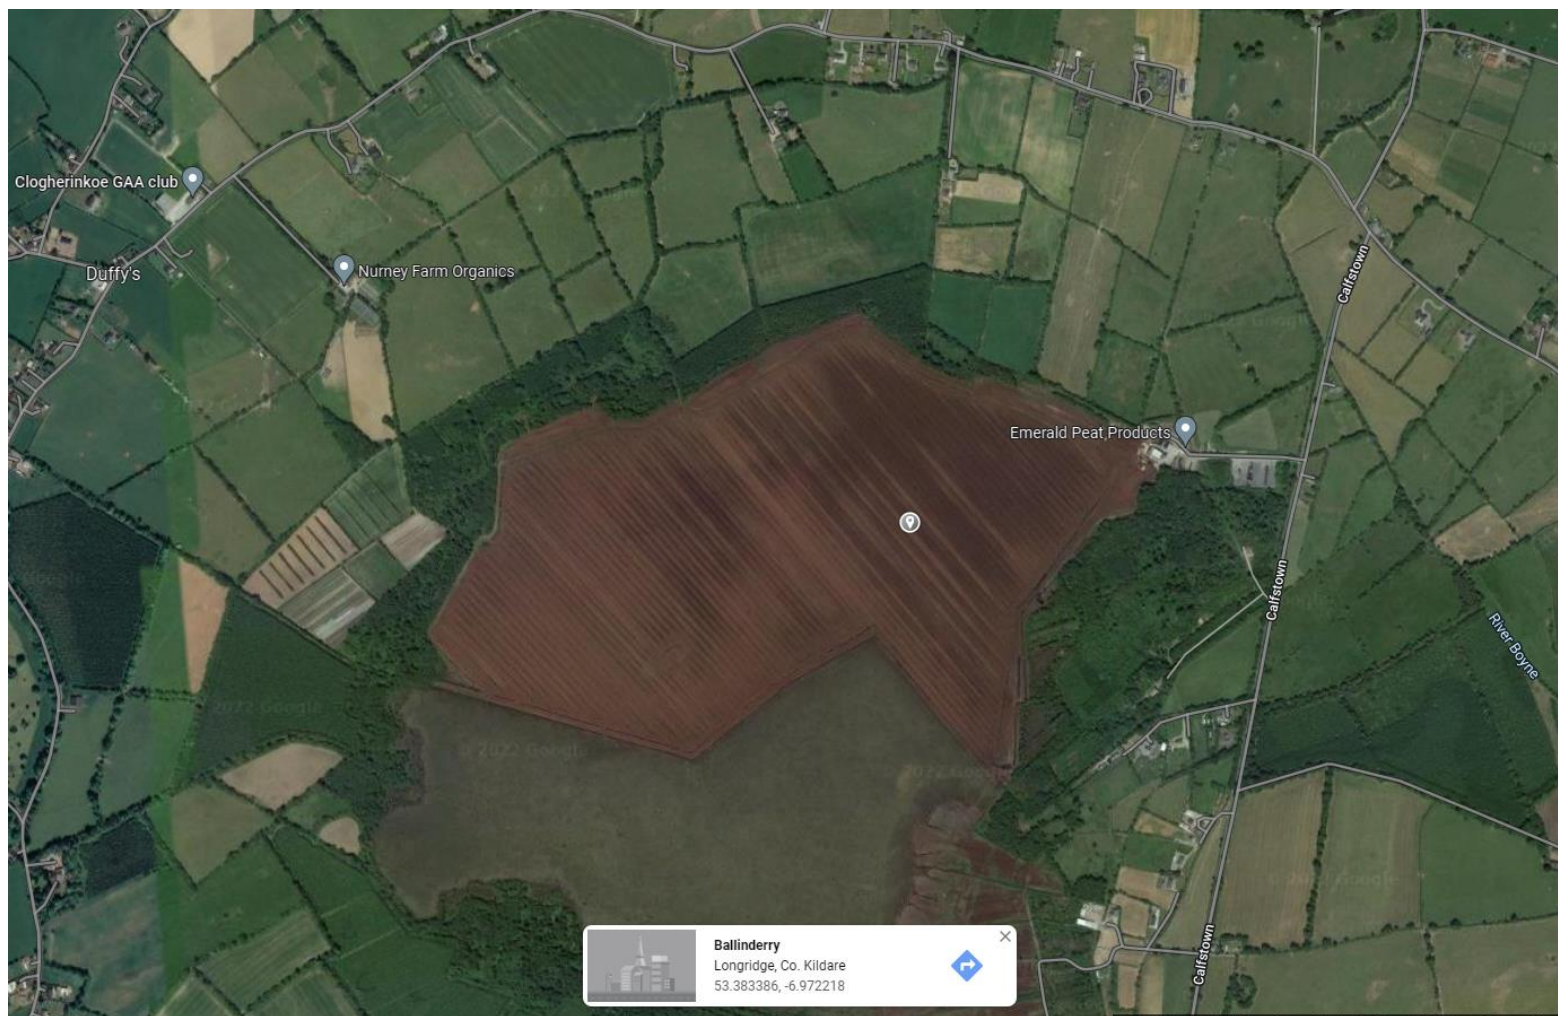
Appendix 1

- i) Ascertain whether peat extraction activities were been carried out on lands at the above address in Ballinderry, Carbury, Co. Kildare (Appendix 1).
- ii) To determine what activity and the location of the activities been undertaken was carried out.
