## C.1 Operational Information Requirements

### 1.1 The Existing Galway Waste Water Works

Project: **EPA WASTE WATER DISCHARGE LICENCE APPLICATION**

## 1.2 Mutton Island WWTP

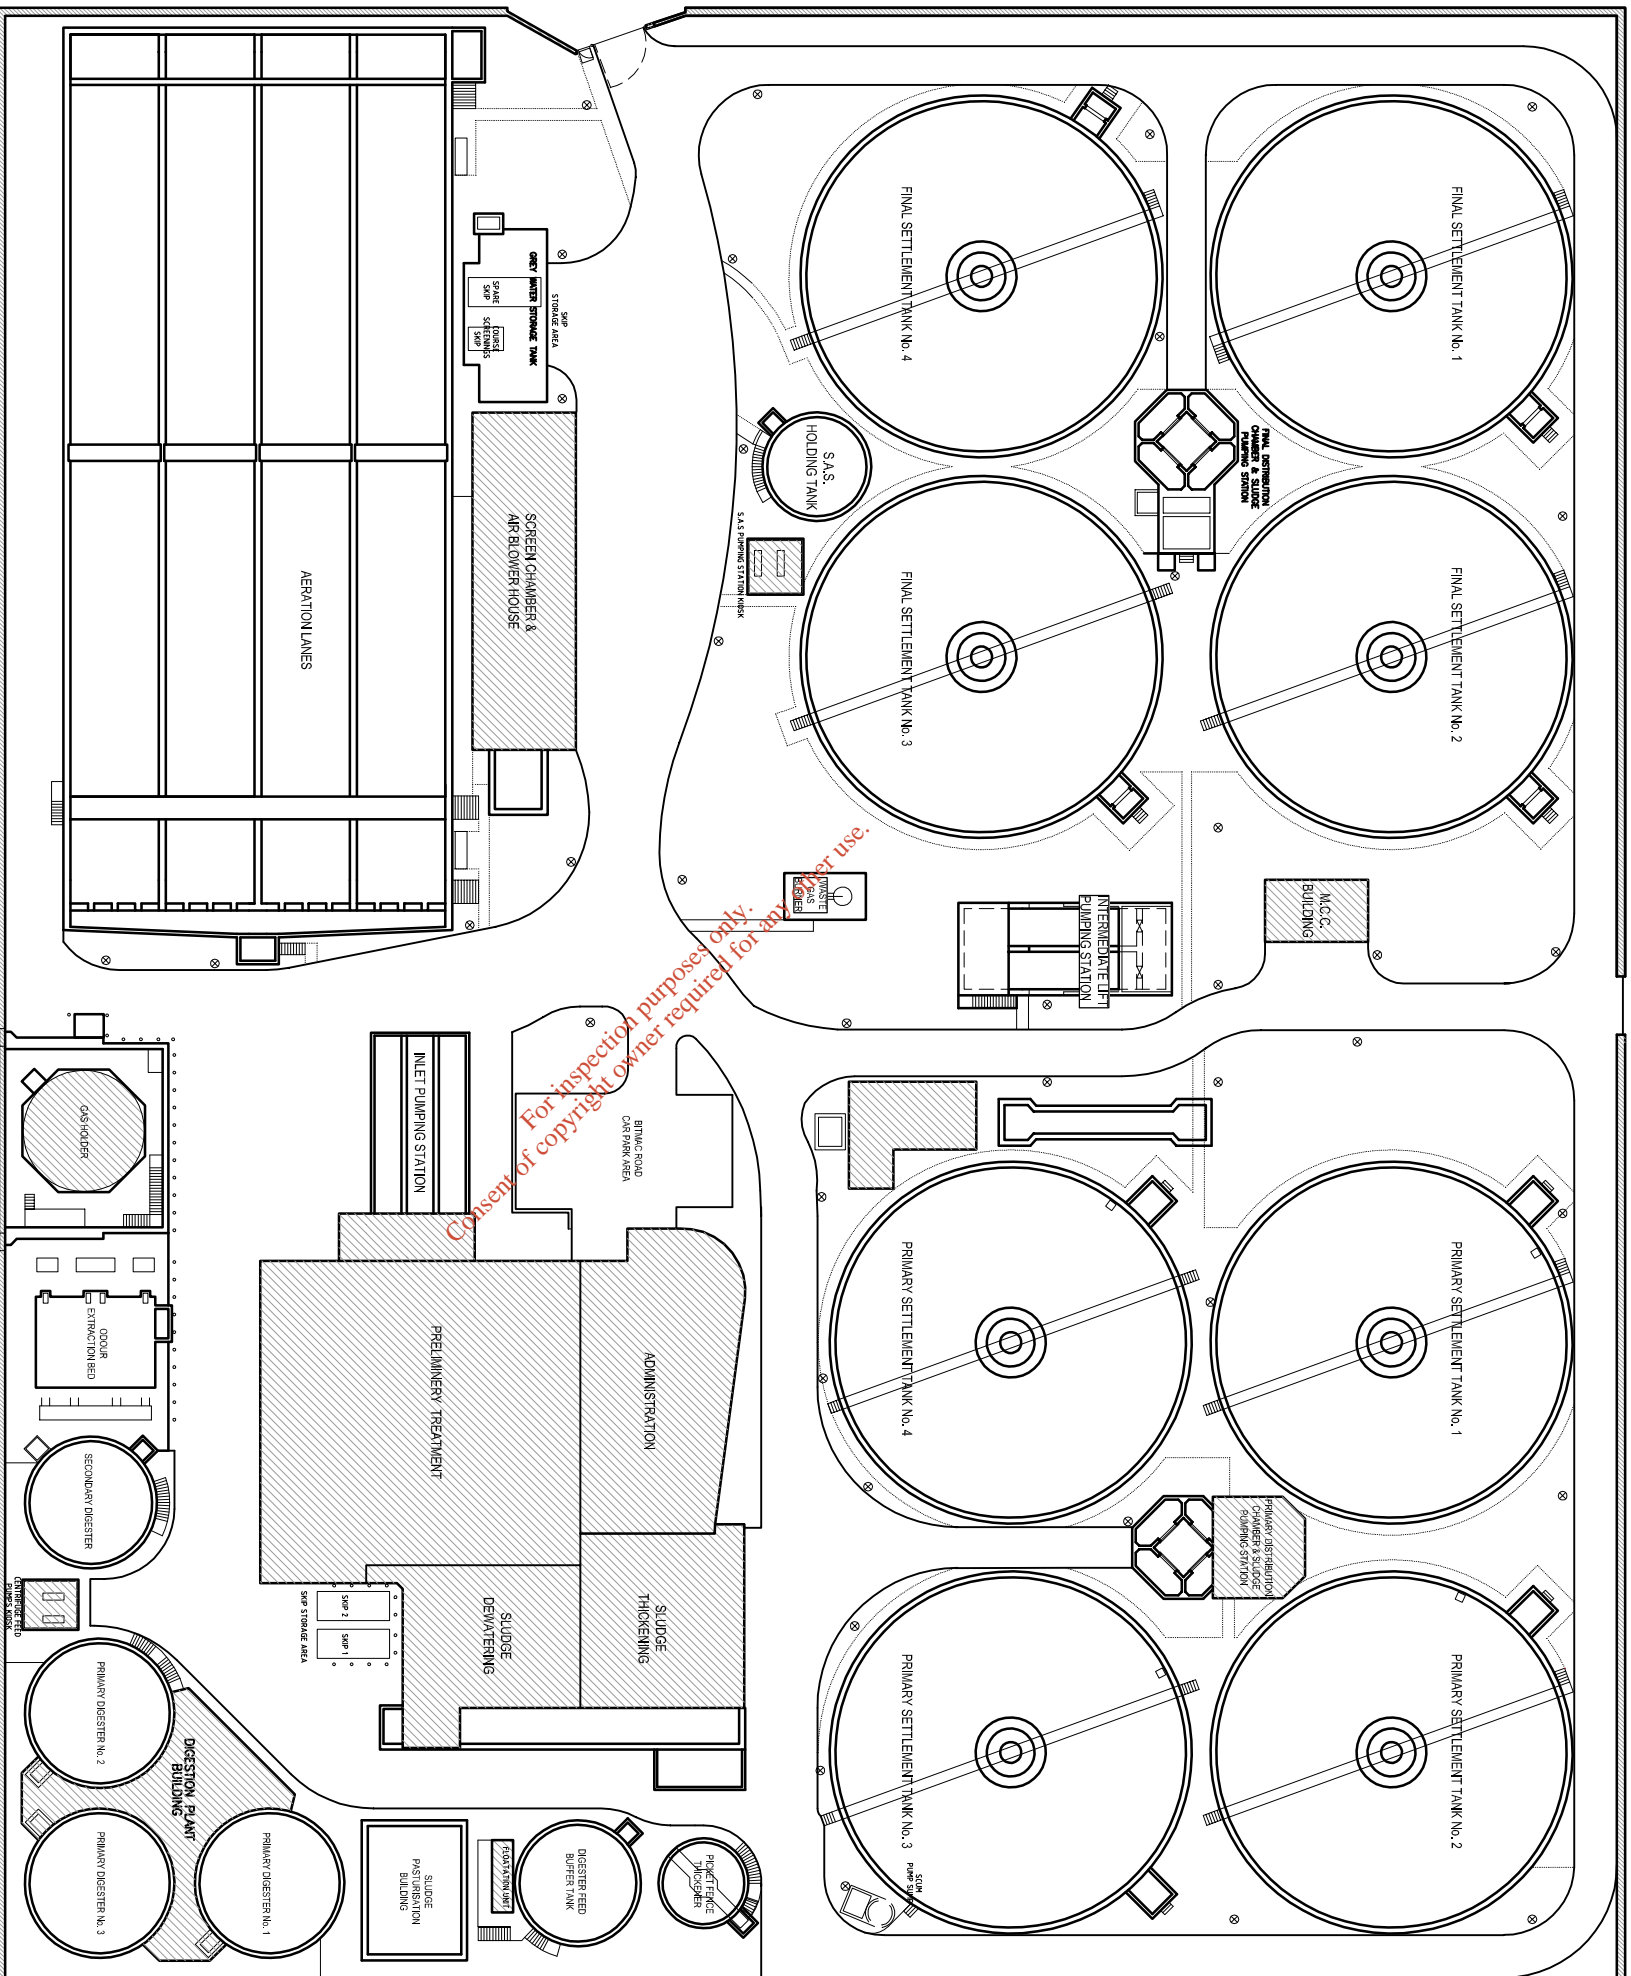
Title: **PLANT/PROCESS SITE PLAN**

Drawing No.: **2148-2619**  
 Attachment No.: **C1**

The existing operating system at the Mutton Island WWTP is illustrated in Figure 1 below, and in Attachment C1, Drawing No. 2148-2619.

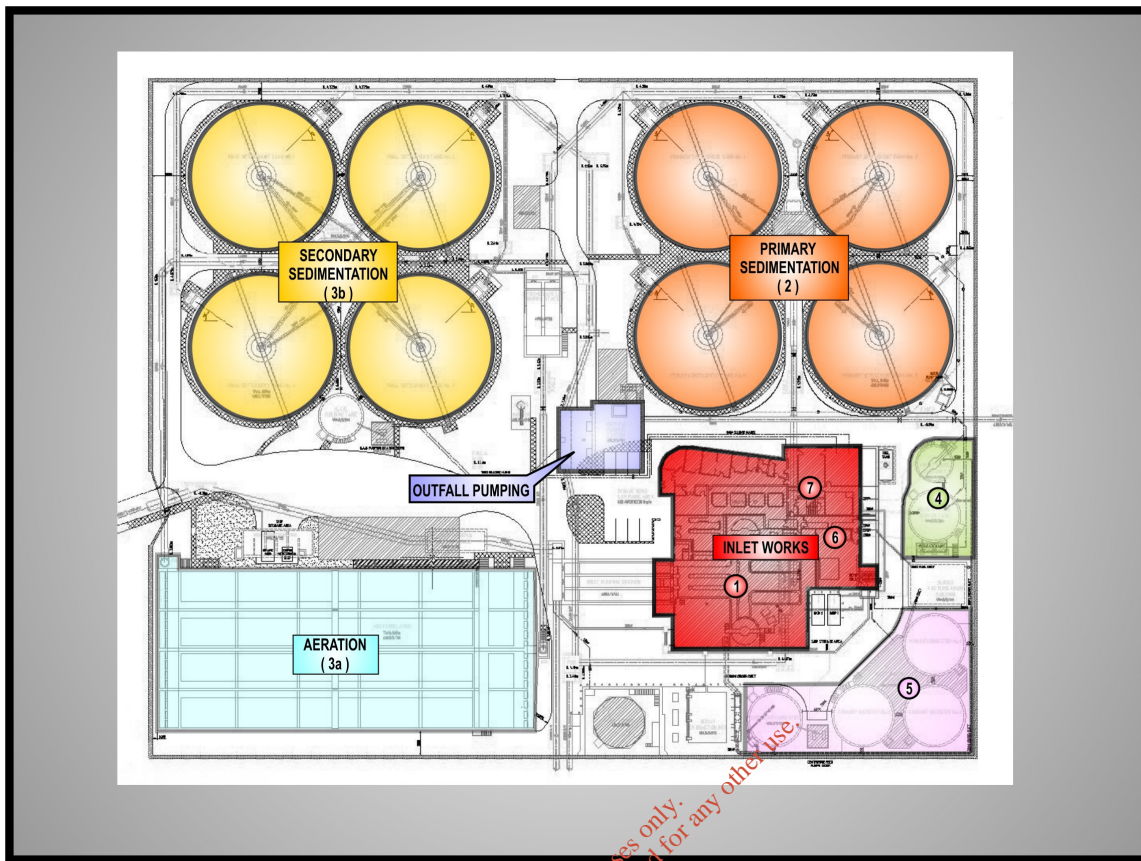
**Figure 1 - Mutton Island Site Plan**

The main elements of the treatment works units at Mutton Island WWTP are as follows:

- inlet works (incorporating screw pumps, fine screens and grit removal) (1);
- primary sedimentation tanks (2);
- an activated sludge plant, incorporating aeration tanks (3a) and final settlement tanks (3b);
- sludge holding tanks (4);
- a sludge digestion plant (5);
- sludge dewatering (6); and
- a Control and Administration Building (7).

All flows to Mutton Island WWTP arrive at the inlet sump, via gravity, through an 1800mm diameter trunk sewer laid in the causeway. Flows up to 6DWF arriving at the treatment plant, are pumped via Screw Pumps to Preliminary Treatment, consisting of screening and grit removal. At this point, flows in excess of 6DWF bypass the plant via a 1200mm diameter overflow pipe to the West Shore of Mutton Island (Secondary Discharge, SD 02).

An overflow channel arrangement at the end of the Preliminary Units allows flows up to 3DWF to advance for full treatment, and these flows are recorded by a flow monitor. Flows in excess of 3DWF overflow to the outfall wet well and discharge to sea with the treated effluent. The treated effluent from the works flows through a 900mm diameter HDPE outfall pipeline and discharges to the sea via a 100m long diffuser section, located some 400 metres south of Mutton Island (PD 01). Flows to the sea diffuser are monitored by the outlet flow monitor.
