Visual Inspection of Slurry Storage Tanks

Michael Sweeney

21st March 2012

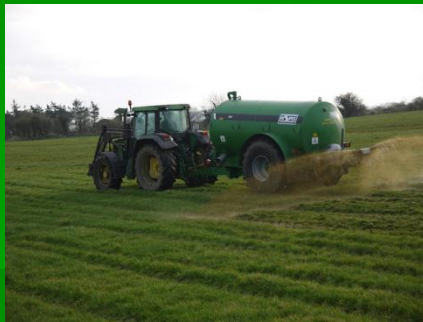
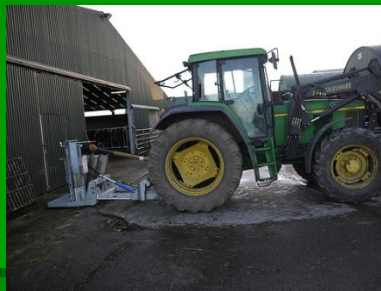
Tank Emptying

- Conventional Emptying with Vacuum Tanker or Agitation Pump

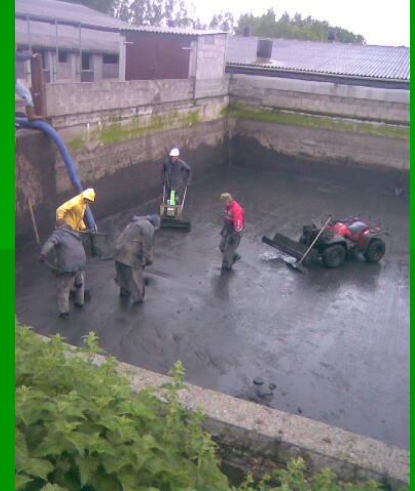
Venting and Solids Removal

- Build up of Gasses when agitating and slurry abstraction is a significant health and safety risk.
- Vacuum tank abstraction will leave a portion of solid material in the bottom of the tanks which have to be manually or mechanically handled.

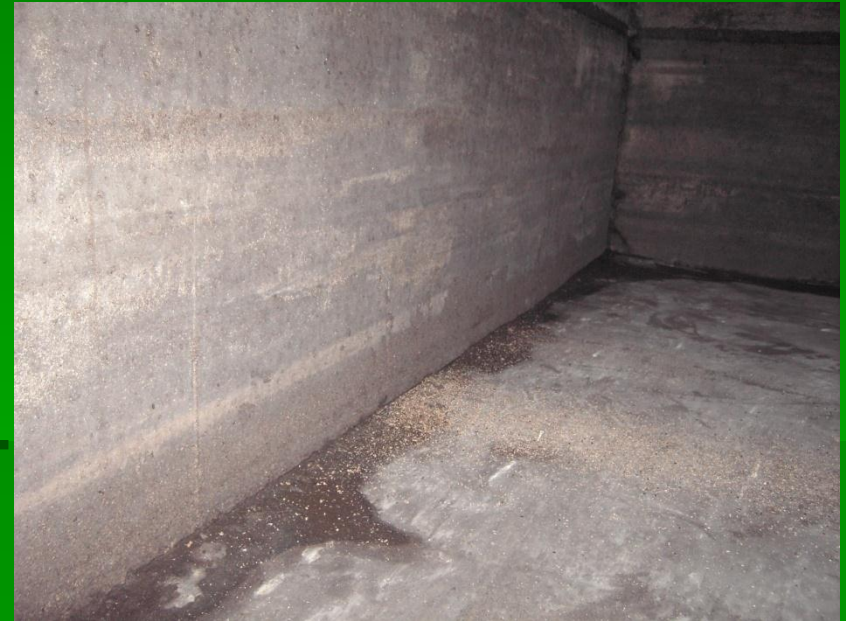
Washing down floors and walls

- Washing down is by high pressure power hose lance
- Accumulated wash water abstracted and the tank allowed to dry for Visual inspection

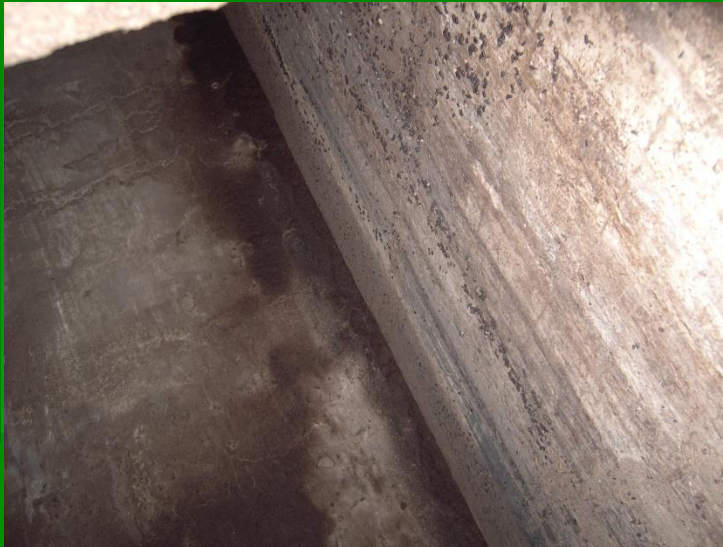
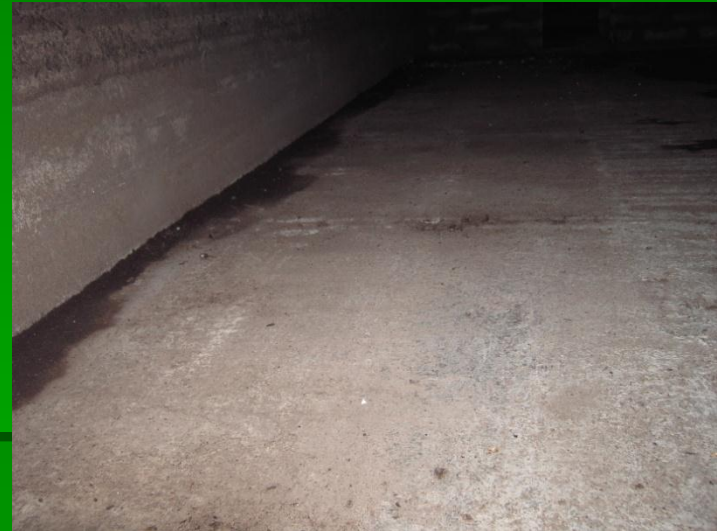
Typical Tanks & Channels

- 1.8m House Tank

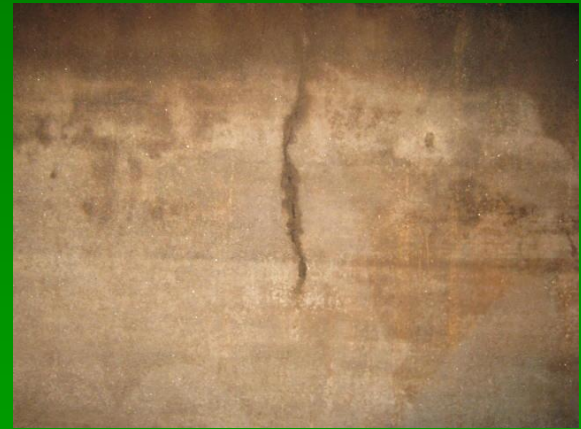
Examples of Problems and Solutions

- Tank Wall Damaged
- Repair by cutting dove tail incisions into wall

50mm deep with con saw/grinder
applying MC-Bauchemie
MC-Fix ST Regulated set
cement
