Drinking Water Audit Report

County:	Dublin City Council	Date of Audit:	23/08/2017
Plant(s) visited:	Reservoir storage (treated water), Ballyboden Water Treatment Plant Scheme Code 0700PUB1002	Date of issue of Audit Report:	25/08/2017
		File Reference:	DW2010/127
		Auditors:	Ms Ruth Barrington Ms Aoife Loughnane
Audit Criteria:	<ul style="list-style-type: none"> • The <i>European Union (Drinking Water) Regulations 2014 (S.I. 122 of 2014)</i>. • The <i>EPA Handbook on the Implementation of the Regulations for Water Services Authorities for Public Water Supplies (ISBN: 978-1-84095-349-7)</i> • The recommendations in a previous EPA audit report issued 09/11/2010.

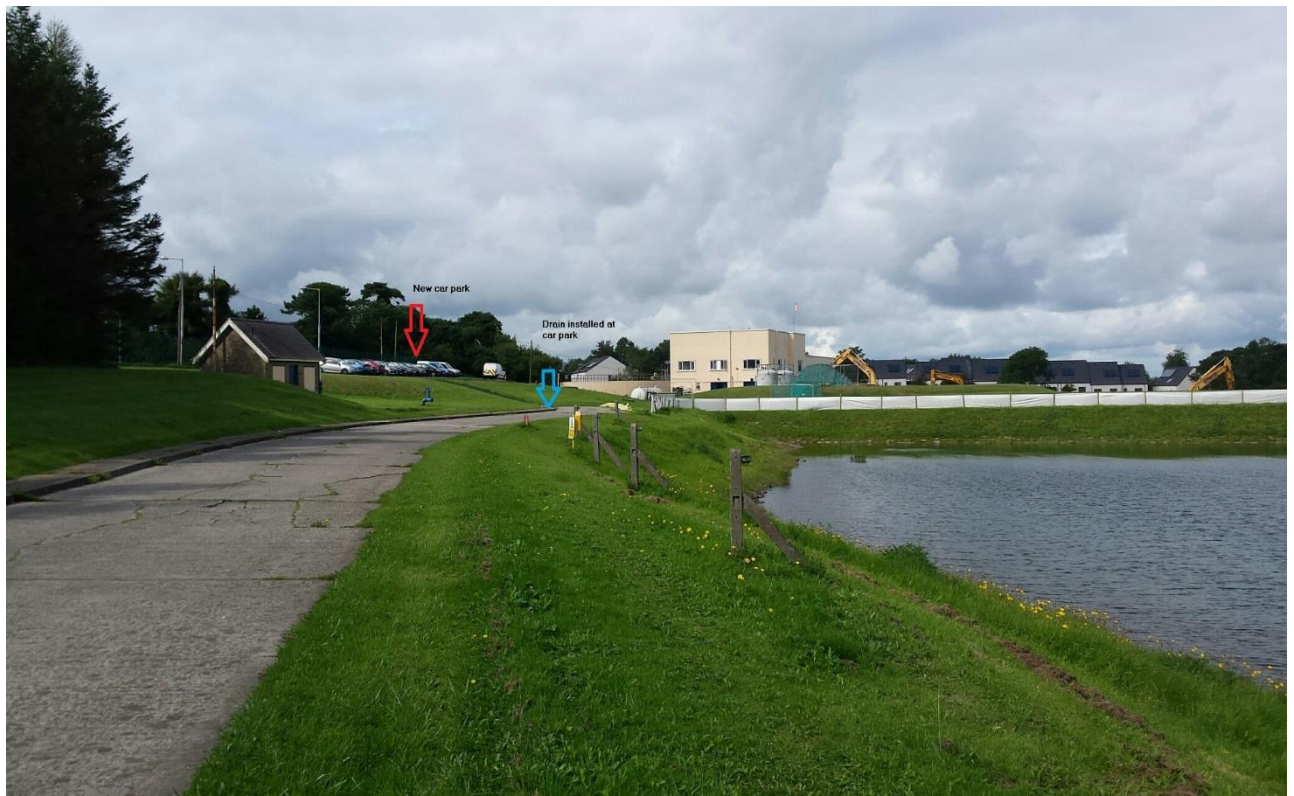
Photo 1. View of Ballyboden access road and open reservoir, showing the new car park and location of the interceptor drain
