# Drinking Water Audit Report

<b>County:</b>	Tipperary	<b>Date of Audit:</b>	08/12/16
<b>Plant(s) visited:</b>	Fethard Regional Public Water Supply – Supply Code 2900PUB0137	<b>Date of issue of Audit Report:</b>	22/12/16
		<b>File Reference:</b>	DW2008/525 (Cloran) DW2008/526 (Gortnapisha)
		<b>Auditors:</b>	Ms. Criona Doyle Mr. Niall Dunne
<b>Audit Criteria:</b>	<ul style="list-style-type: none"> <li>• The <i>European Union (Drinking Water) Regulations 2014 (S.I. 122 of 2014)</i>.</li> <li>• <i>The EPA Handbook on the Implementation of the Regulations for Water Services Authorities for Public Water Supplies (ISBN: 978-1-84095-349-7)</i></li> <li>• The recommendations specified in the <i>EPA Drinking Water Report</i>.</li> <li>• EPA Drinking Water Advice Notes No.s 1 to 15.</li> </ul>

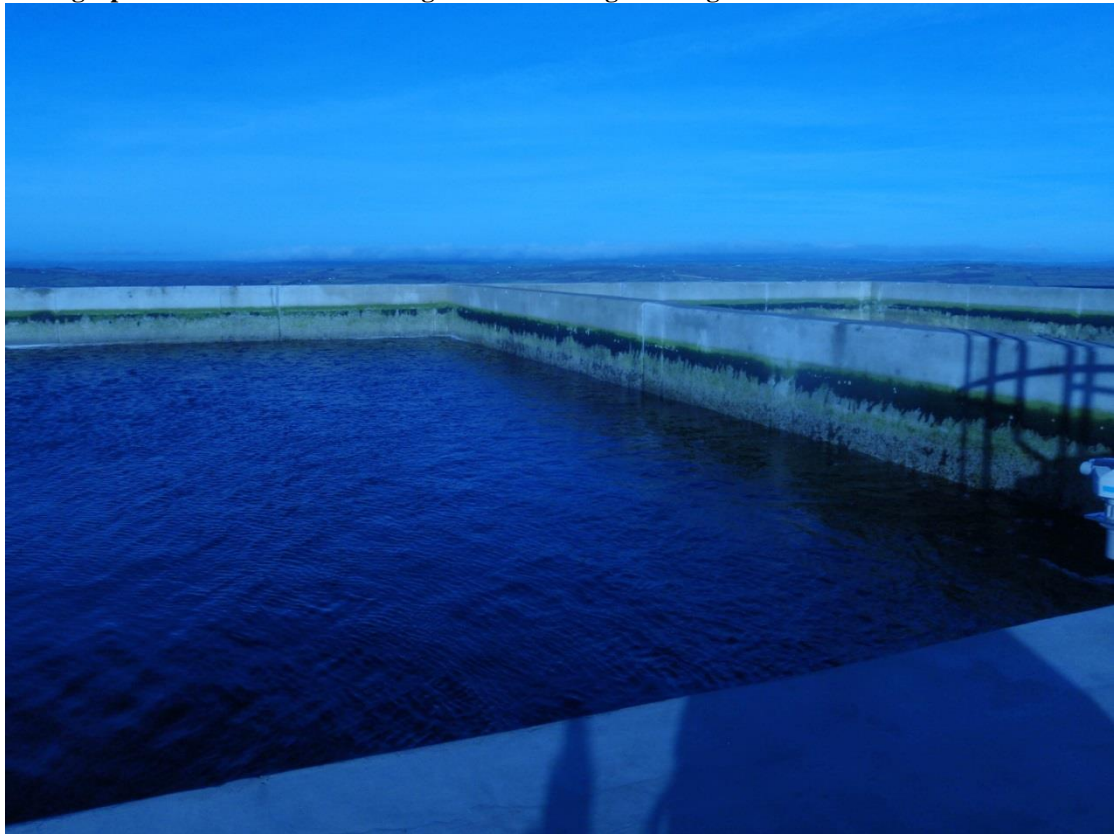
<b>10.</b>	<p><b>Treated Water Storage and Distribution Network</b></p> <ul style="list-style-type: none"> <li>a. A twin cell reservoir with a capacity of 6,900m<sup>3</sup> provides 30 hours treated water storage (15 hours per cell).</li> <li>b. All hatches were locked.</li> <li>c. The vents were fitted with suitably sized mesh to prevent ingress of insects or vermin.</li> <li>d. The planned reservoir maintenance includes an annual drain down and inspection.</li> <li>e. There are two flow metres with isolation vales on the outlet from the reservoir to separately supply the Cloran and Gortnapisha networks.</li> </ul>
<b>11.</b>	<p><b>Hygiene and Housekeeping</b></p> <ul style="list-style-type: none"> <li>a. Raw water from the 4 no. sources is mixed in the twin cell raw water tank which is fitted with a baffle wall to ensure good mixing. Each individual cell provides two hours storage and the cells can be isolated to facilitate cleaning. Typically cleaning takes place every 2 to 3 months. A build up of algae was visible on the inside of the walls of the raw water storage tank (Photograph No. 1). Glan Agua outlined that cleaning of the walls is scheduled</li> </ul>

to take place during December 2016.
--	-------------------------------------

**Photograph No. 1: Raw Water Storage Tank Showing Staining on Walls**

8. Irish Water should ensure that regular cleaning of the walls of the raw water storage tanks is undertaken.
