# Drinking Water Audit Report

County:	Waterford	Date of Audit:	15/05/2017	
Plant(s) visited:	Clonea - Power WTP (3100PUB1031)	Date of issue of Audit Report:	02/06/2017	
		File Reference:	DW2015/78	
		Auditors:	Mr Niall Dunne	
Audit Criteria:	• The European Union (Drinking Water) Regulations 2014 (S.I. 122 of 2014).			
	• The EPA Handbook on the Implementation of the Regulations for Water Services Authorities for Public Water Supplies (ISBN: 978-1-84095-349-7)			
	• The recommendations specified in the EPA <i>Drinking Water Report</i> .			
	EPA Drinking Water Advice Notes No.s 1 to 15.			
	The recommendations in any previous audit reports.

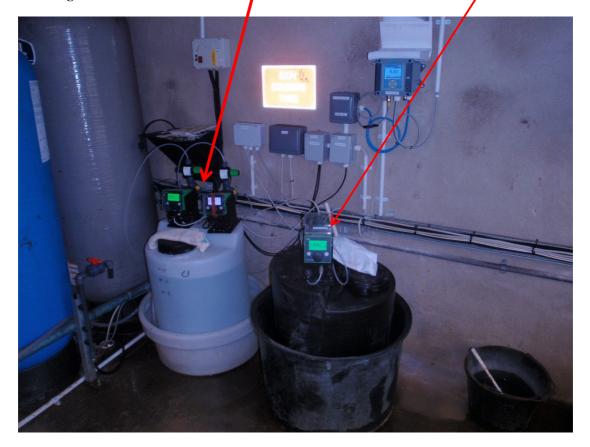
- a. At this plant manganese is brought out of solution via oxidation. Oxidation is achieved by chlorinating the water prior to filtration. The chlorine dosing pumps are set to a duty/assist, flow proportional dosing arrangement, (see photograph 1), however, only one of the pumps is continually set as the duty pump i.e. duty dosing is not altered between the pumps. Auto switchover between the pumps is in place but the system is not alarmed or linked to a monitor or a recording device, (see photograph 1).

- b. Prior to oxidation pH is adjusted with sodium hydroxide. The sodium hydroxide is dosed via a single duty dosing pump (see photograph 1). The target pH is 8.5. The reading on the pH monitor at the time of the audit was 8.82. The pH monitor is not linked to a recording device.

Photograph 1: Oxidation / pre chlorination, dosing via duty/standby pumps. This dosing system is not connected to a chlorine residual monitor. Sodium Hydroxide (pH adjustment) is dosed via a duty pump there is no standby dosing pump. Neither system is alarmed or connected to a recording device.

- 1. Irish Water should continue to monitor the performance of the pressure filter with regard to the removal of manganese and should progress the installation of the second pressure filter.
- 2. Irish Water should continue to submit monthly manganese monitoring results and updates on the decommissioning of the plant on a quarterly basis.
- 3. Irish Water should install a monitor on the pre-chlorination oxidation systems and link this and the pH monitor to a recording device with dial out alarms.

- 4. Irish Water should ensure that the duty chlorine dosing is regularly altered between the chlorine dosing pumps.
- 5. Irish Water should ensure that calibration stickers are placed on all the monitoring equipment including the caretaker's handheld chlorine residual monitor.
- 6. Irish Water should investigate what impact the backwash water is having on the stream it is being discharged to.
